Inspection Report

To: Bill McGraw (Cheswick Generating Station)
From: Richard Southorn, P.E., P.G.
Re: Cheswick Ash Disposal Site – Annual CCR Unit Inspection Report
Inspection Date: November 12, 2020
Report Date: January 15, 2021

Project: Cheswick Landfill 2020 Annual Inspection

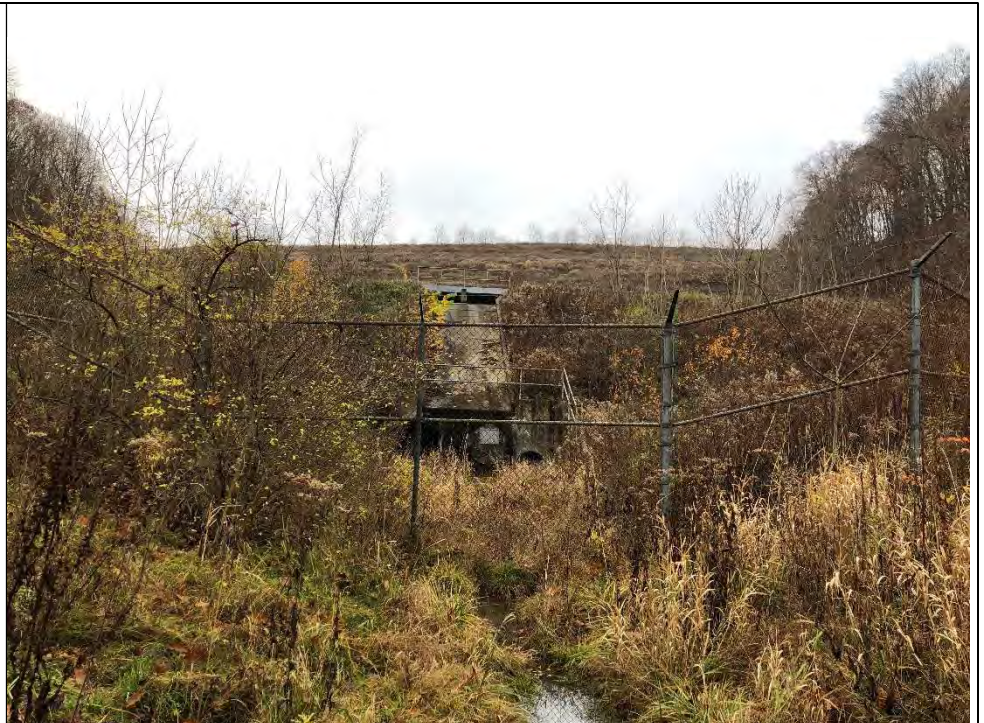
Image: 7990
Date: 11/12/2020
Time: 7:06 AM
Direction: West

View of Sedimentation Pond spillway. Clear of debris. Landfill is in background.

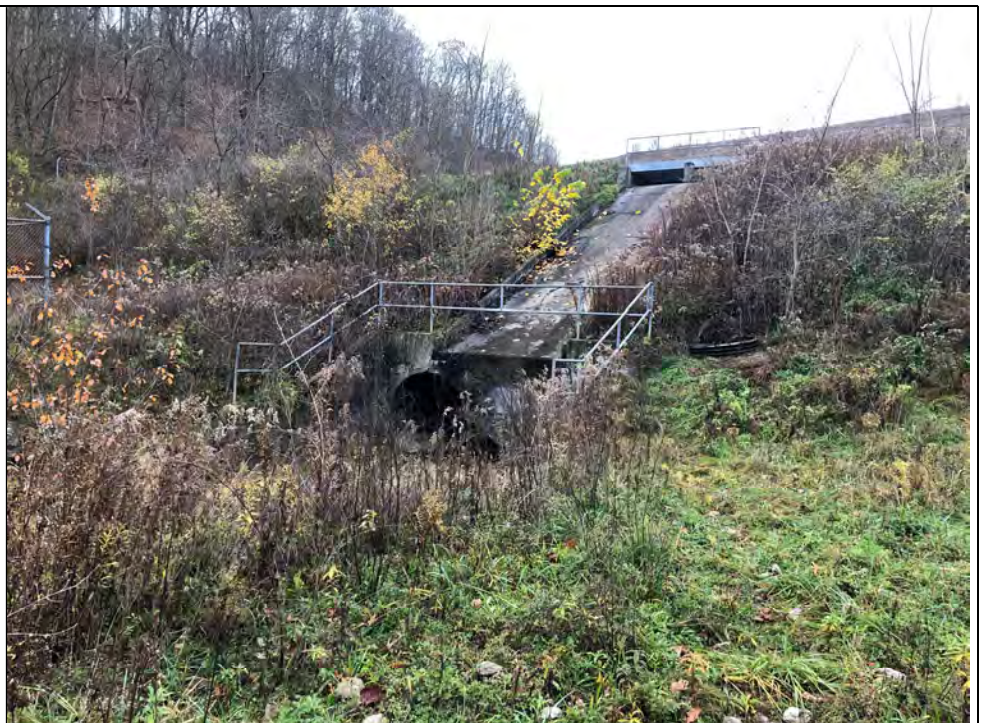
Image: 7992
Date: 11/12/2020
Time: 7:07 AM
Direction: Southwest

Description: View of Sedimentation Pond spillway. Clear of debris.

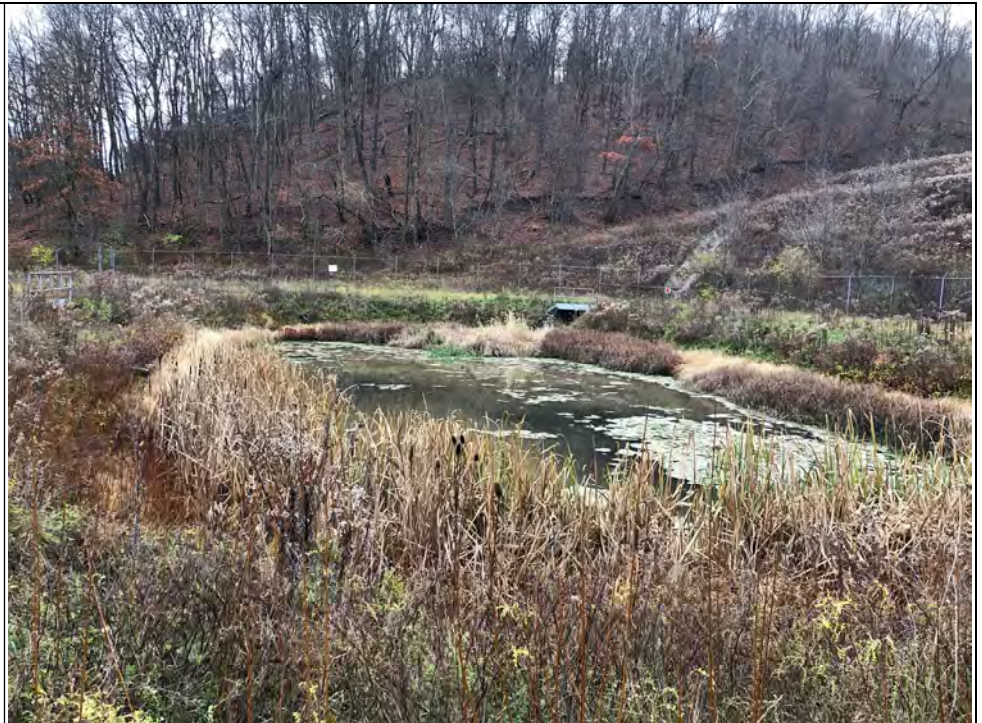
Image: 7994
Date: 11/12/2020
Time: 7:10 AM
Direction: South

Sedimentation Pond.
Healthy vegetation on pond
sideslopes. No trash noted
on water surface or in
surrounding vegetation.

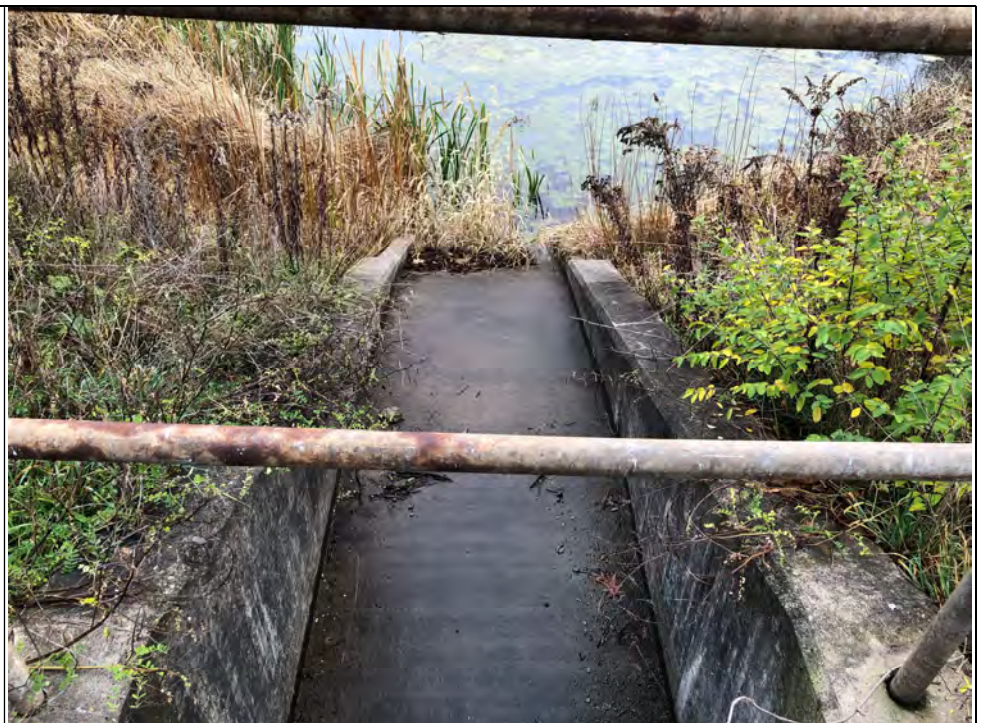
Image: 7996
Date: 11/12/2020
Time: 7:11 AM
Direction: East

Outfall 010 inlet to
Sedimentation Pond
looking downslope.
Functioning as intended.

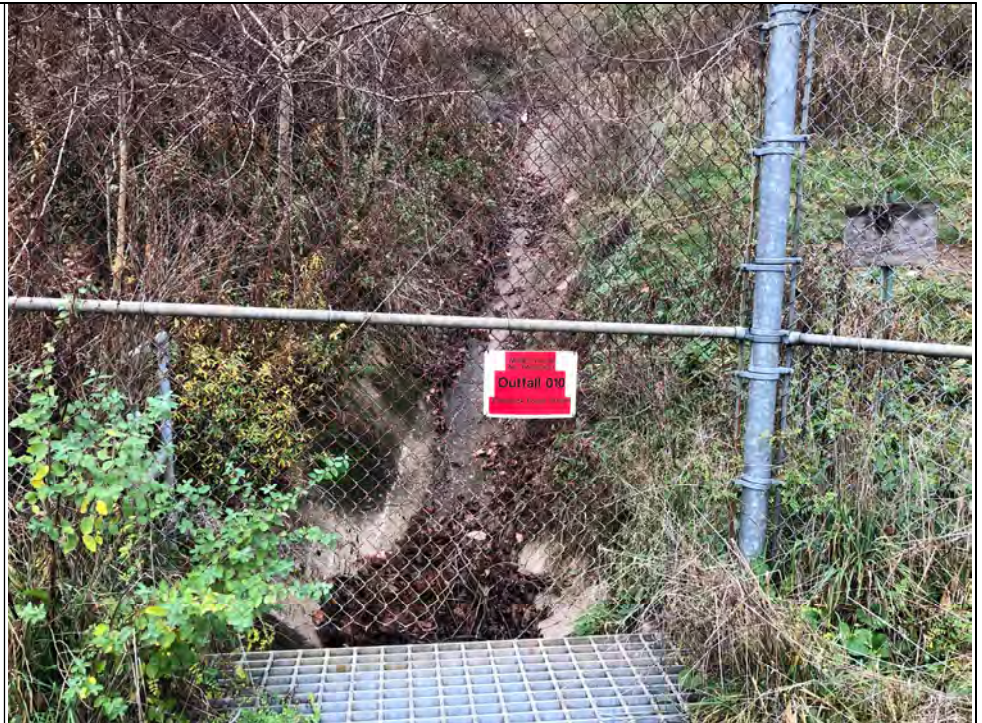
Image: 7998
 Date: 11/12/2020
 Time: 7:11 AM
 Direction: West-Northwest

North non-contact water channel (at Outfall 010) inlet to Sedimentation Pond looking upslope. Some leaves are present in channel, which are regularly removed during autumn. Functioning as intended.

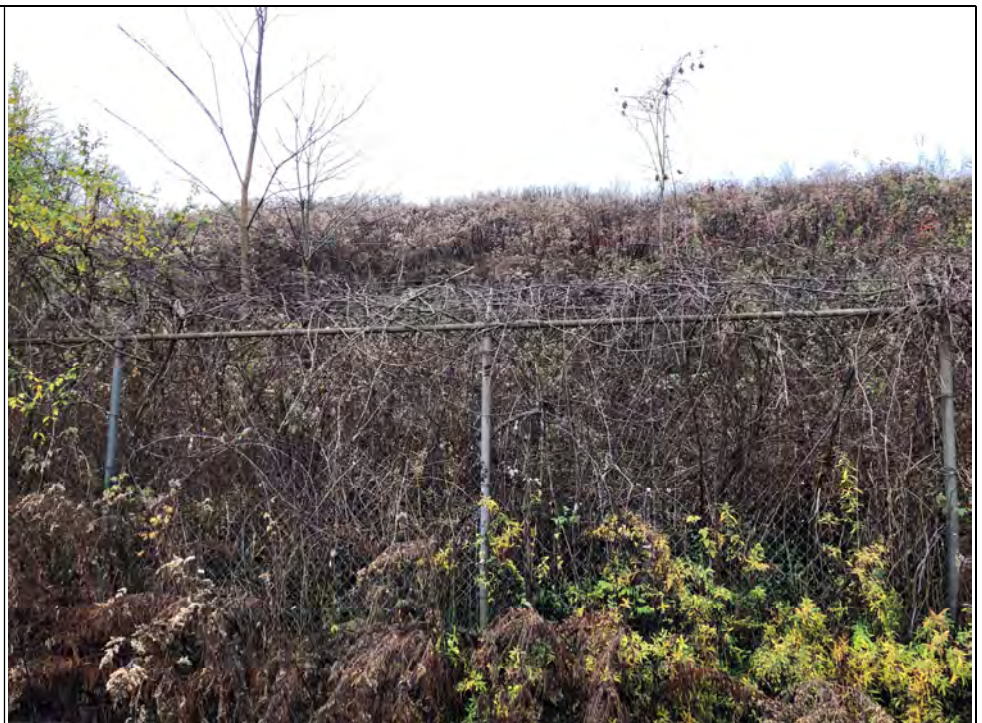
Image: 8001
 Date: 11/12/2020
 Time: 7:12 AM
 Direction: West-Southwest

The toe of the landfill slope is located at the fenceline. No evidence of erosion, sloughing, or indications of stability issues. Vegetation is healthy and present across the entire sideslope.

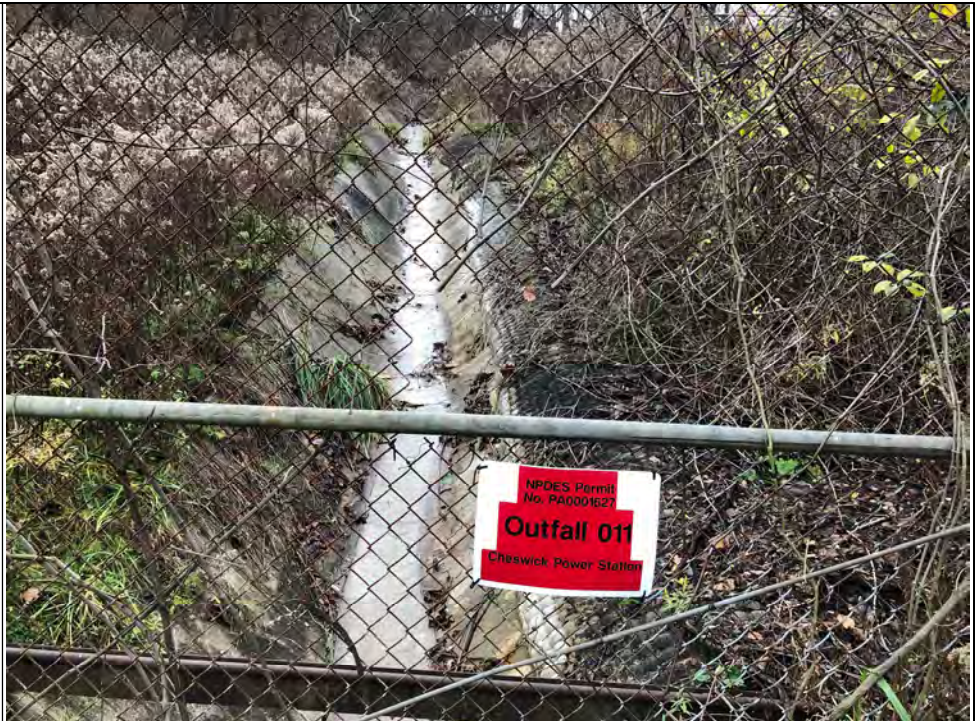
Image: 8003
Date: 11/12/2020
Time: 7:12 AM
Direction: Southwest

South non-contact water channel (at Outfall 011) inlet to Sedimentation Pond looking upslope. Clear of debris. Functioning as intended.

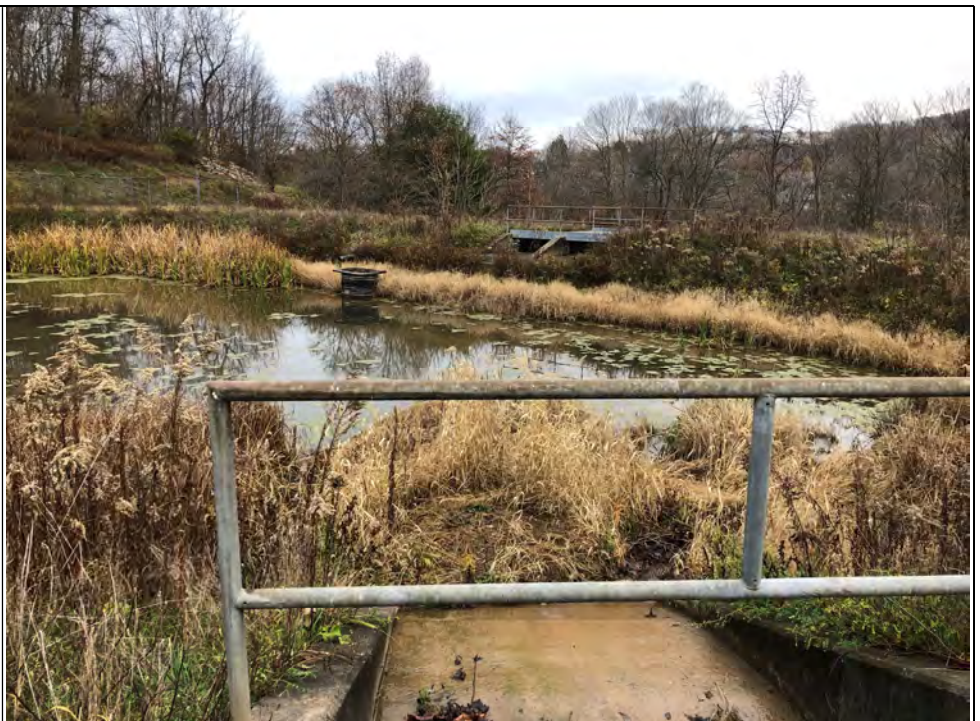
Image: 8005
Date: 11/12/2020
Time: 7:13 AM
Direction: North-Northeast

Outfall 011 inlet to Sedimentation Pond looking downslope. Concrete flume has minor leaves and autumnal debris, which are regularly removed. Functioning as intended.

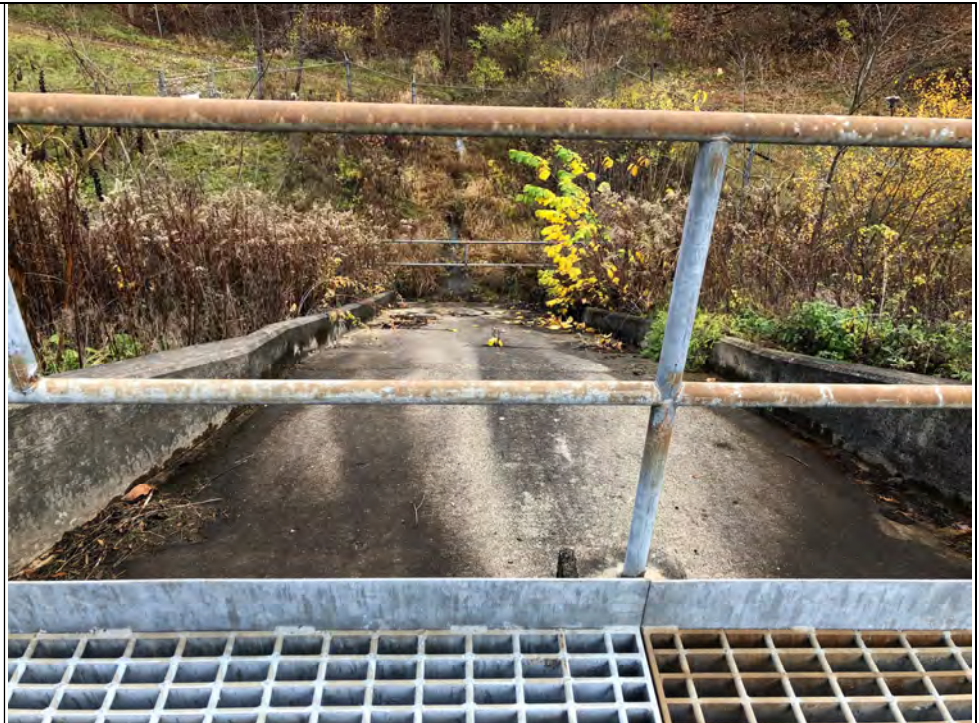
Image: 8008
Date: 11/12/2020
Time: 7:15 AM
Direction: Northeast

View of Sedimentation Pond spillway from above. Clear and in good condition.

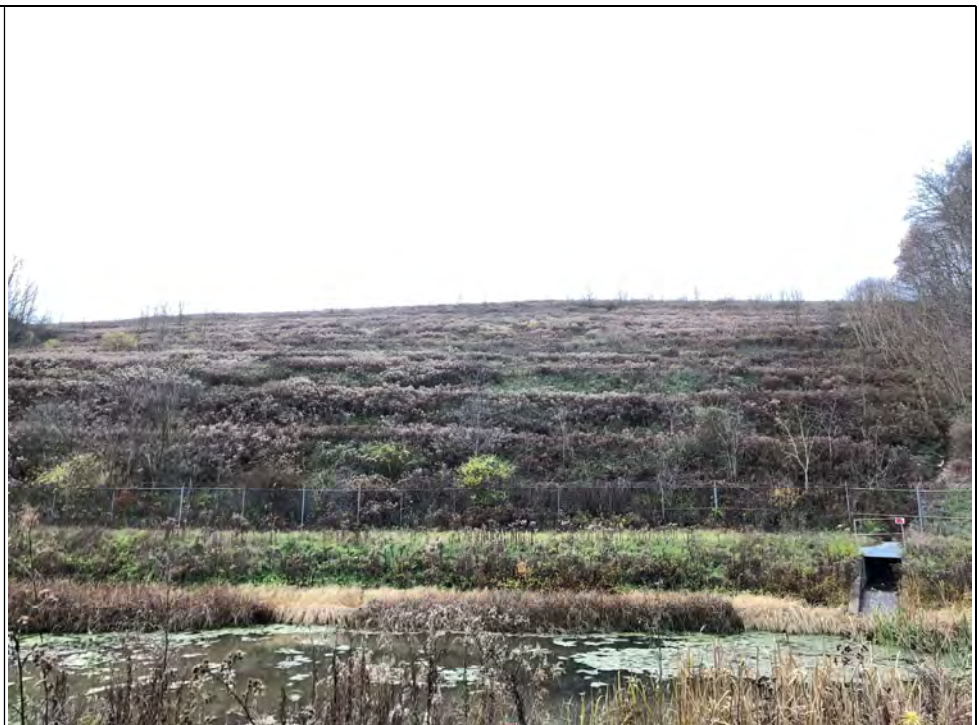
Image: 8010
Date: 11/12/2020
Time: 7:15 AM
Direction: West

Overview of landfill. Vegetation is healthy with no identified distressed vegetation areas.

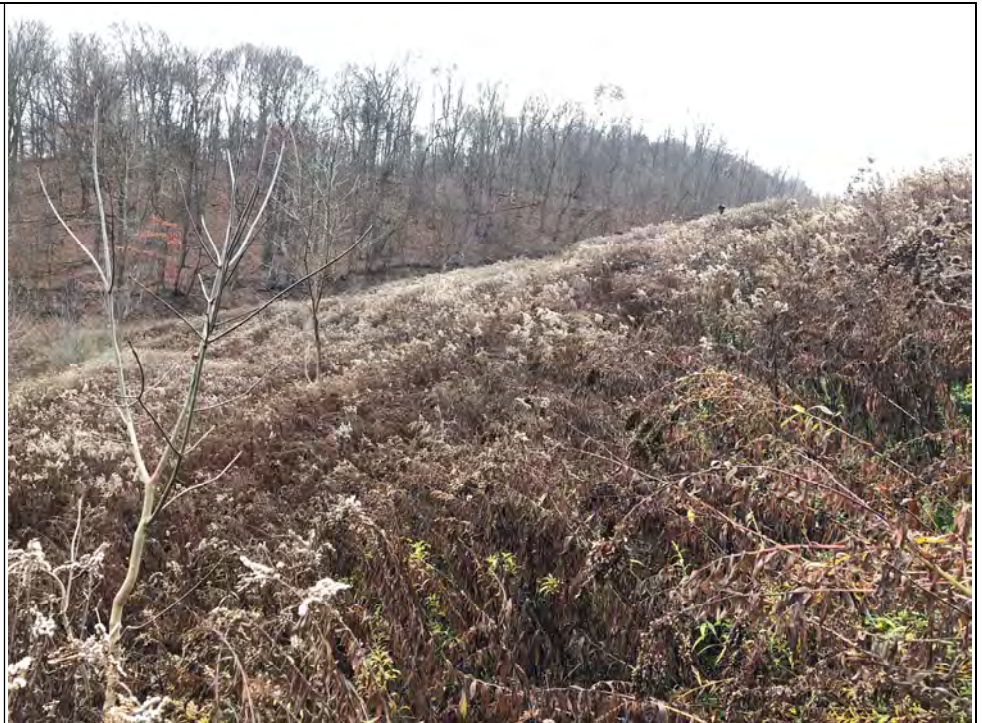
Image: 8012
Date: 11/12/2020
Time: 7:17 AM
Direction: South

Vegetation is healthy and present across the entire sideslope. No evidence of erosion, sloughing, or indications of stability issues.

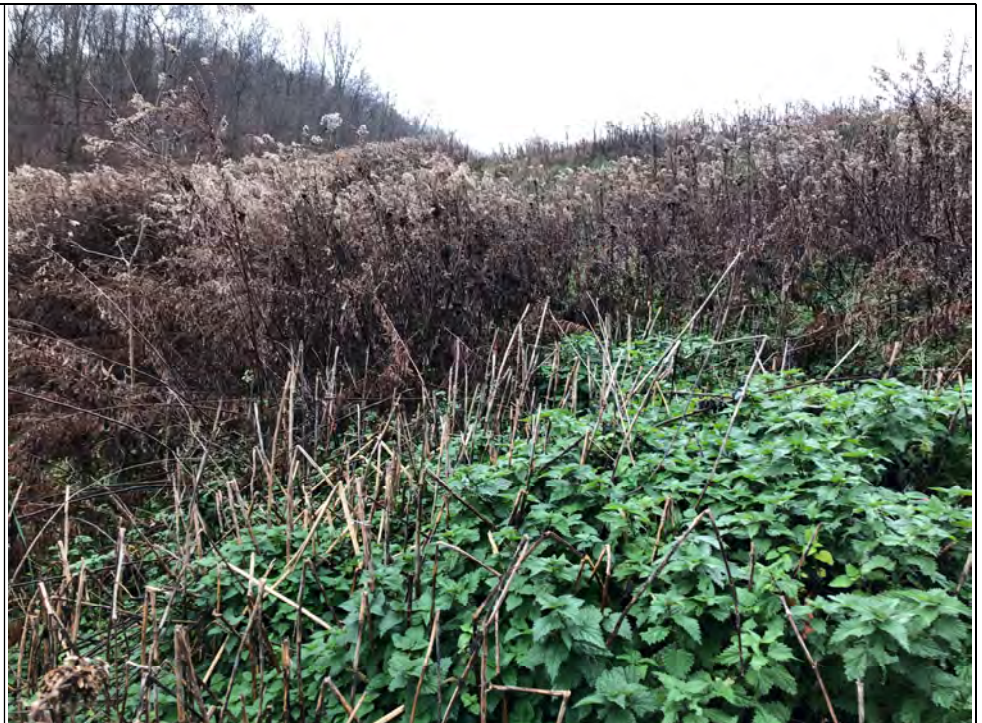
Image: 8014
Date: 11/12/2020
Time: 7:17 AM
Direction: Southwest

Vegetation is healthy and present across the entire sideslope. No evidence of erosion, sloughing, or indications of stability issues.

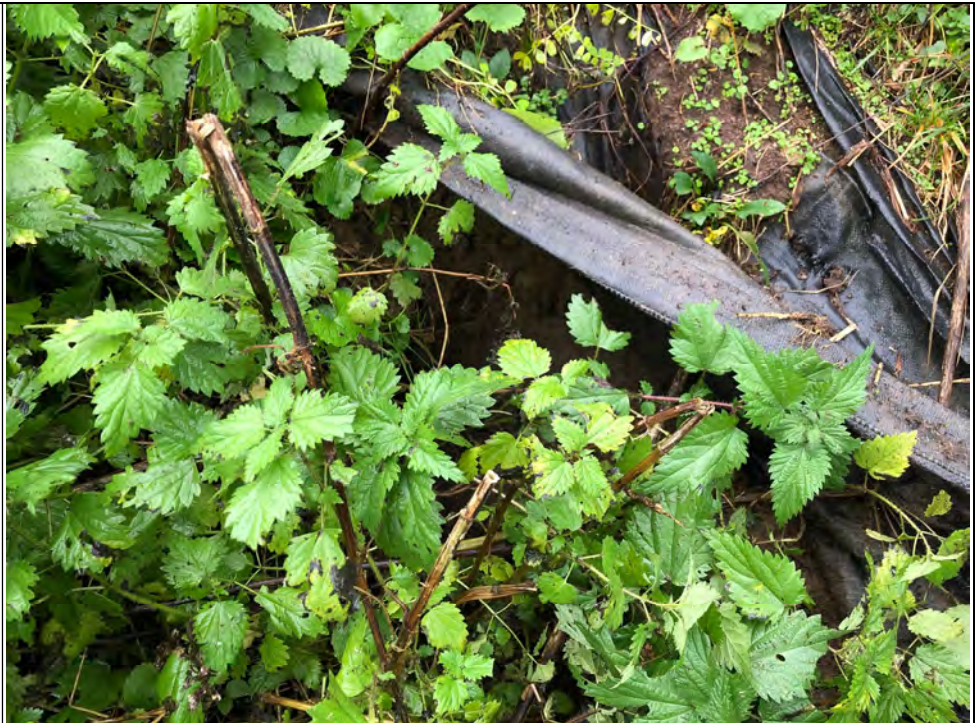
Image: 8016
Date: 11/12/2020
Time: 7:18 AM
Direction: West-Southwest

An animal burrow was found under an old silt fence line. Animal burrow is obscured from vegetation but is in center of picture. Animal burrows are repaired (filled in) when they are identified.

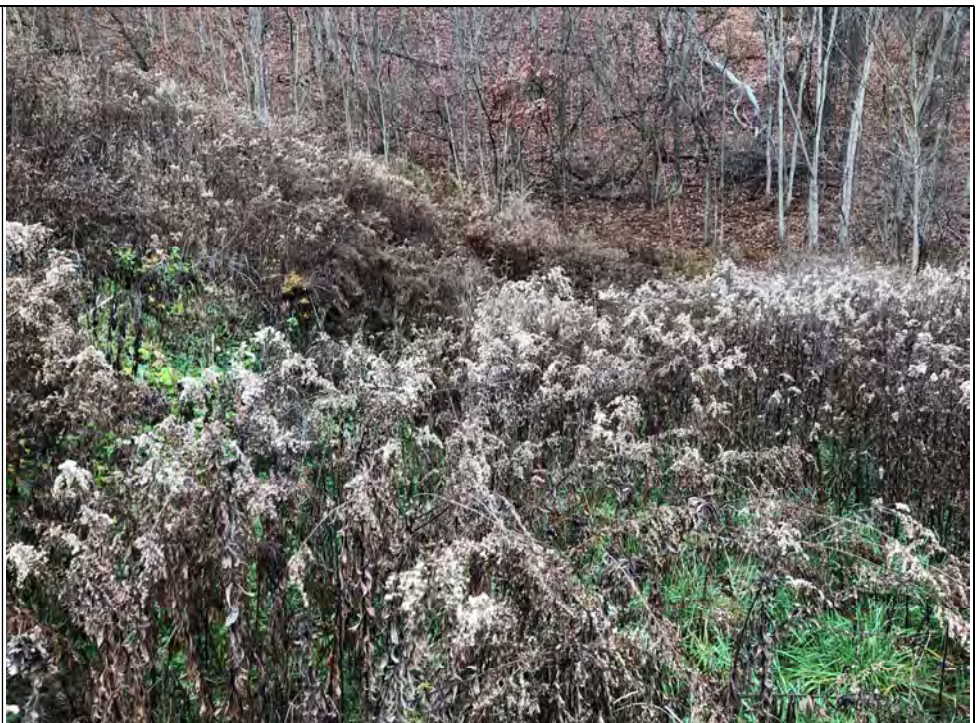
Image: 8018
Date: 11/12/2020
Time: 7:18 AM
Direction: Northwest

Vegetation is healthy and present across the entire sideslope. No evidence of erosion, sloughing, or indications of stability issues.

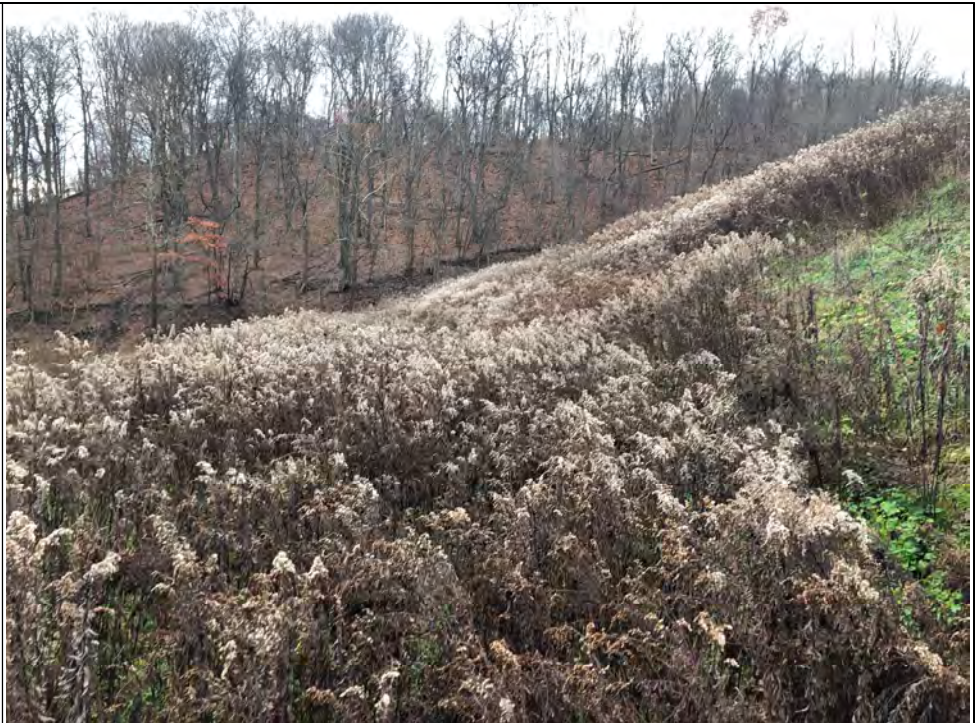
Image: 8020
Date: 11/12/2020
Time: 7:19 AM
Direction: South-Southeast

Vegetation is healthy and present across the entire sideslope. No evidence of erosion, sloughing, or indications of stability issues.

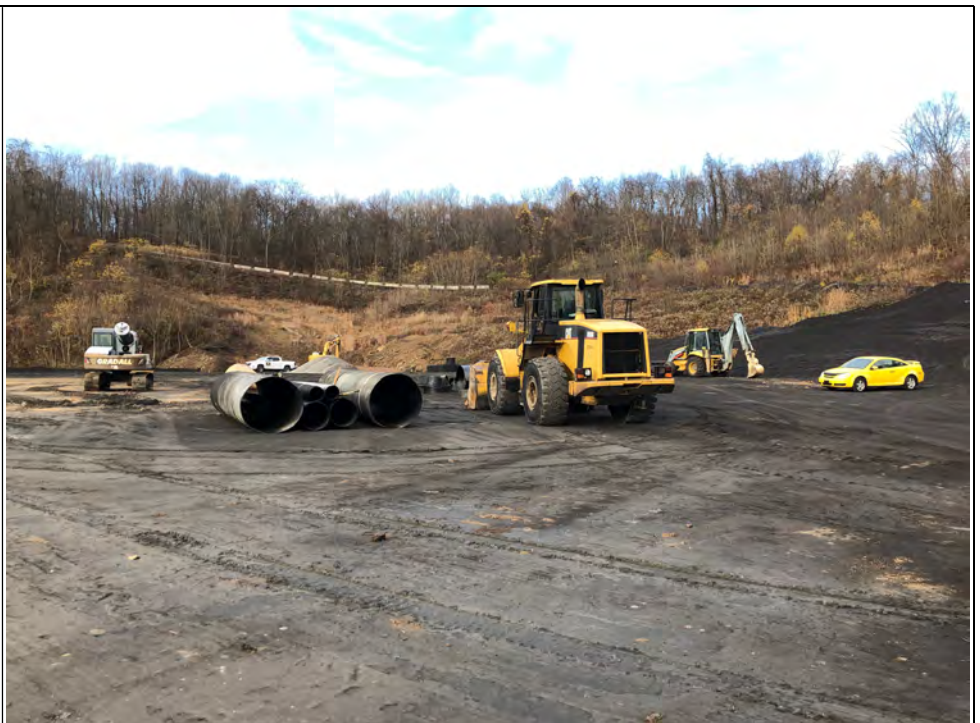
Image: 8022
Date: 11/12/2020
Time: 7:32 AM
Direction: West

Contact and non-contact stormwater pipes were being extended at the time of inspection. Pipe to be used to extend a non-contact riser is shown. It will continue to be extended until reaching the final cover elevation and will accept stormwater after final cover is in place.

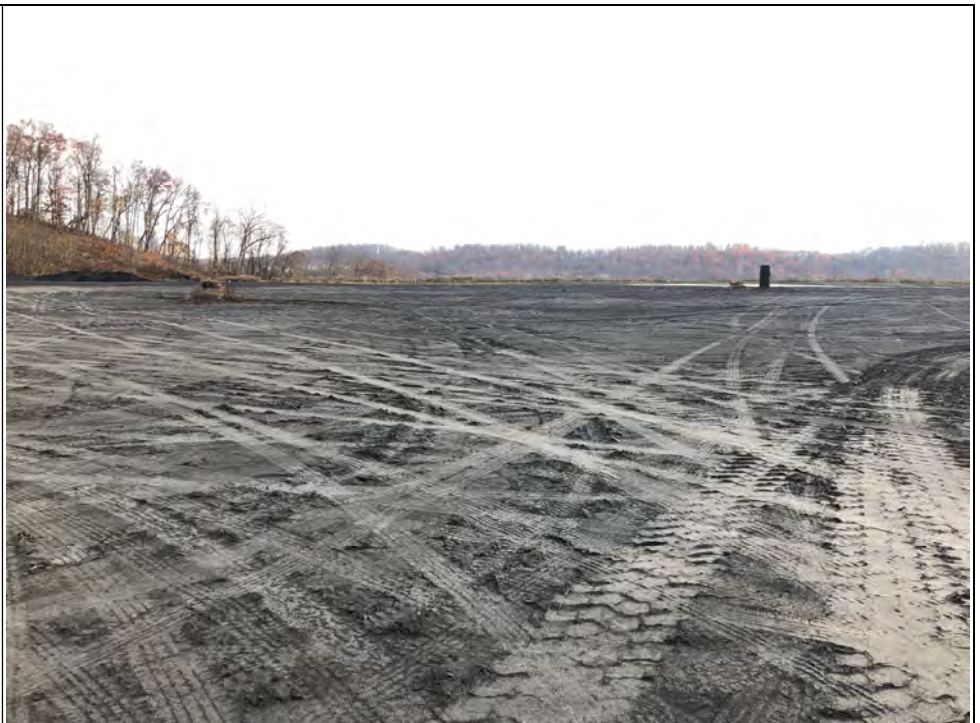
Image: 8024
Date: 11/12/2020
Time: 7:34 AM
Direction: East-Northeast

Active area. Material is placed in even lifts that are spread and compacted. Top surface is well maintained, with no ponding water.

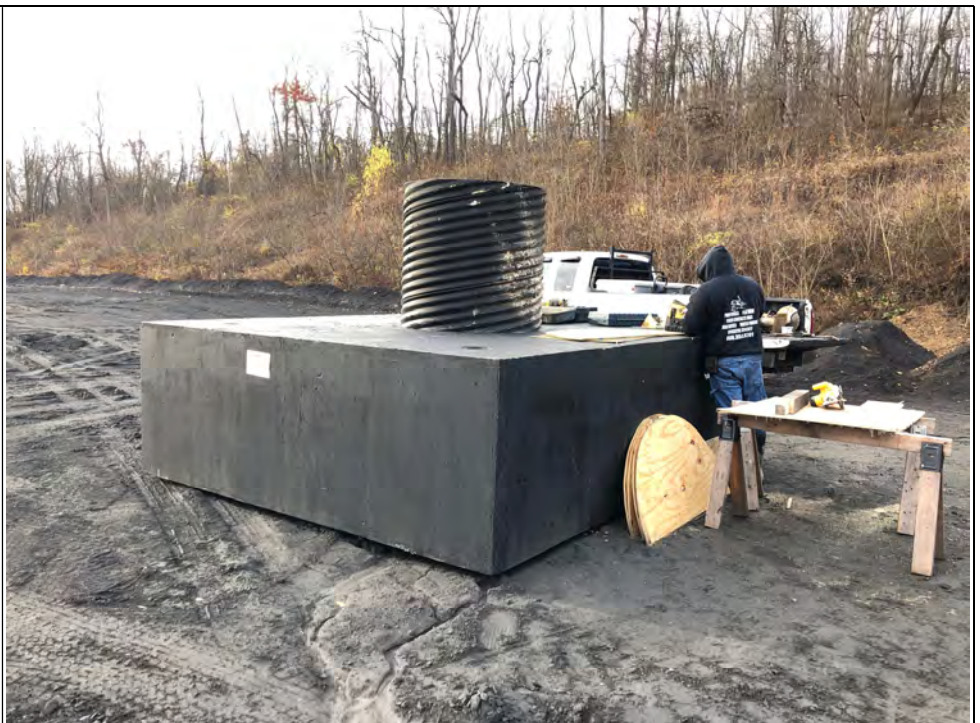
Image: 8026
Date: 11/12/2020
Time: 7:34 AM
Direction: Southwest

A junction box lid and riser are being fabricated to extend a non-contact stormwater pipe (see Image 8028 for location where this will be installed).

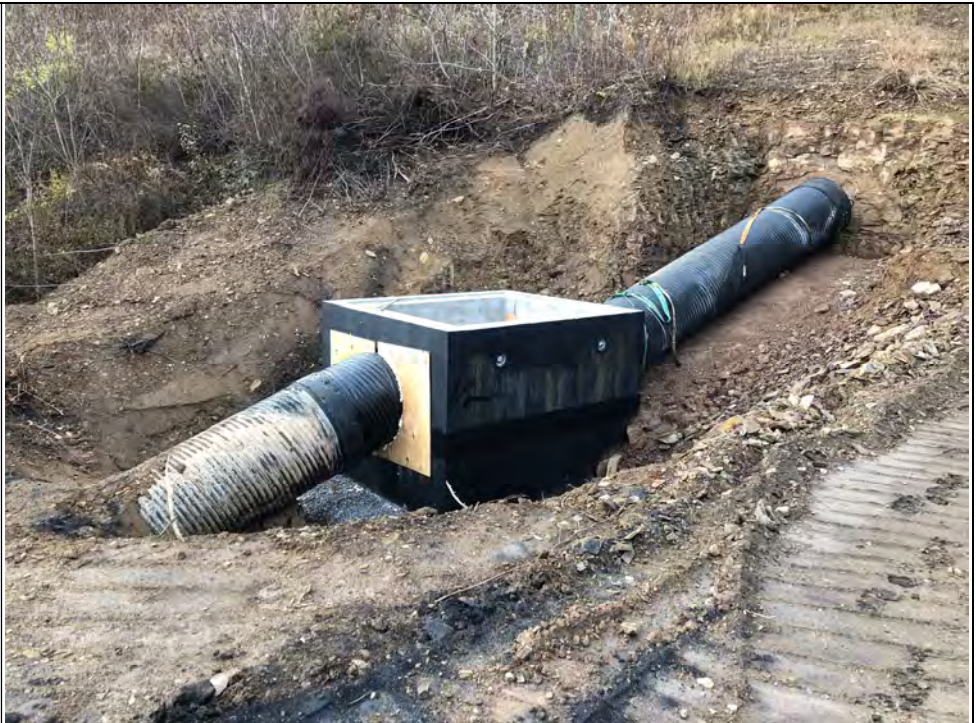
Image: 8028
Date: 11/12/2020
Time: 7:35 AM
Direction: Southwest

A non-contact stormwater junction box is being installed.

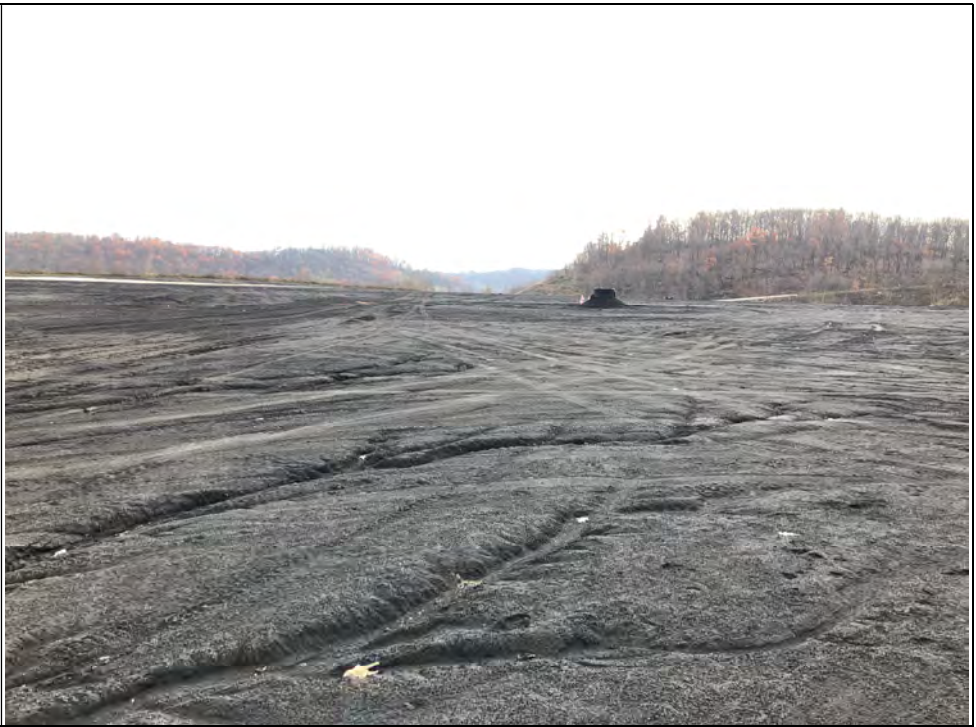
Image: 8030
Date: 11/12/2020
Time: 7:37 AM
Direction: East-Southeast

Active area. Material is placed in even lifts that are spread and compacted. Some erosion ruts and rills have formed on the active face due to recent rains, but do not affect stability or safety of the landfill.

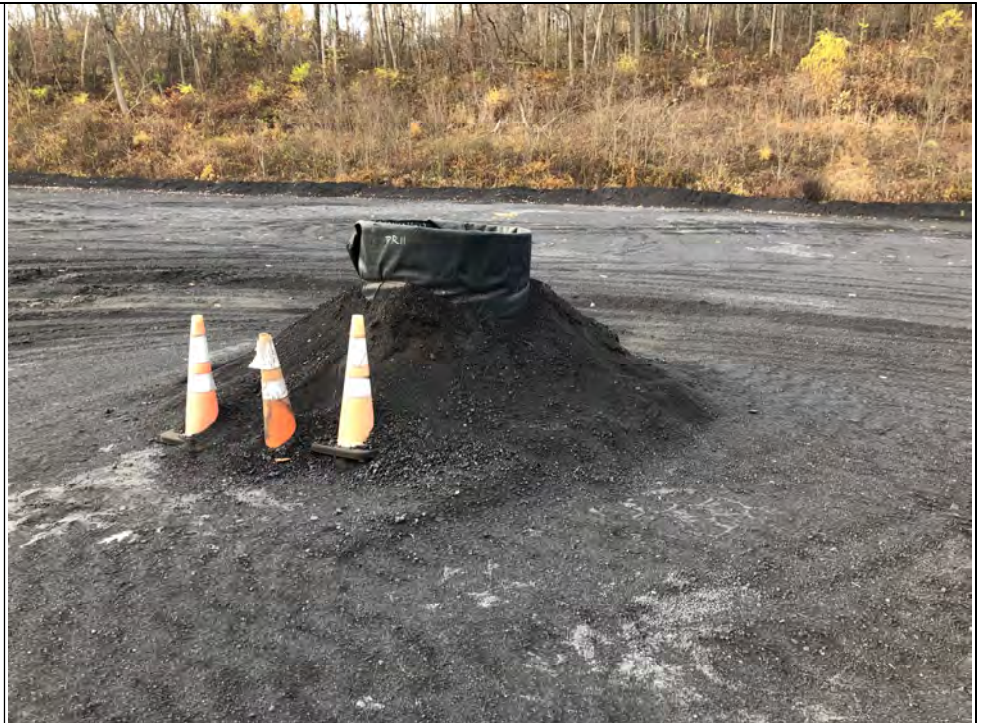
Image: 8032
Date: 11/12/2020
Time: 7:38 AM
Direction: Southwest

A perforated contact stormwater (leachate) riser is shown. This riser is wrapped in filter fabric and surrounded with bottom ash. It will be extended prior to additional CCR material placement.

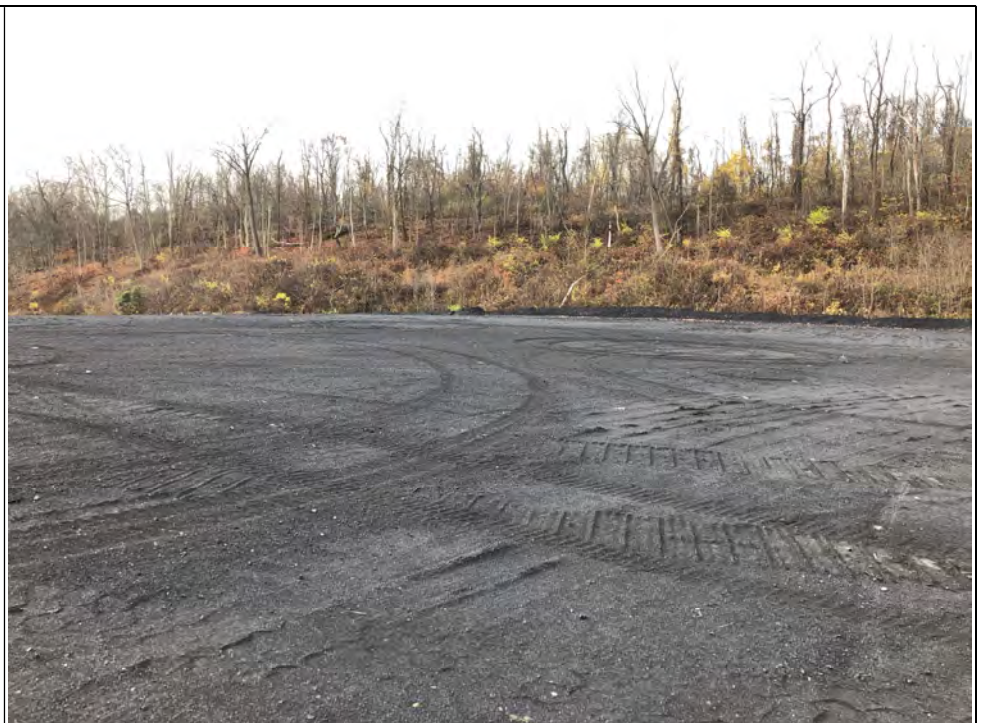
Image: 8034
Date: 11/12/2020
Time: 7:38 AM
Direction: Southwest

The active area is well maintained with no ponding water. CCR material is spread and rolled shortly after being received.

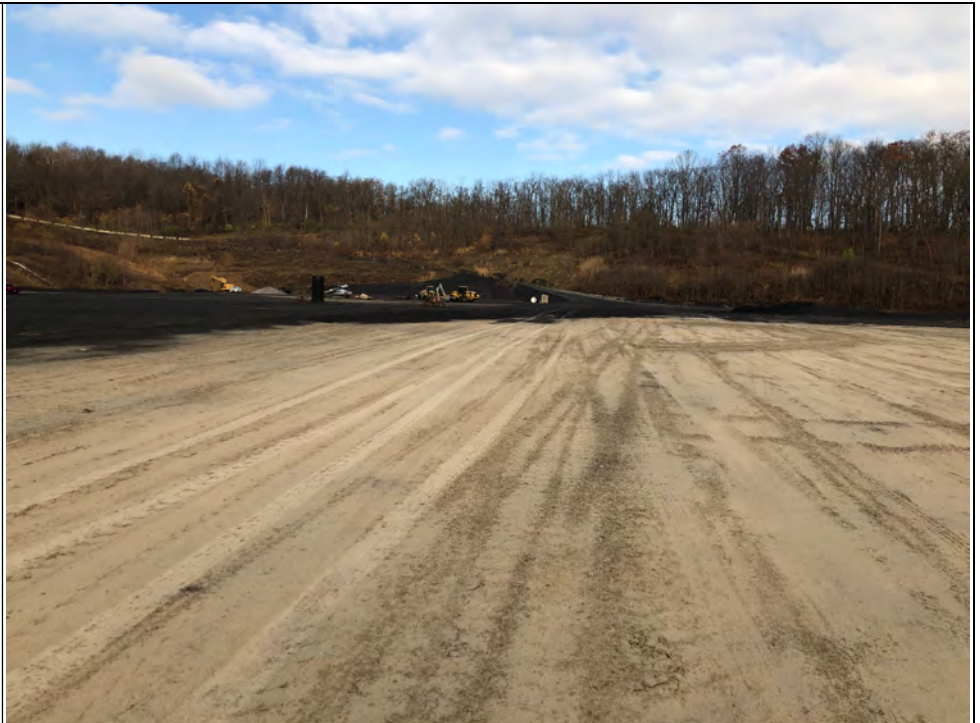
Image: 8038
Date: 11/12/2020
Time: 7:39 AM
Direction: Northwest

Gypsum lift placed within the active area. Gypsum material is spread and rolled shortly after being received.

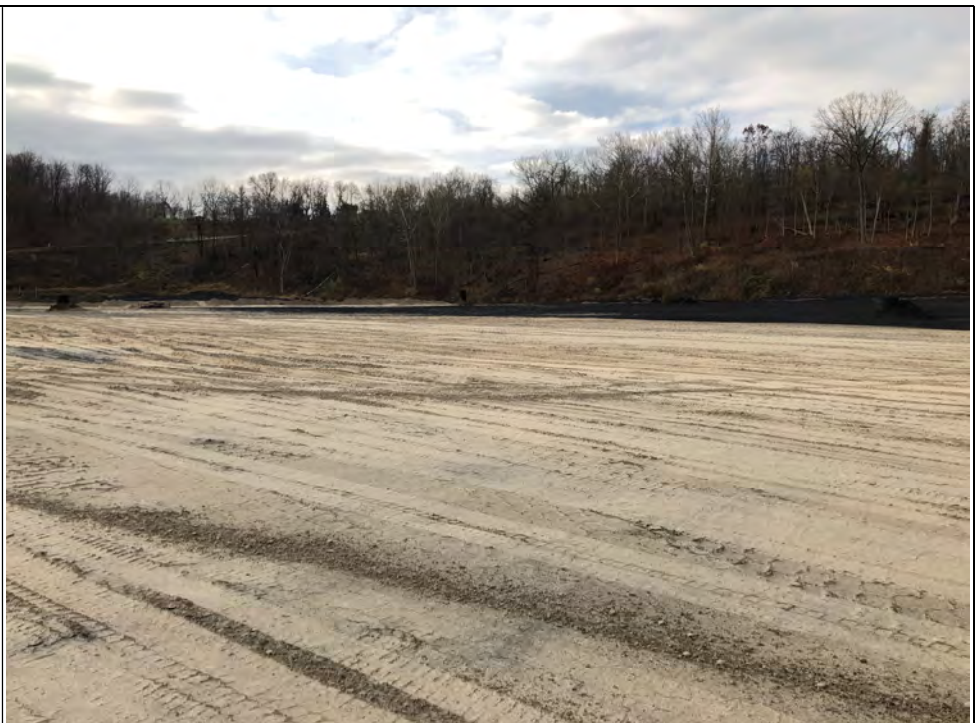
Image: 8040
Date: 11/12/2020
Time: 7:40 AM
Direction: Southwest

Gypsum lift placed within the active area. Gypsum material is spread and rolled shortly after being received.

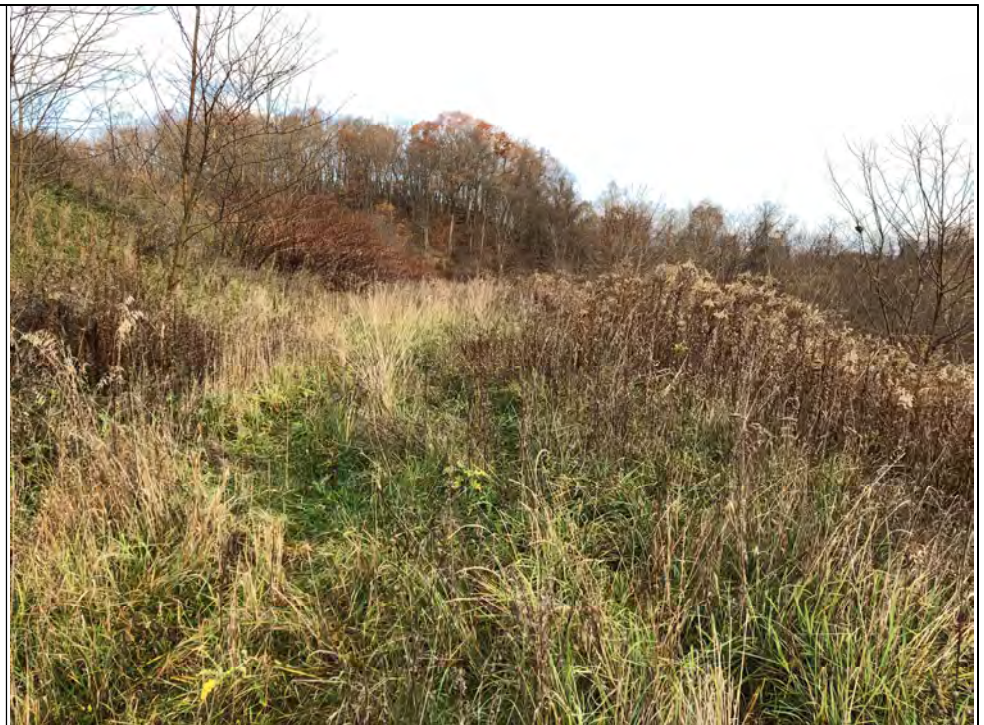
Image: 8046
Date: 11/12/2020
Time: 7:41 AM
Direction: North-Northwest

Vegetation is healthy and present across the entire sideslope. No evidence of erosion, sloughing, or indications of stability issues. Some woody vegetation is present.

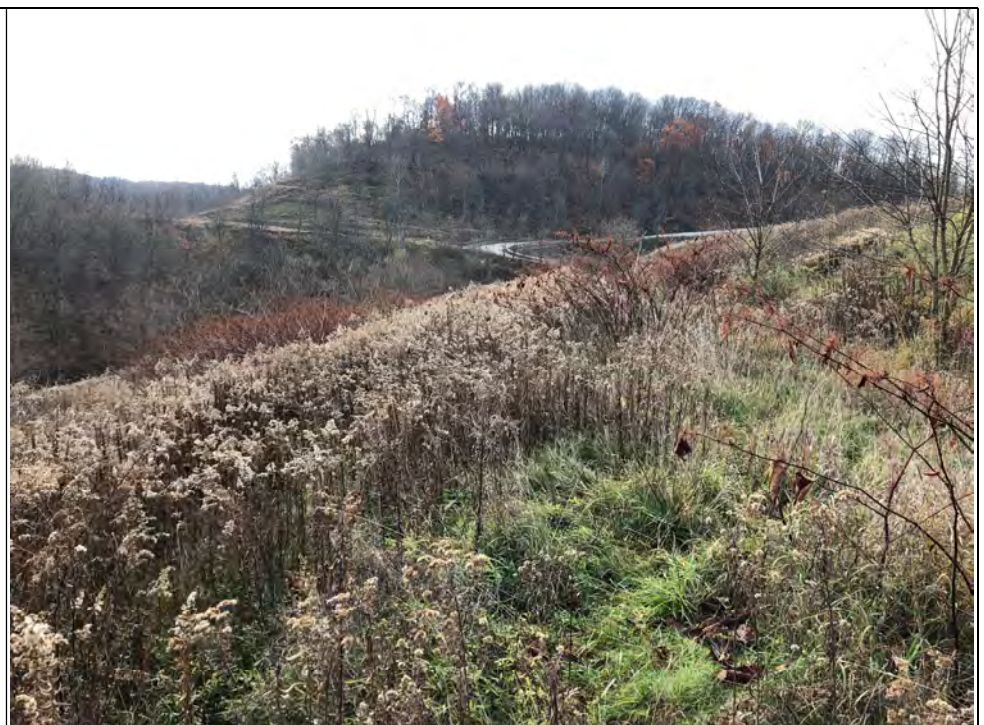
Image: 8048
Date: 11/12/2020
Time: 7:41 AM
Direction: Southeast

Vegetation is healthy and present across the entire sideslope. No evidence of erosion, sloughing, or indications of stability issues.

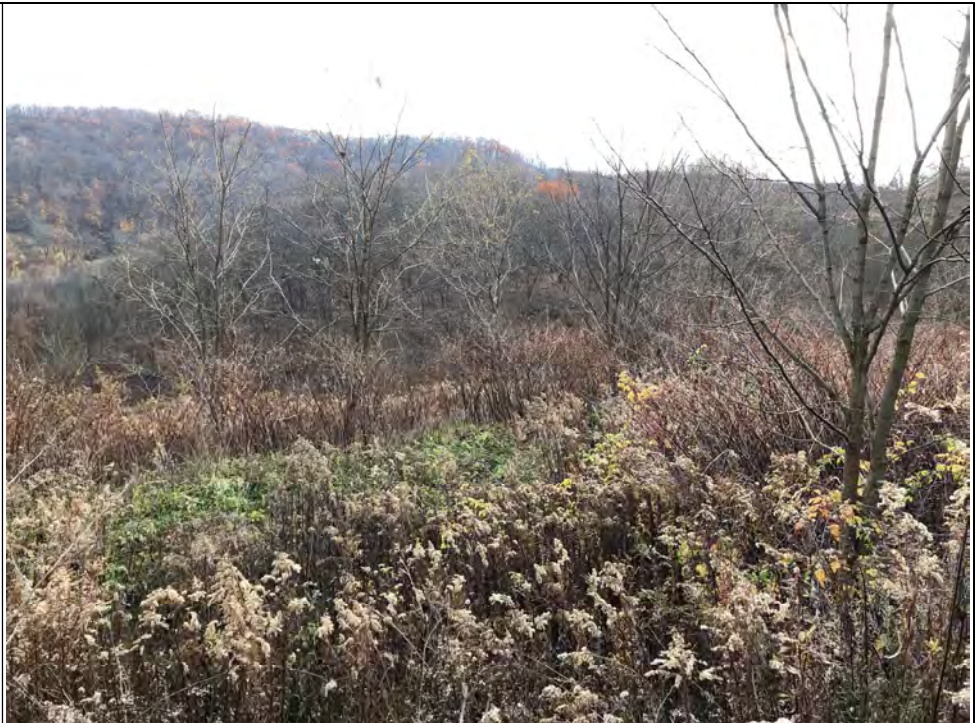
Image: 8050
Date: 11/12/2020
Time: 7:41 AM
Direction: East-Southeast

Vegetation is healthy and present across the entire sideslope. No evidence of erosion, sloughing, or indications of stability issues. Some woody vegetation is present.

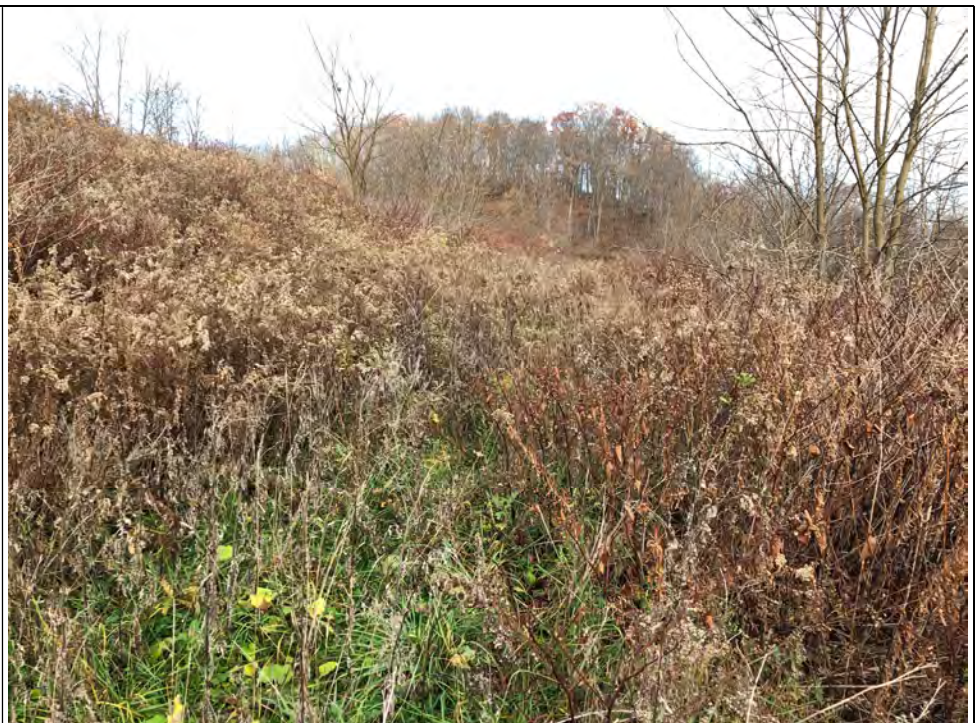
Image: 8054
Date: 11/12/2020
Time: 7:42 AM
Direction: Northwest

Vegetation on sideslopes is healthy and present across the entire sideslope. No evidence of erosion, sloughing, or indications of stability issues. Some woody vegetation is present.

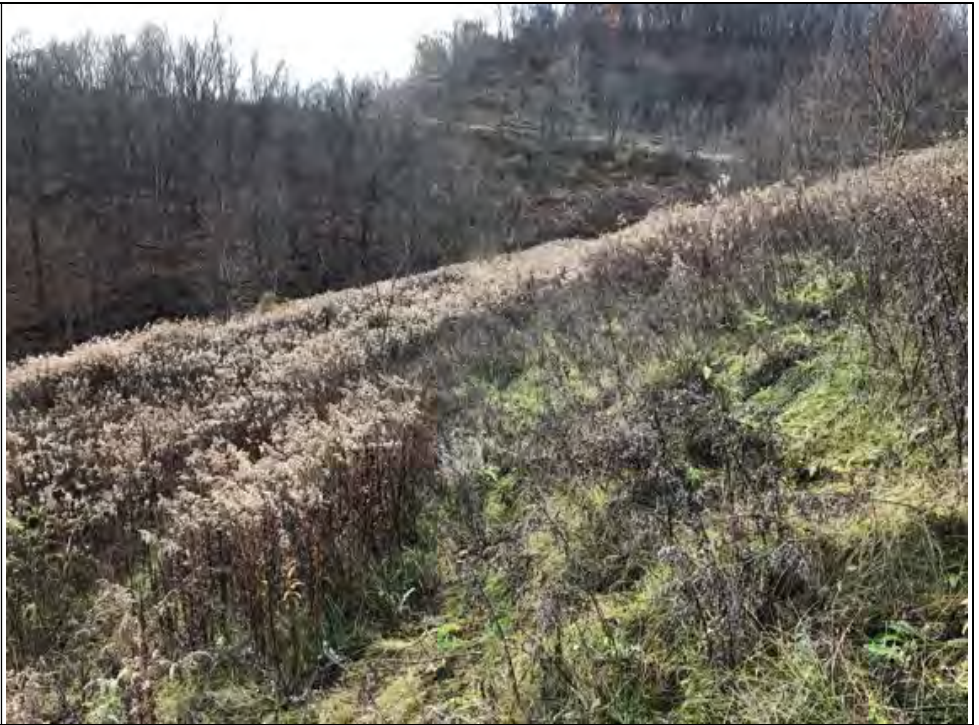
Image: 8058
Date: 11/12/2020
Time: 7:43 AM
Direction: Southeast

Vegetation on sideslopes is healthy and present across the entire sideslope. No evidence of erosion, sloughing, or indications of stability issues.

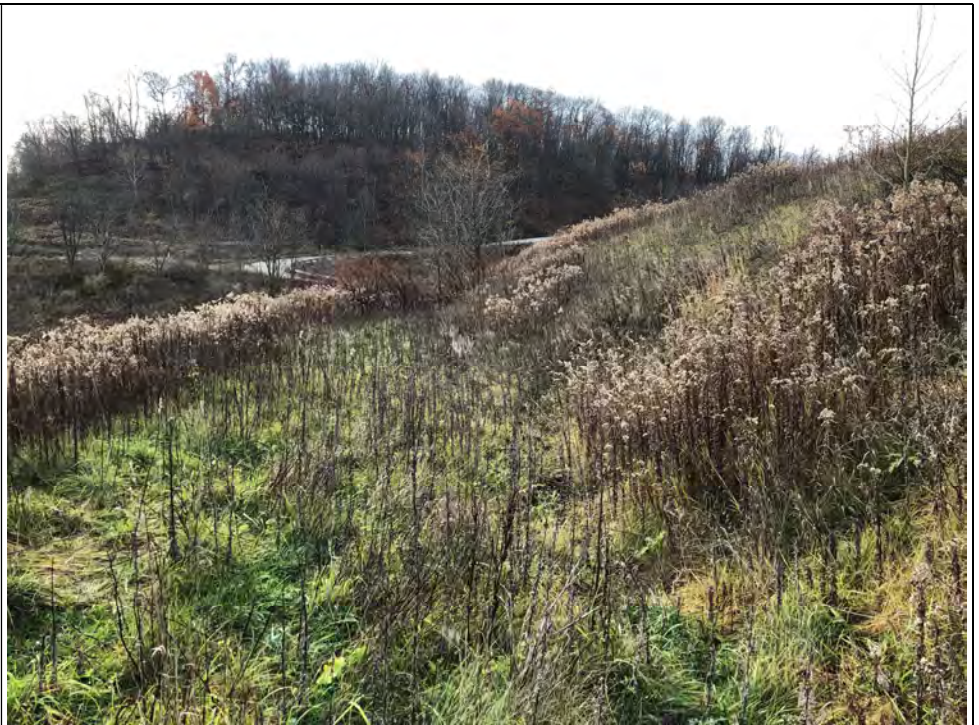
Image: 8060
Date: 11/12/2020
Time: 7:45 AM
Direction: South-Southeast

Vegetation on sideslopes is healthy and present across the entire sideslope. No evidence of erosion, sloughing, or indications of stability issues.
