Inspection Report

To: Bill McGraw (Cheswick Generating Station)
From: Richard Southorn, P.E., P.G.
Re: Cheswick Ash Disposal Site – Annual CCR Unit Inspection Report
Inspection Date: November 12, 2020
Report Date: January 15, 2021

Project: Cheswick Landfill 2020 Annual Inspection

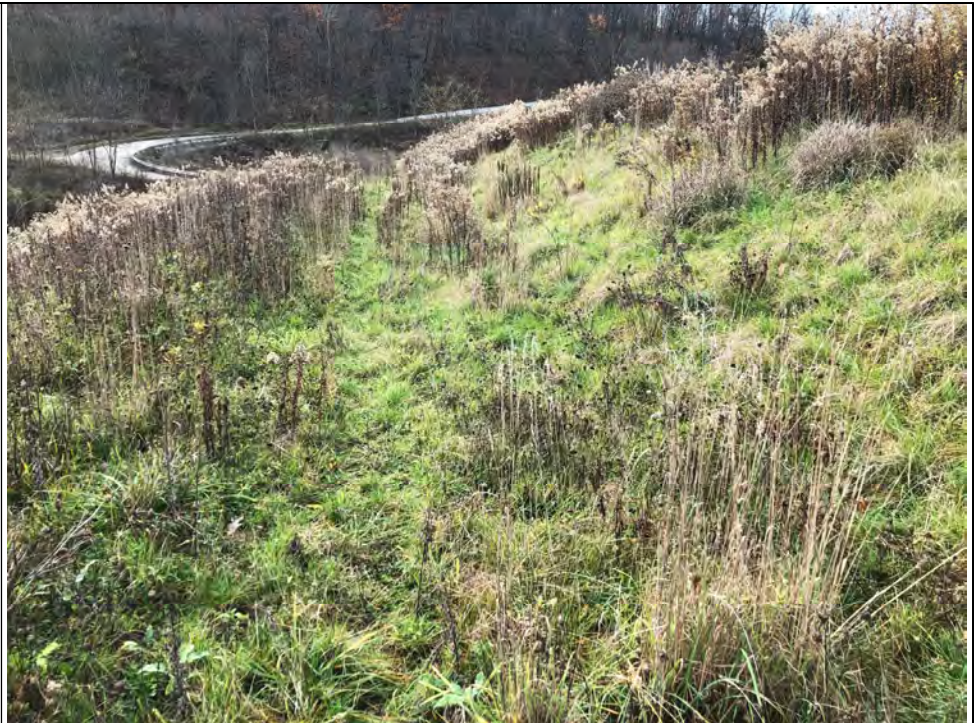
Image: 8062
Date: 11/12/2020
Time: 7:45 AM
Direction: South-Southeast

Vegetation on sideslopes is healthy and present across the entire sideslope. No evidence of erosion, sloughing, or indications of stability issues.

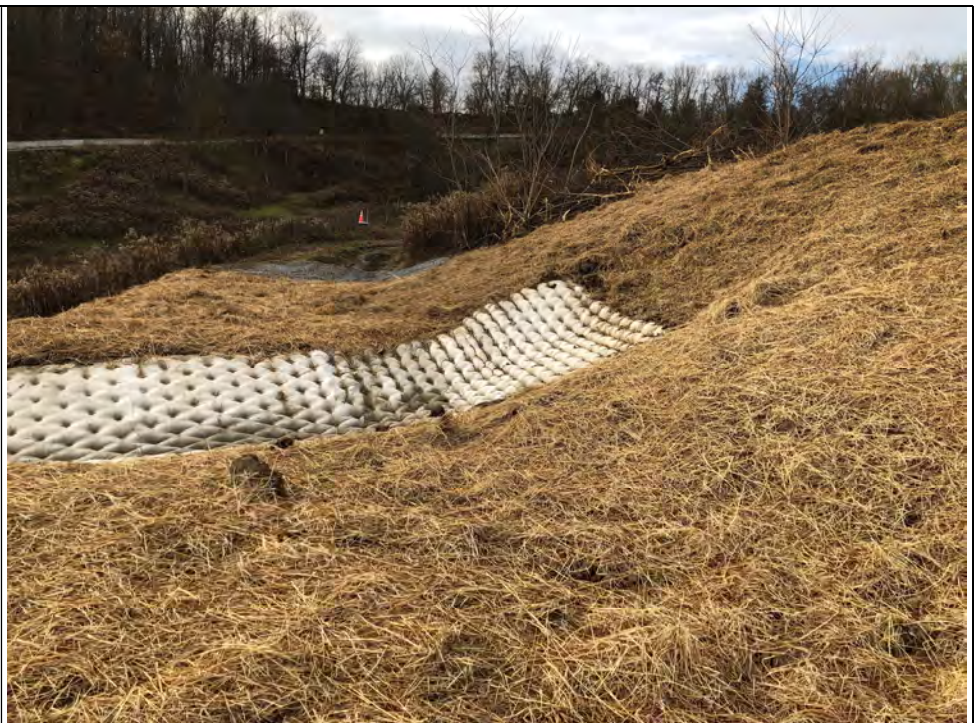
Image: 8064
Date: 11/12/2020
Time: 7:46 AM
Direction: Southwest

Recently installed revetment matting. This matting will be used to convey non-contact stormwater that falls on the closed landfill sideslope to Outfall 011.

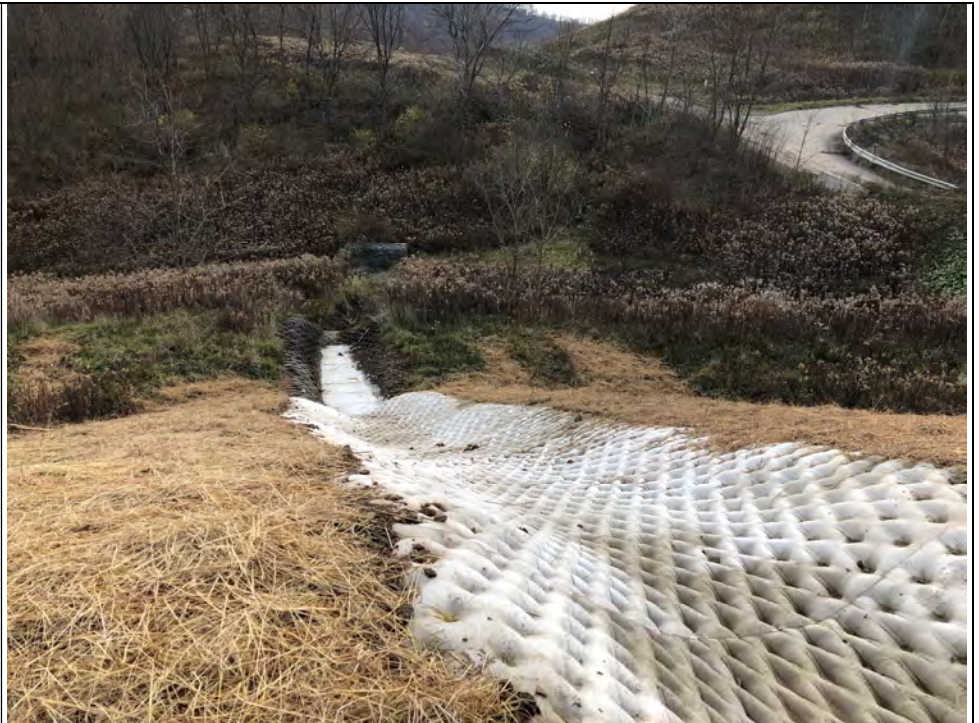
Image: 8066
Date: 11/12/2020
Time: 7:46 AM
Direction: East

Recently installed
revetment matting. This
matting will be used to
convey non-contact
stormwater that falls on
the closed landfill
sideslope to Outfall 011.

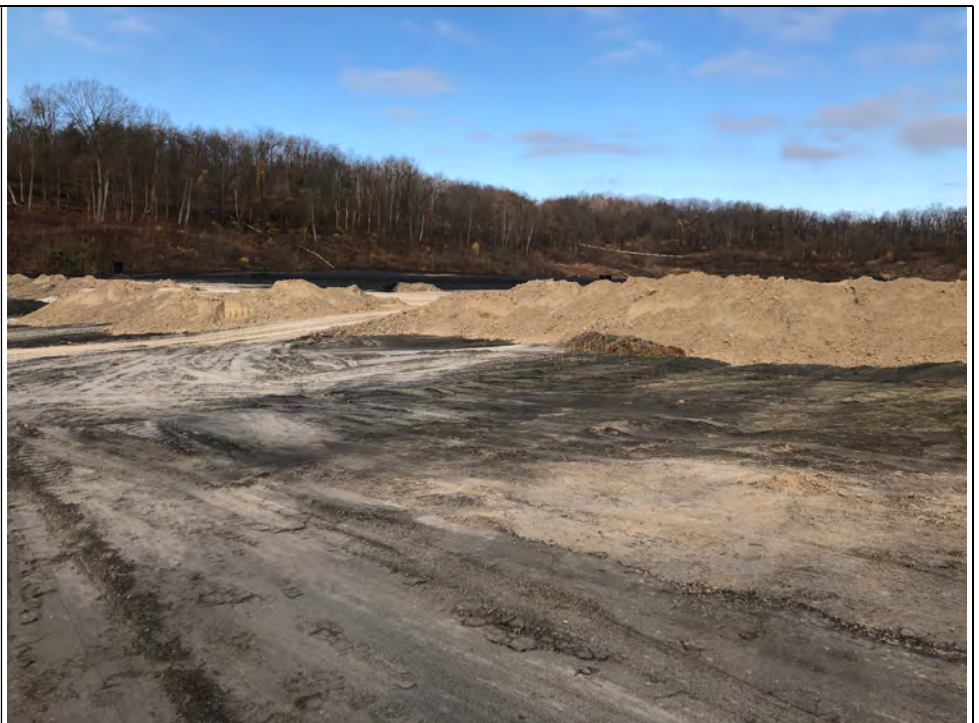
Image: 8068
Date: 11/12/2020
Time: 7:47 AM
Direction: West-Northwest

Active area with recently
received loads of gypsum.

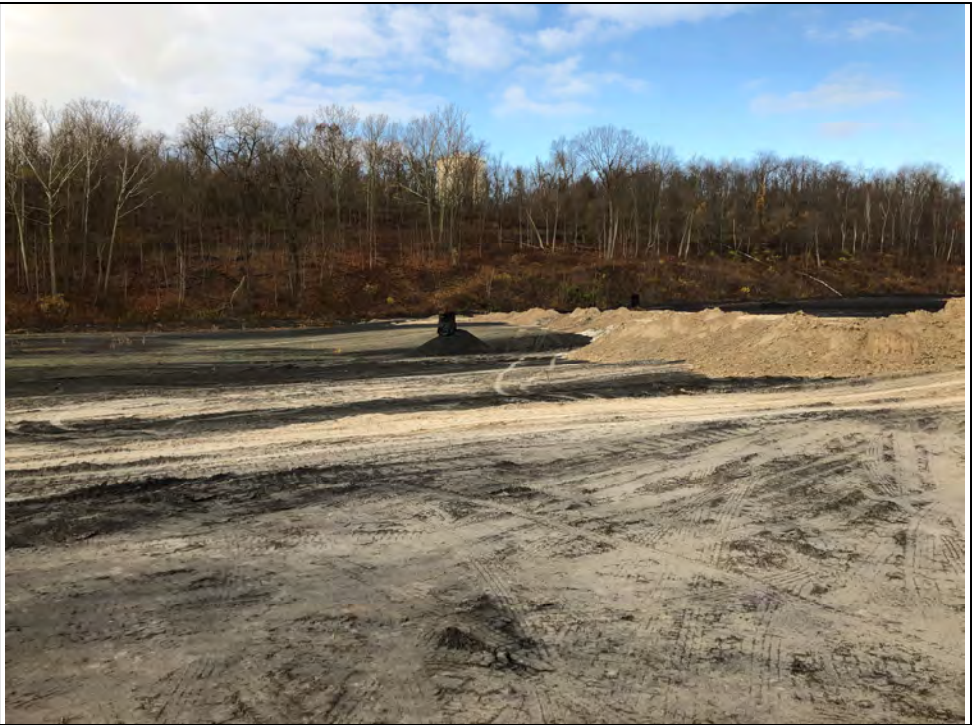
Image: 8070
Date: 11/12/2020
Time: 7:47 AM
Direction: West

Active area with recently received loads of gypsum.

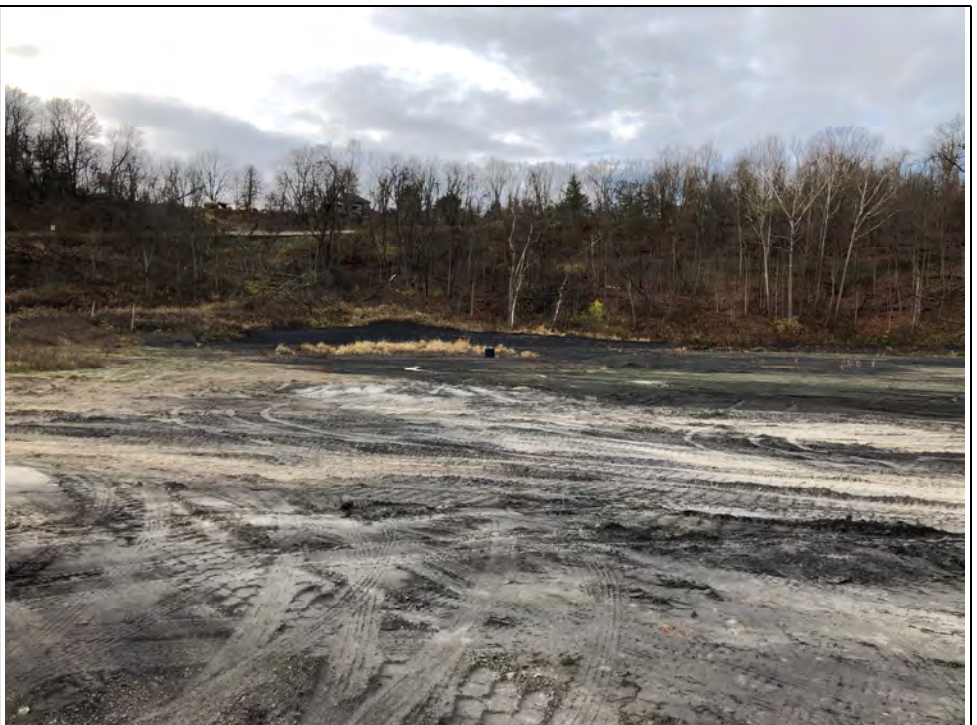
Image: 8072
Date: 11/12/2020
Time: 7:47 AM
Direction: South-Southwest

Active area drains toward low area near treeline. No standing water is present.
