Inspection Report

To: Bill McGraw (Cheswick Generating Station)
From: Richard Southorn, P.E., P.G.
Re: Cheswick Ash Disposal Site – Annual CCR Unit Inspection Report
Inspection Date: October 21, 2019
Report Date: January 16, 2020

**CHESWICK GENERATING STATION
SPRINGDALE, PENNSYLVANIA**

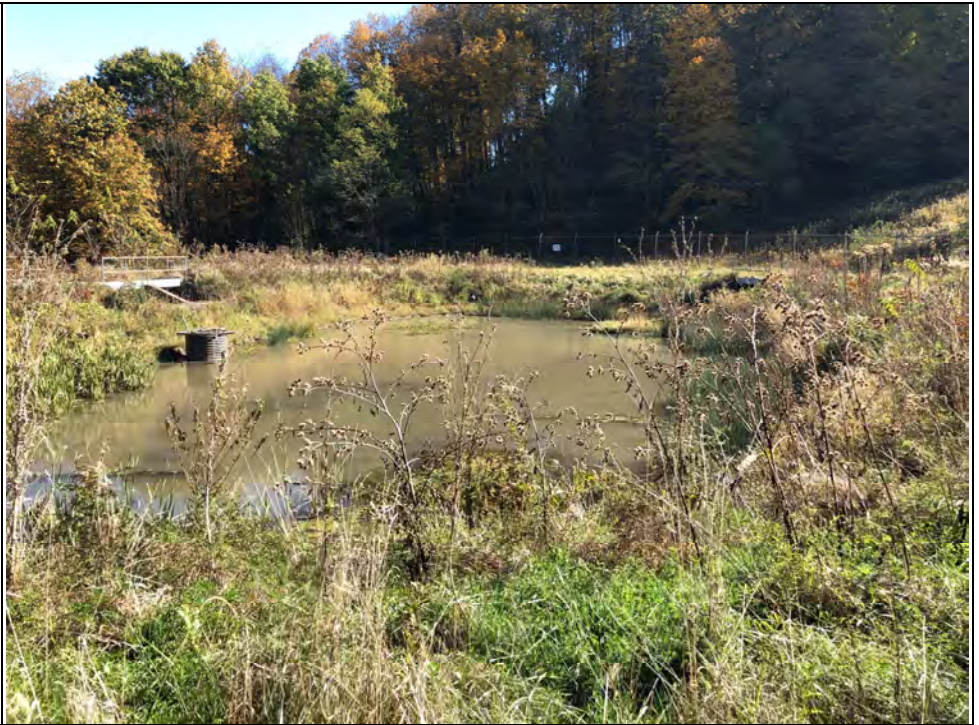
Image: 3643
Date: 10/21/2019
Time: 1:20 PM
Direction: Southeast

Sedimentation Pond.
Healthy vegetation on pond sideslopes. No trash or debris noted on water surface or in surrounding vegetation.

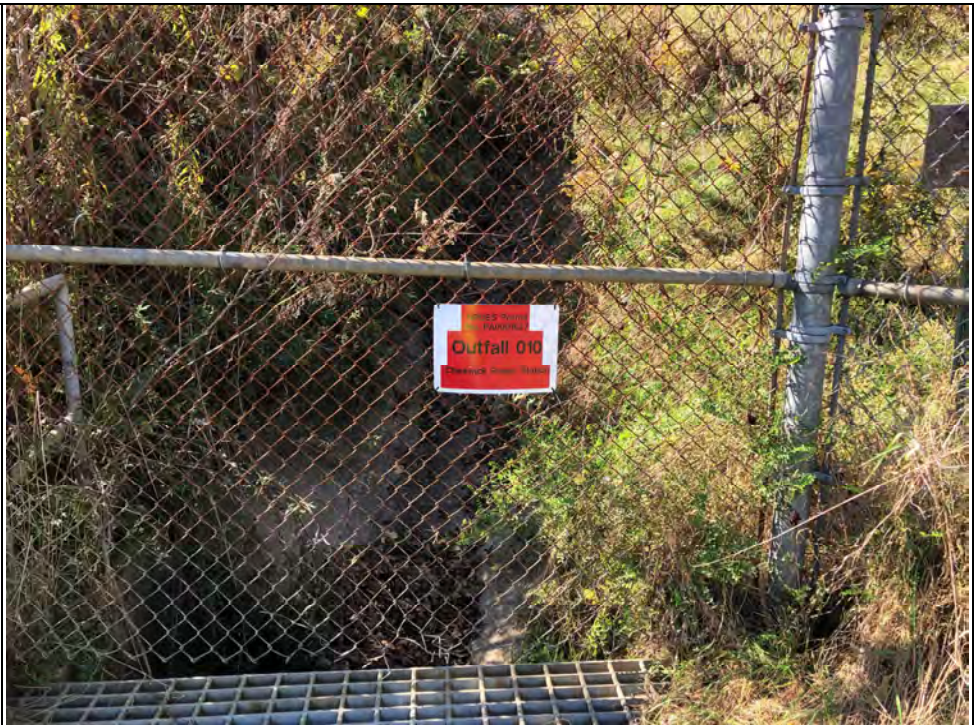
Image: 3645
Date: 10/21/2019
Time: 1:21 PM
Direction: West

North non-contact water channel (at Outfall 010) inlet to Sedimentation Pond looking upslope. Clear of debris. Functioning as intended.

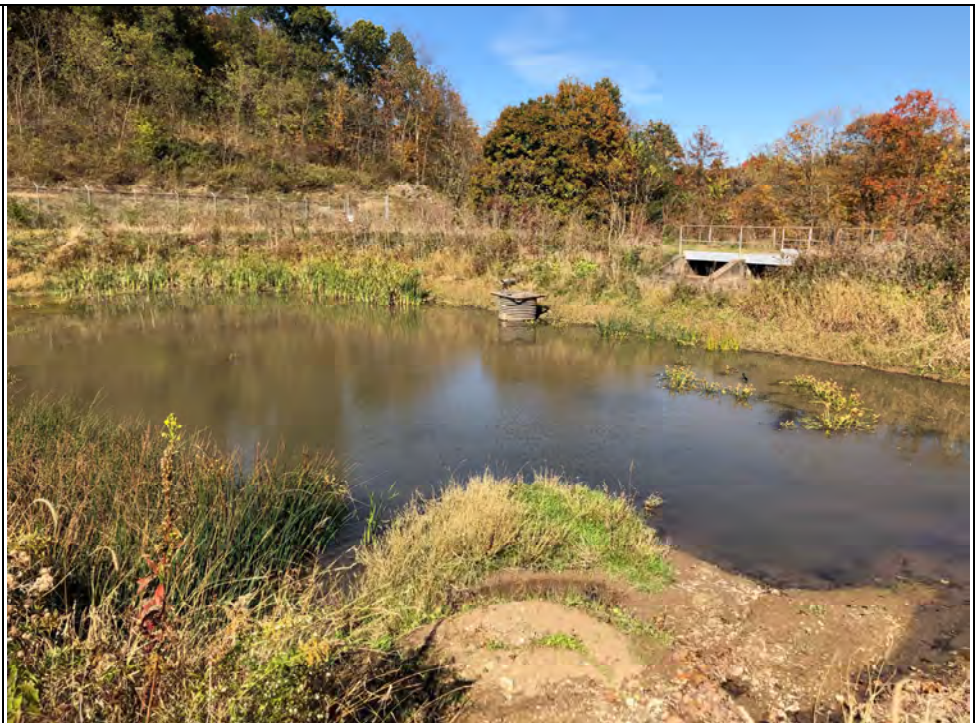
Image: 3649
 Date: 10/21/2019
 Time: 1:22 PM
 Direction: North

Sedimentation Pond.
 Healthy vegetation on pond sideslopes. No trash or debris noted on water surface or in surrounding vegetation. Spillway is clear of obstructions. No cracking or evidence of structural damage in outlet structure or spillway.

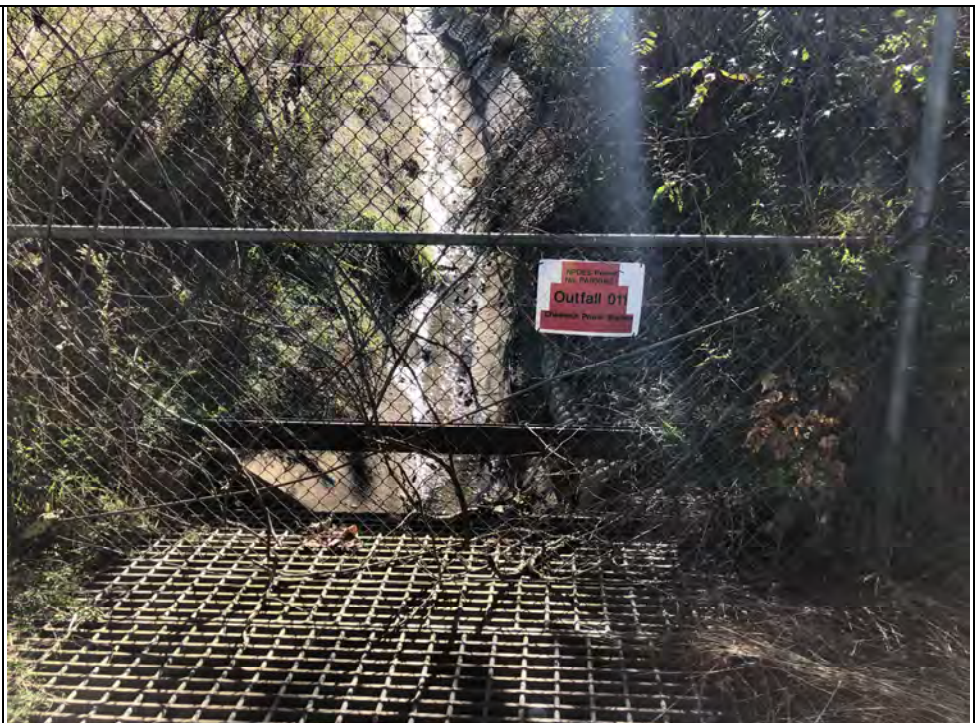
Image: 3651
 Date: 10/21/2019
 Time: 1:23 PM
 Direction: South

South non-contact water channel (at Outfall 011) inlet to Sedimentation Pond looking upslope. Clear of debris. Functioning as intended.

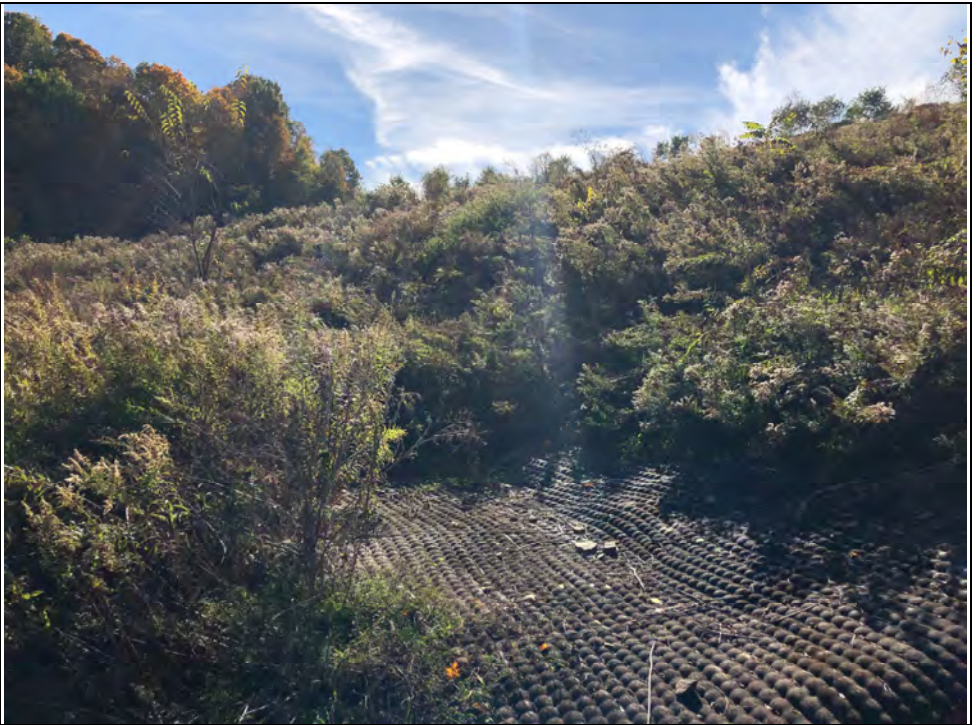
Image: 3653
Date: 10/21/2019
Time: 1:25 PM
Direction: West

North non-contact water channel, looking upslope. Clear of debris. Functioning as intended.

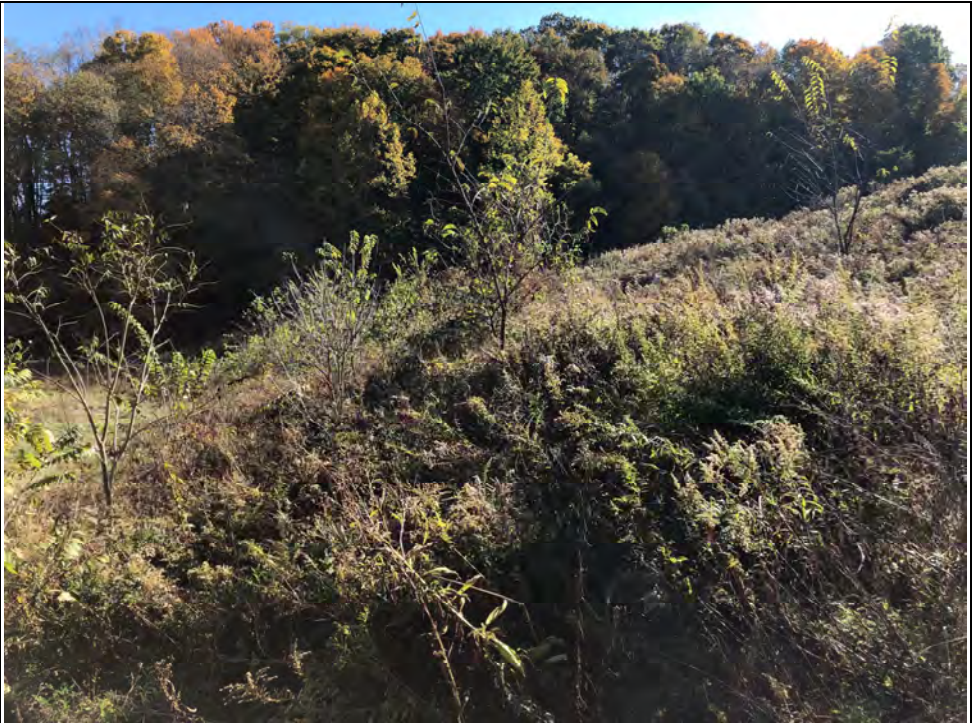
Image: 3655
Date: 10/21/2019
Time: 1:25 PM
Direction: South

Vegetation is healthy and present across the entire sideslope. No evidence of erosion, sloughing, or indications of stability issues.

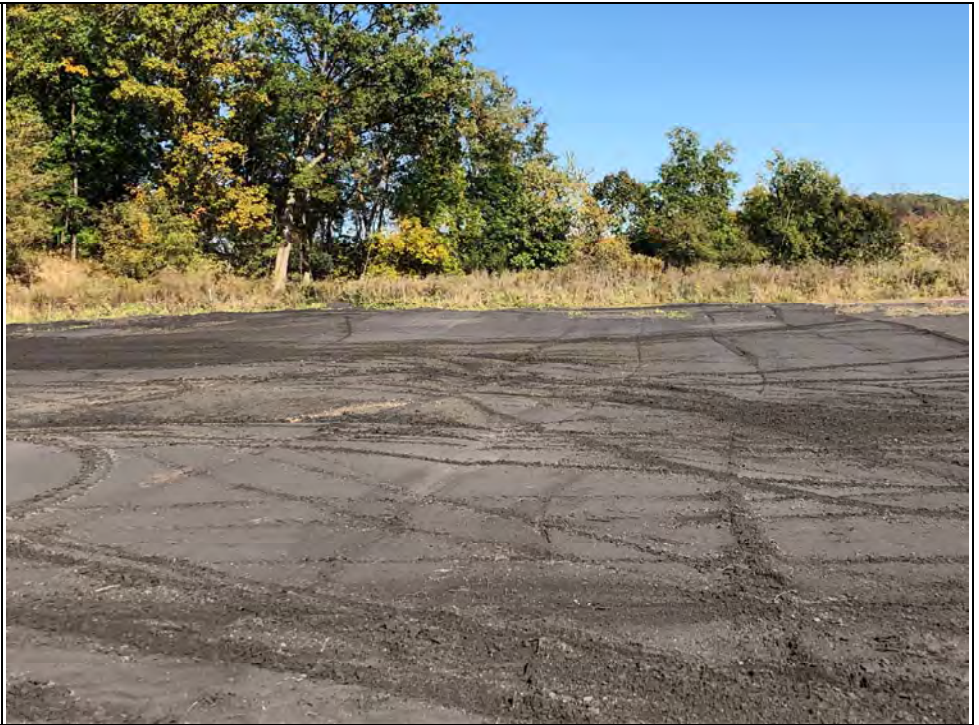
Image: 3659
Date: 10/21/2019
Time: 1:41 PM
Direction: Northeast

Active area. Well maintained, no ponding water. Material is placed in even lifts that are spread and compacted.

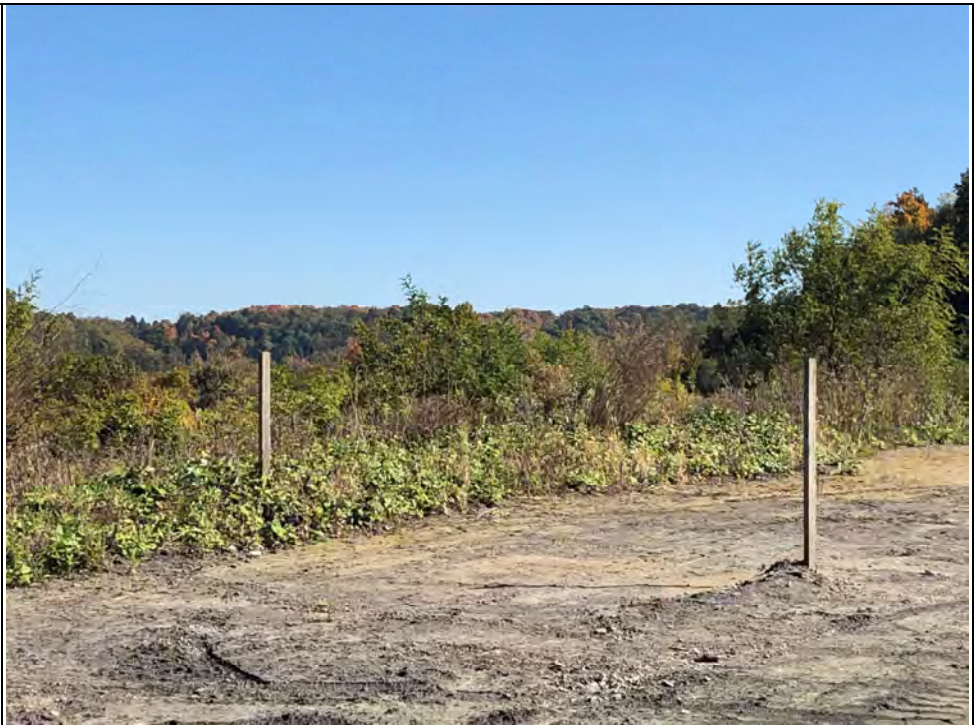
Image: 3661
Date: 10/21/2019
Time: 1:41 PM
Direction: Southeast

Staking has been placed to represent the location and final target CCR elevation for the next terrace bench. Once final CCR material grades are achieved, final cover will be installed.

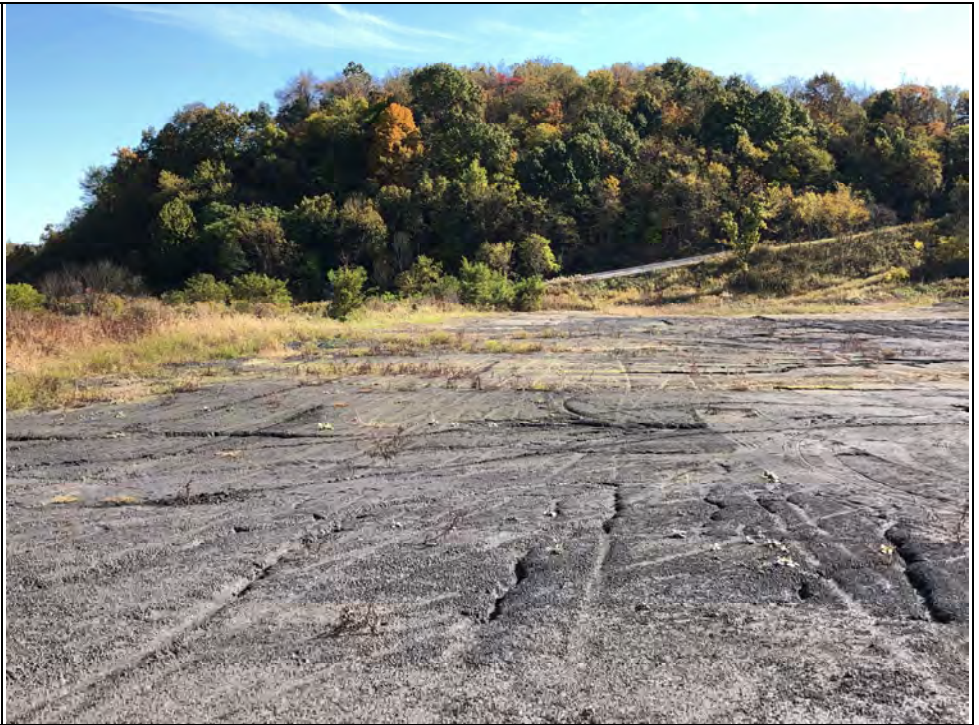
Image: 3663
Date: 10/21/2019
Time: 1:43 PM
Direction: Southeast

Active area. Material is placed in even lifts that are spread and compacted. Some erosion ruts and rills have formed on the active face due to recent rains, but do not affect stability or safety of the landfill.

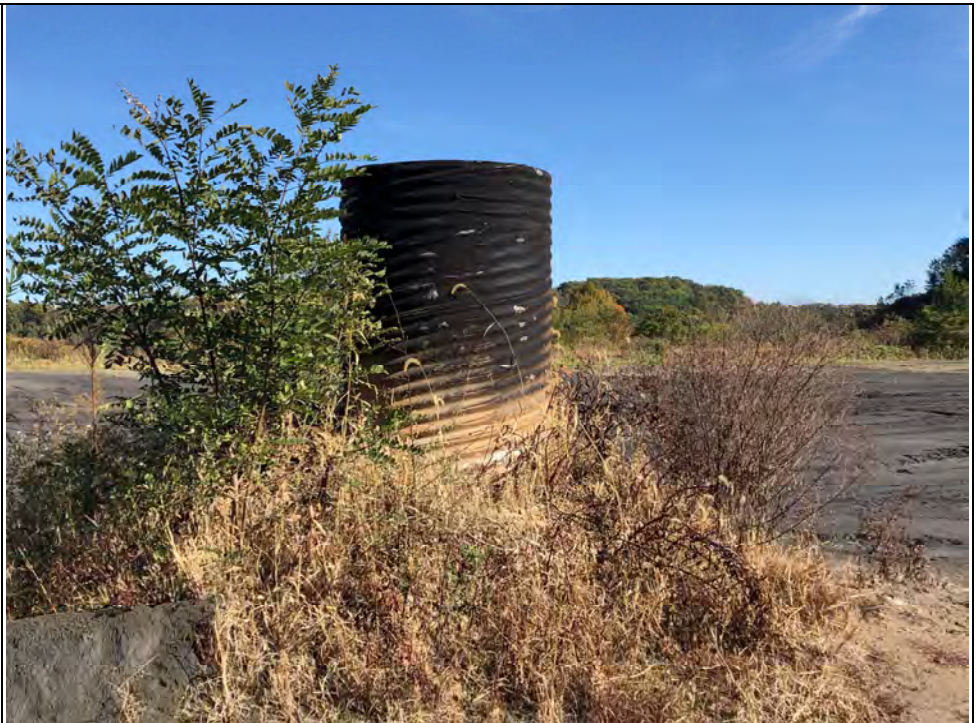
Image: 3665
Date: 10/21/2019
Time: 1:43 PM
Direction: Northeast

A non-contact water (stormwater) non-perforated riser, which will be extended to final cover elevation and will accept stormwater after final cover is in place.

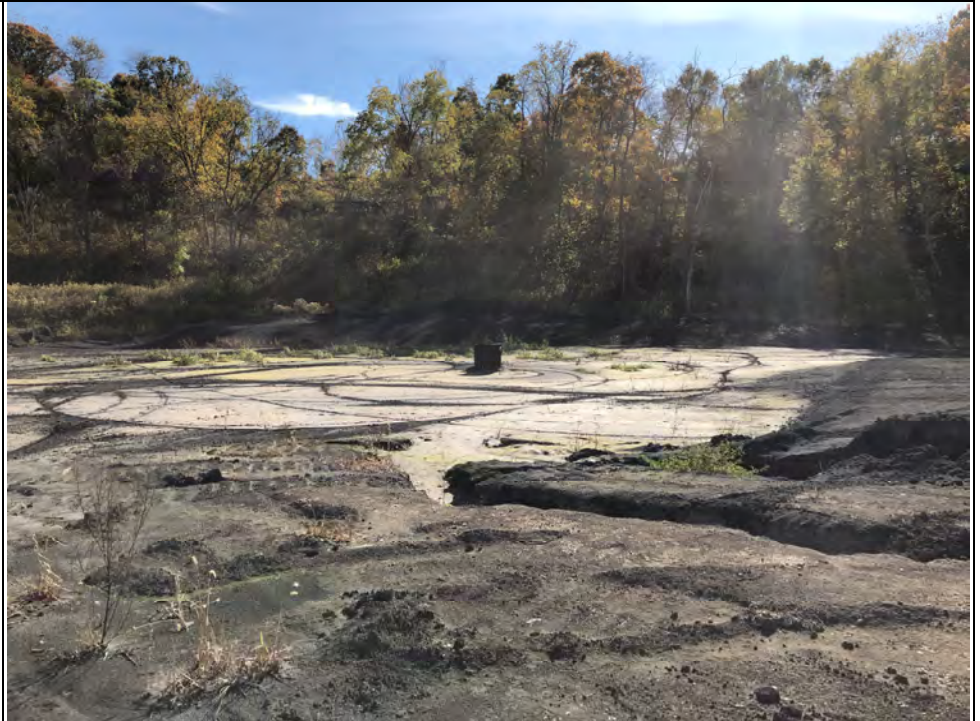
Image: 3667
Date: 10/21/2019
Time: 1:45 PM
Direction: Southeast

Low point in active area. Active face drains to this location, where contact water enters the perforated contact-water (leachate) riser. This riser is wrapped in filter fabric and surrounded with bottom ash.

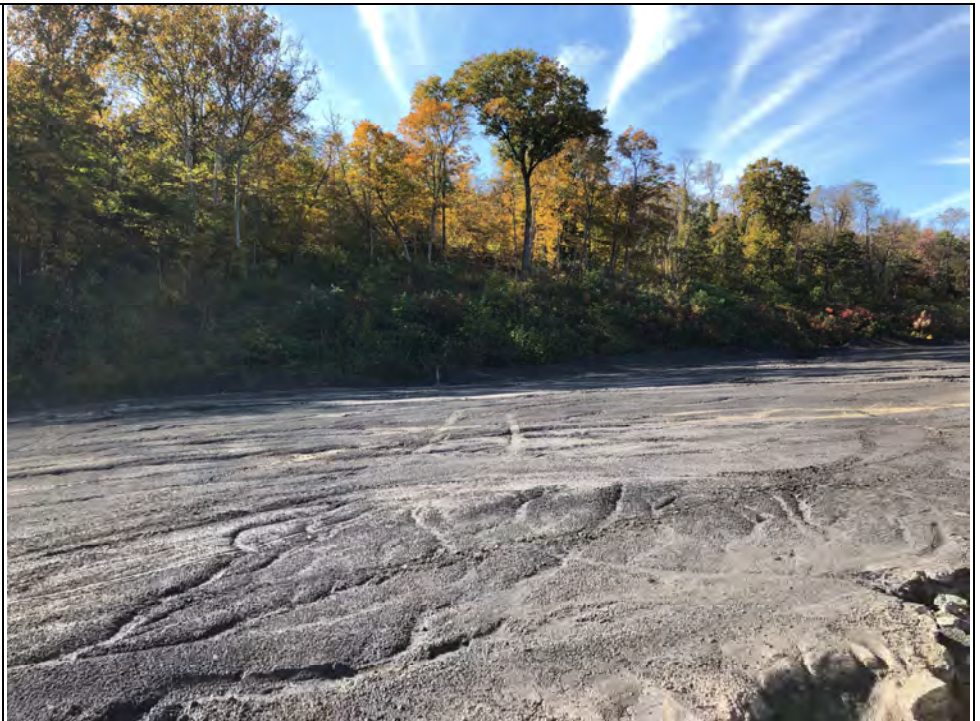
Image: 3669
Date: 10/21/2019
Time: 1:45 PM
Direction: Southwest

Active area. Material is placed in even lifts that are spread and compacted. Some erosion ruts and rills have formed on the active face due to recent rains, but do not affect stability or safety of the landfill.

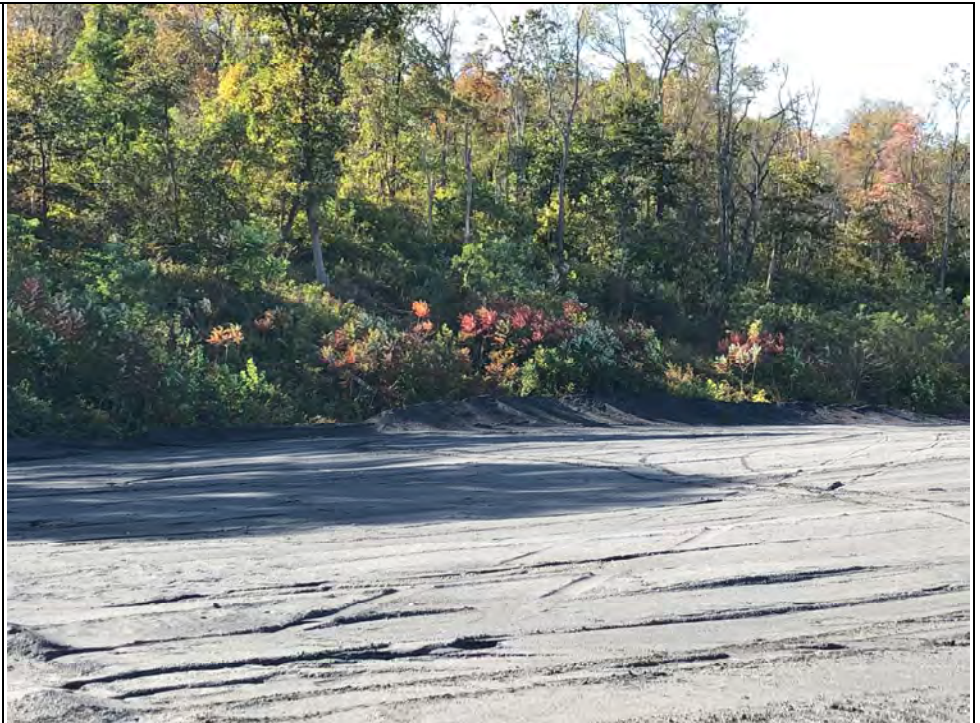
Image: 3671
Date: 10/21/2019
Time: 1:46 PM
Direction: Southwest

The active area is well maintained with no ponding water. CCR material is spread and rolled shortly after being received.

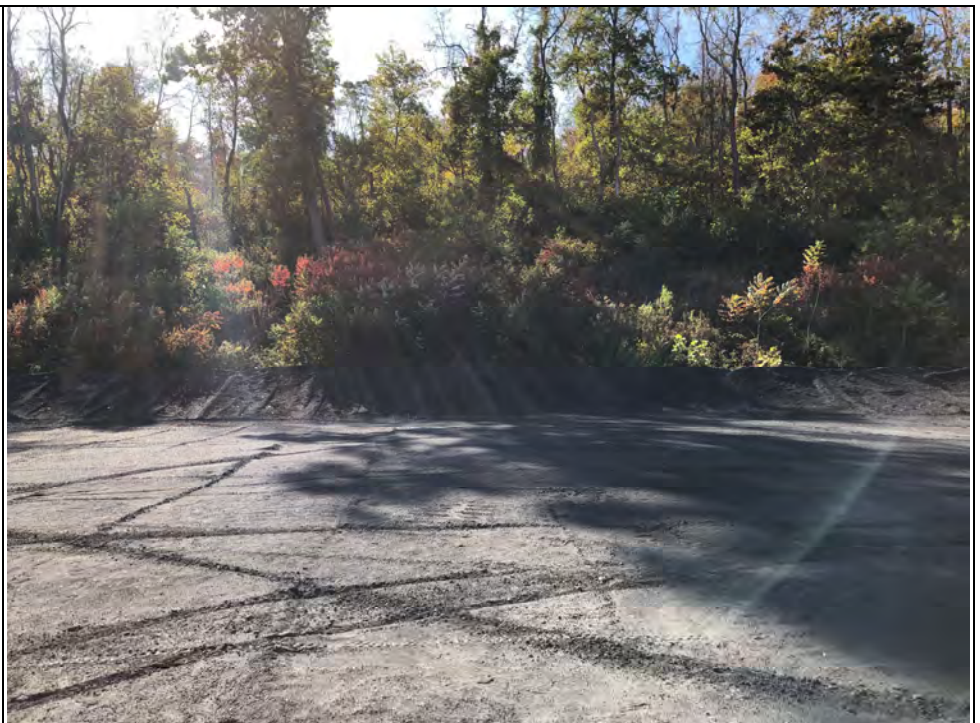
Image: 3673
Date: 10/21/2019
Time: 1:47 PM
Direction: South

The active area is well maintained with no ponding water. CCR material is spread and rolled shortly after being received.

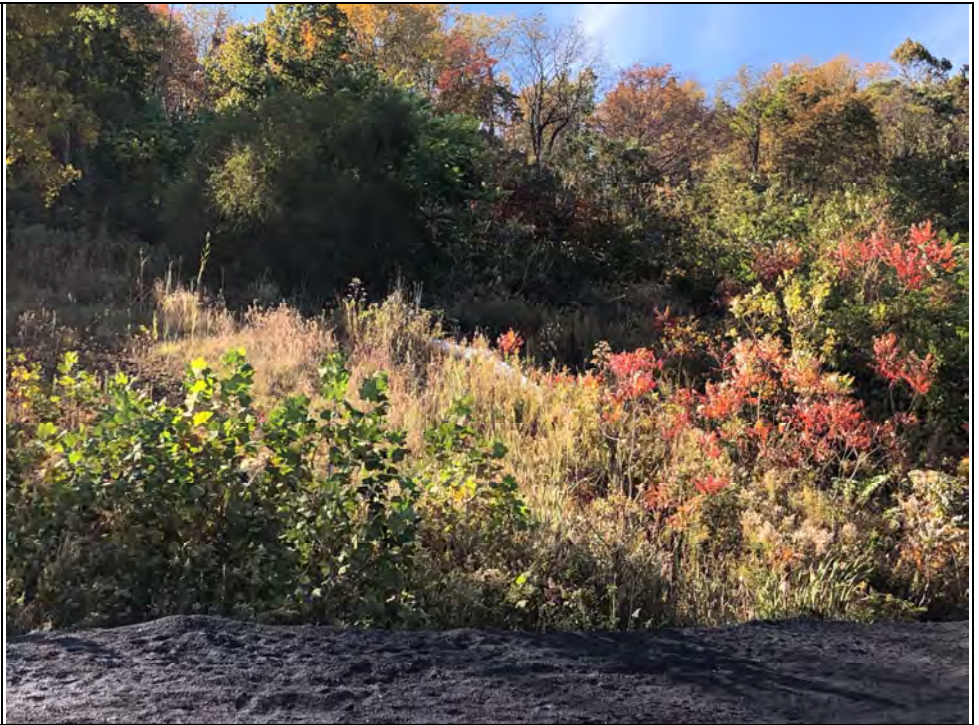
Image: 3675
 Date: 10/21/2019
 Time: 1:48 PM
 Direction: Southwest

Non-contact stormwater pipe along western sideslope. No evidence of erosion or sloughing.

Active area is shown in foreground (spread and compacted bottom ash).

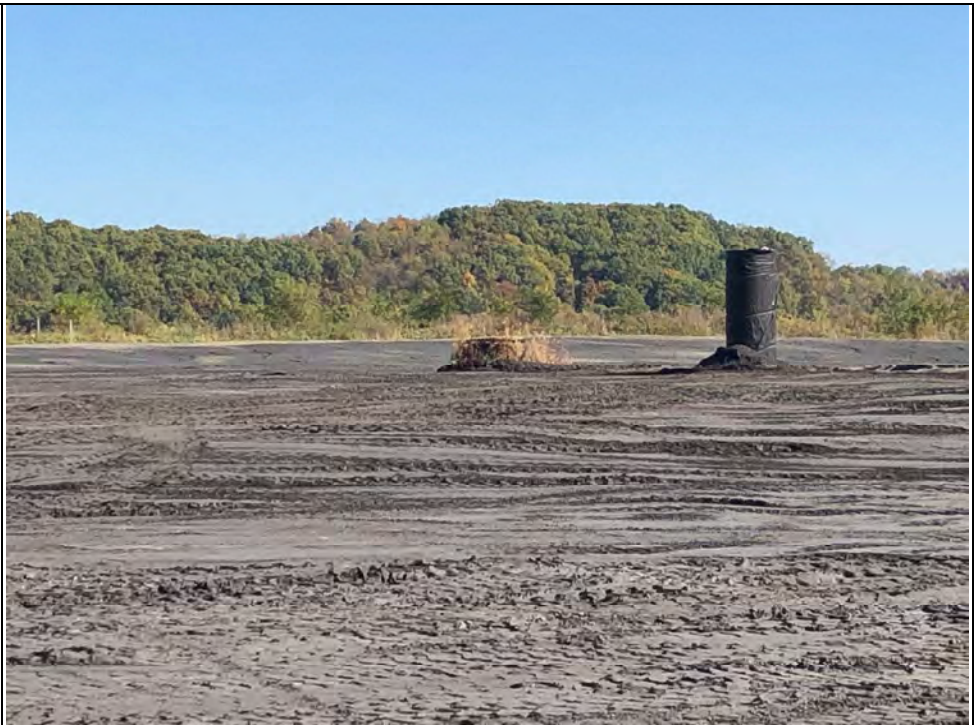
Image: 3677
 Date: 10/21/2019
 Time: 1:49 PM
 Direction: East

A non-contact water (stormwater) non-perforated riser is shown on the left. This riser will be extended to final cover elevation and will accept stormwater after final cover is in place.

A perforated contact-water (leachate) riser is shown on the right. This riser is wrapped in filter fabric and surrounded with bottom ash.

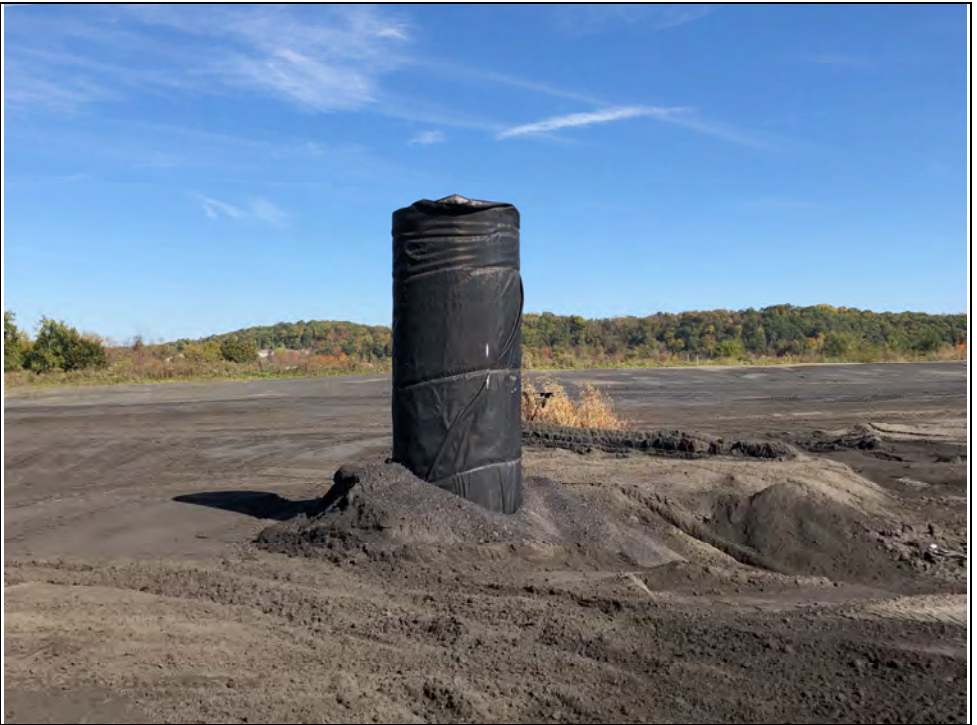
Image: 3679
Date: 10/21/2019
Time: 1:50 PM
Direction: East

A perforated contact-water (leachate) riser is wrapped in filter fabric and surrounded with bottom ash.

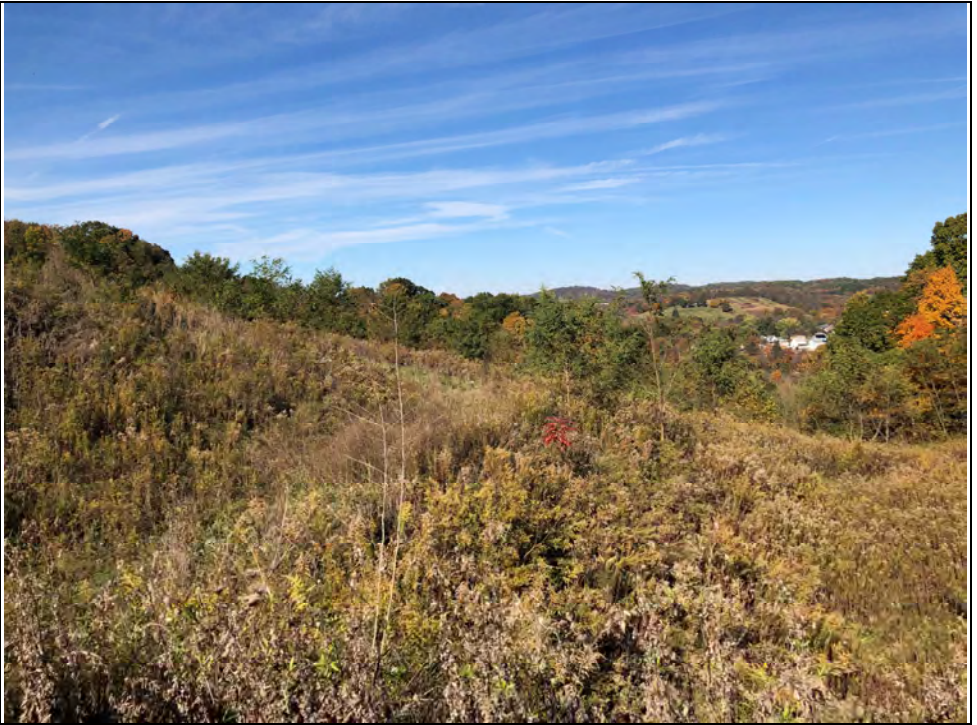
Image: 3681
Date: 10/21/2019
Time: 1:52 PM
Direction: Northeast

Sideslope near active face. Vegetation is healthy and present across the entire sideslope. No evidence of erosion, sloughing, or indications of stability issues.

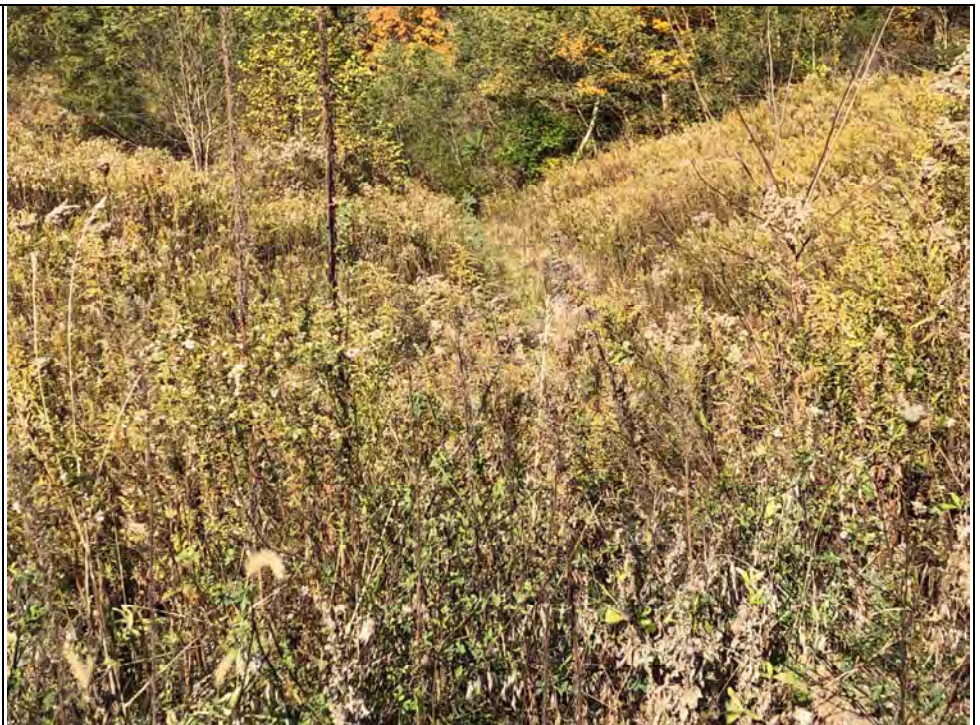
Image: 3683
Date: 10/21/2019
Time: 1:52 PM
Direction: Northeast

Vegetation on sideslope. Vegetation is well established. No evidence of erosion or sloughing.

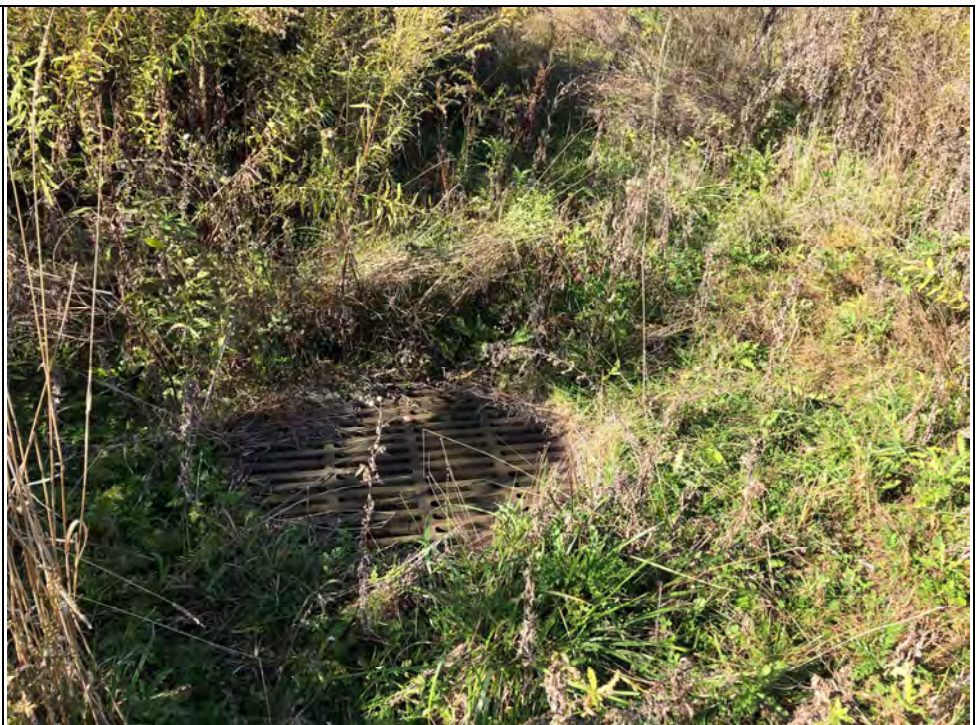
Image: 3685
Date: 10/21/2019
Time: 1:56 PM
Direction: Northwest

Manhole inlet for non-contact water (stormwater), located at the low point on a terrace bench.

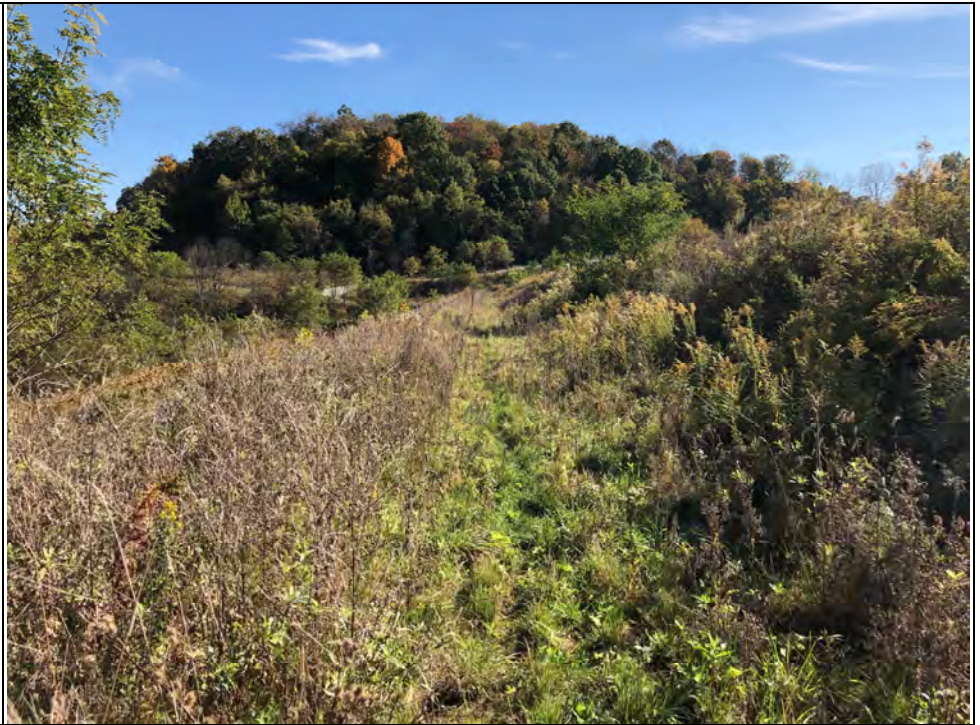
Image: 3687
Date: 10/21/2019
Time: 1:56 PM
Direction: Southeast

Sideslope on bench below active face. Vegetation is healthy and present across the entire sideslope. No evidence of erosion, sloughing, or indications of stability issues.

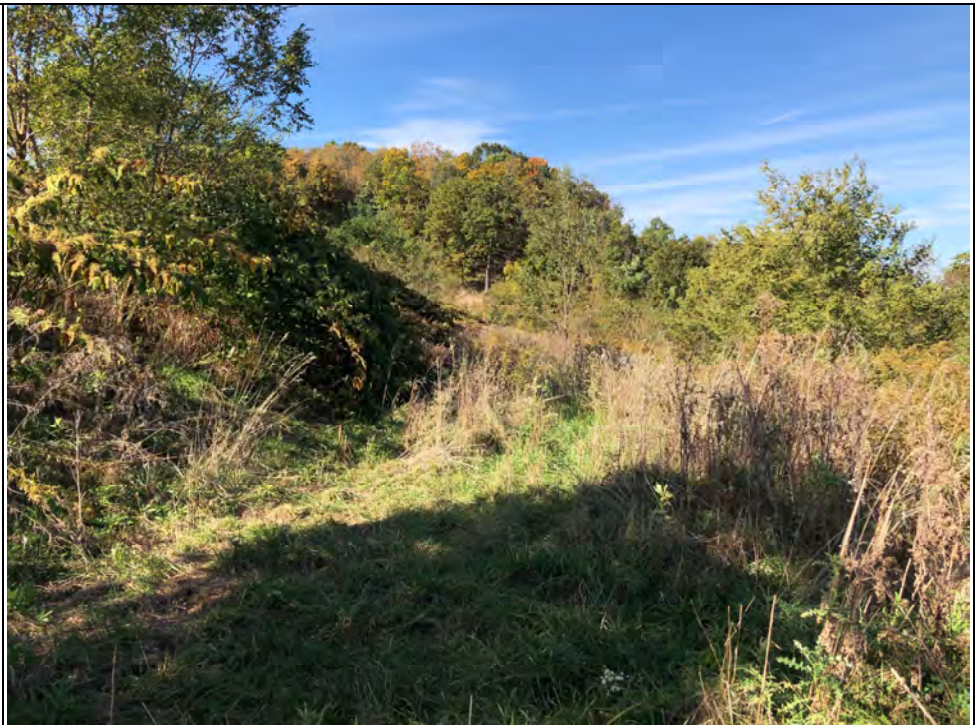
Image: 3689
Date: 10/21/2019
Time: 1:57 PM
Direction: North

Typical slope terrace. Terraces are well maintained with no evidence of sloughing or erosion. Vegetation is healthy.

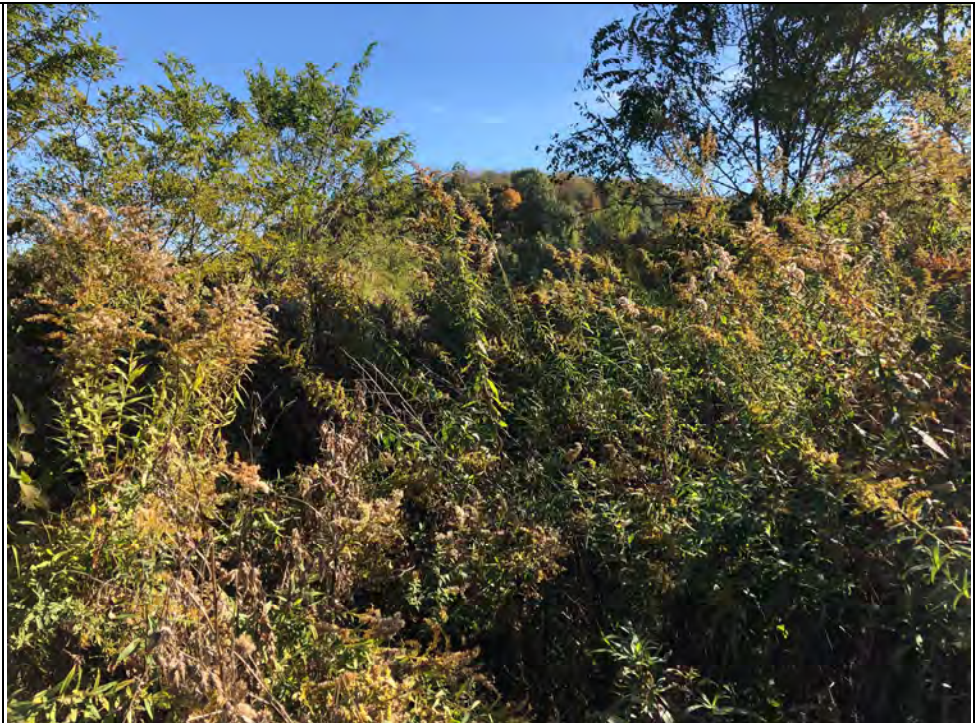
Image: 3691
Date: 10/21/2019
Time: 1:58 PM
Direction: Southeast

Vegetation on sideslope. Vegetation is well established. No evidence of erosion or sloughing.

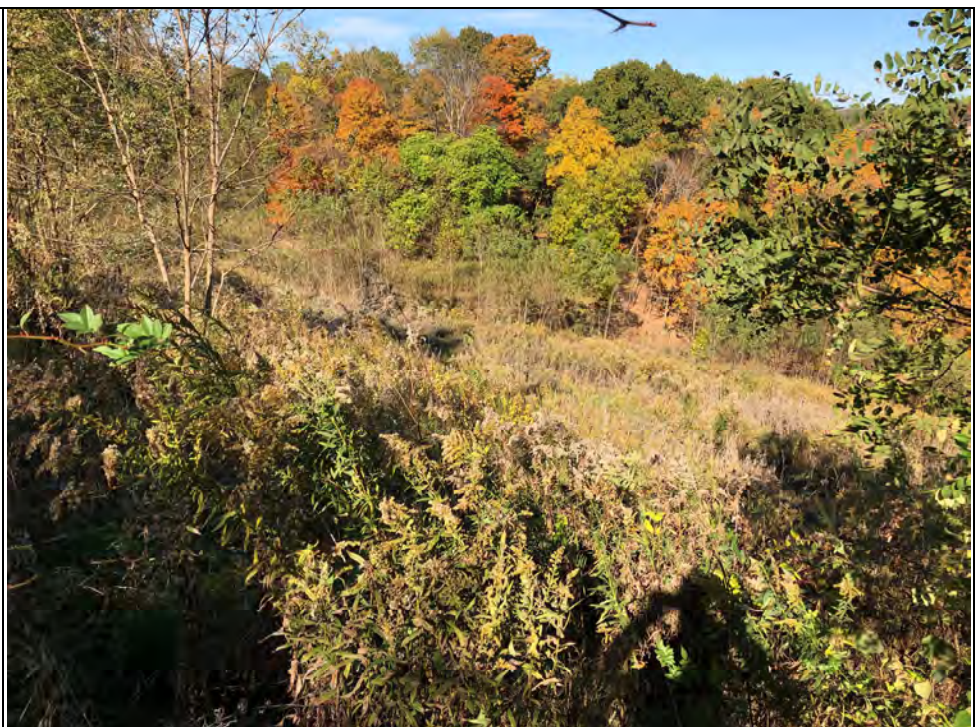
Image: 3693
Date: 10/21/2019
Time: 1:59 PM
Direction: North

Vegetation on sideslope. Vegetation is well established. No evidence of erosion or sloughing.

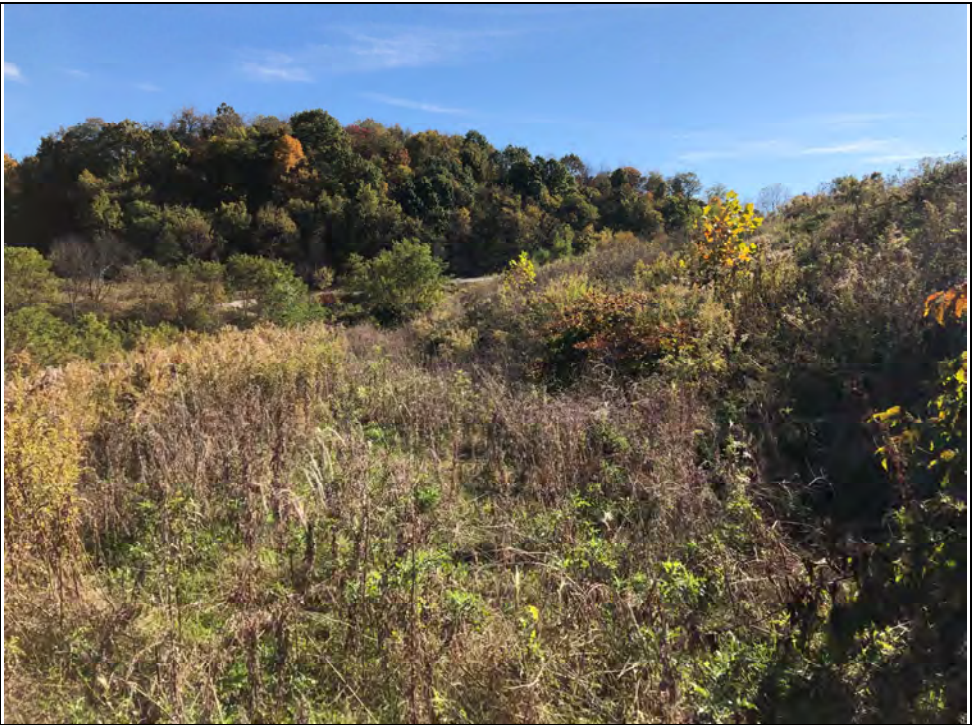
Image: 3695
Date: 10/21/2019
Time: 2:02 PM
Direction: South

Vegetation on sideslope. Vegetation is well established. No evidence of erosion or sloughing.

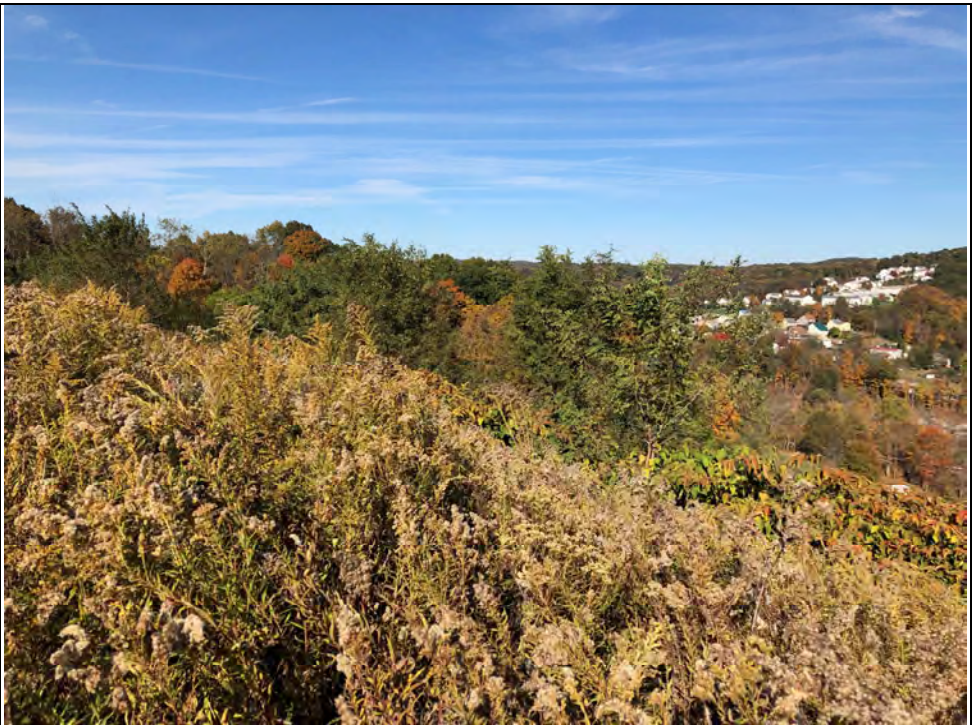
Image: 3697
Date: 10/21/2019
Time: 2:02 PM
Direction: North

Vegetation is healthy and present across the entire sideslope. No evidence of erosion, sloughing, or indications of stability issues.

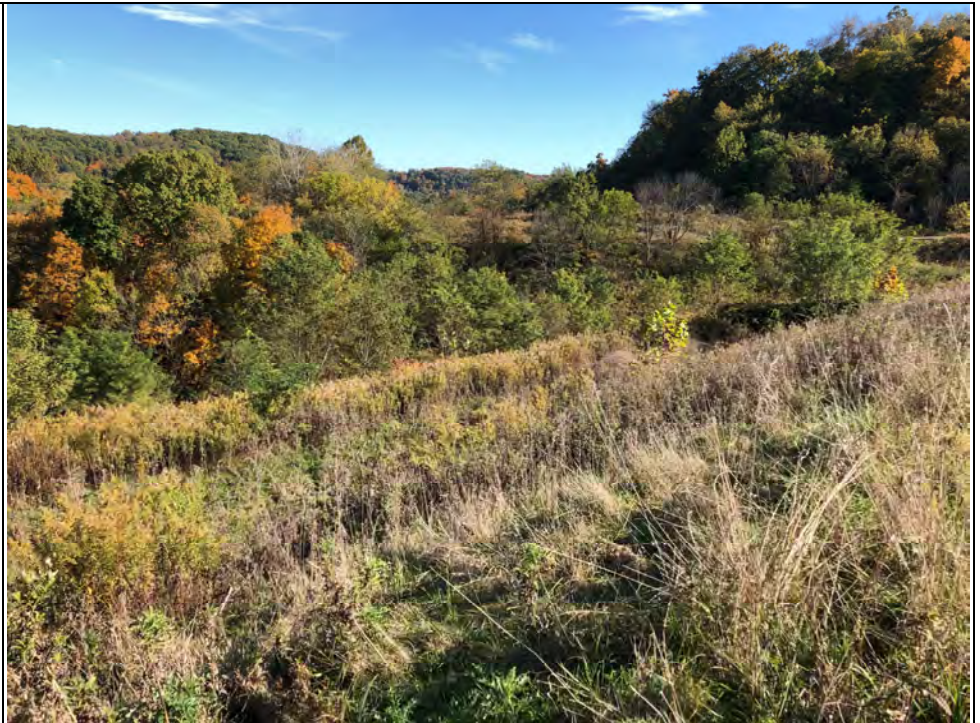
Image: 3699
Date: 10/21/2019
Time: 2:03 PM
Direction: Southeast

Vegetation is healthy and present across the entire sideslope. No evidence of erosion, sloughing, or indications of stability issues.
