Inspection Report

To: Brian Baierl (New Castle Generating Station)
From: Richard Southorn, P.E., P.G.
Re: New Castle Plant Ash Landfill–Annual CCR Unit Inspection Report
Inspection Date: October 22, 2019
Report Date: January 16, 2020

**NEW CASTLE GENERATING STATION
WEST PITTSBURG, PENNSYLVANIA**

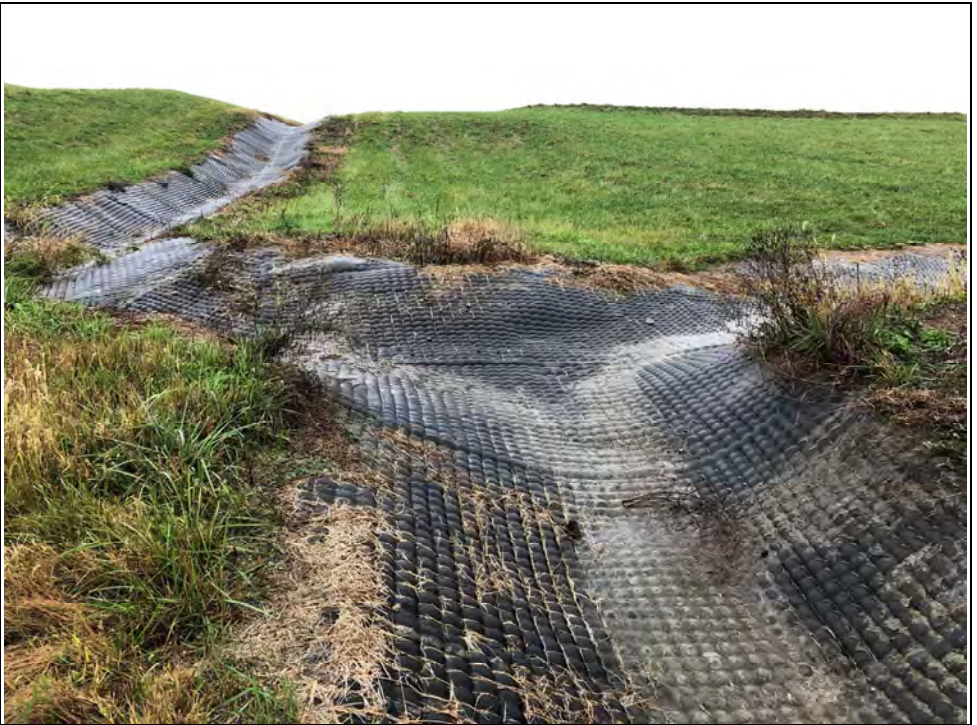
Image: 3707
Date: 10/22/2019
Time: 8:34 AM
Direction: North

Non-contact stormwater downchute. Clear of obstructions. Revetment is in good condition. Functioning as intended.

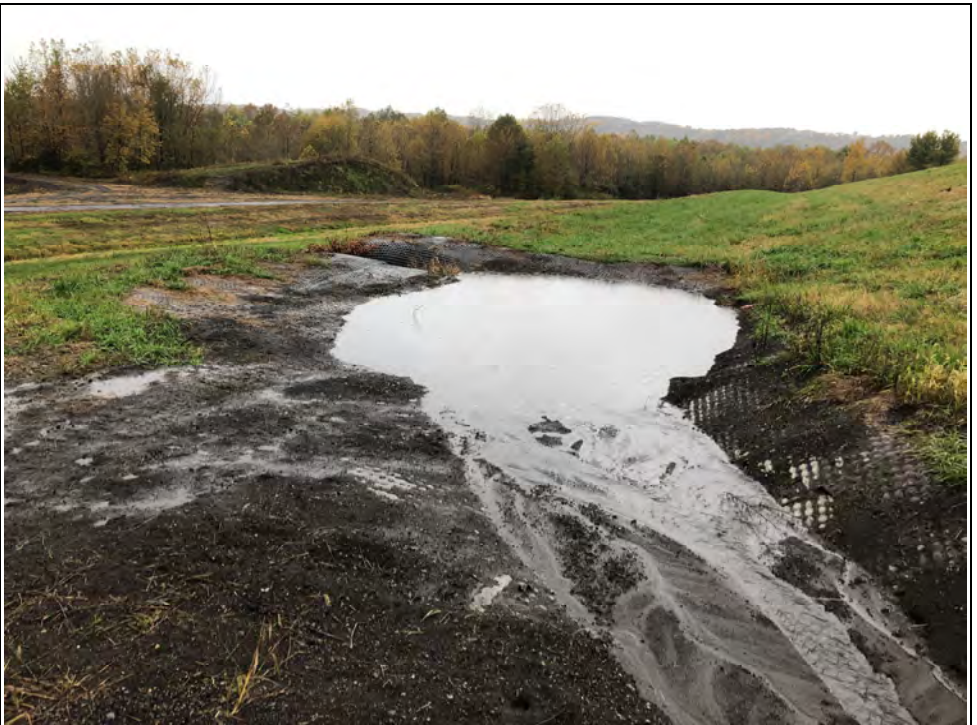
Image: 3709
Date: 10/22/2019
Time: 8:35 AM
Direction: Southwest

Minor ponding of water behind downchute. Ponding occurs over revetment lined area (Photograph taken during rainstorm).

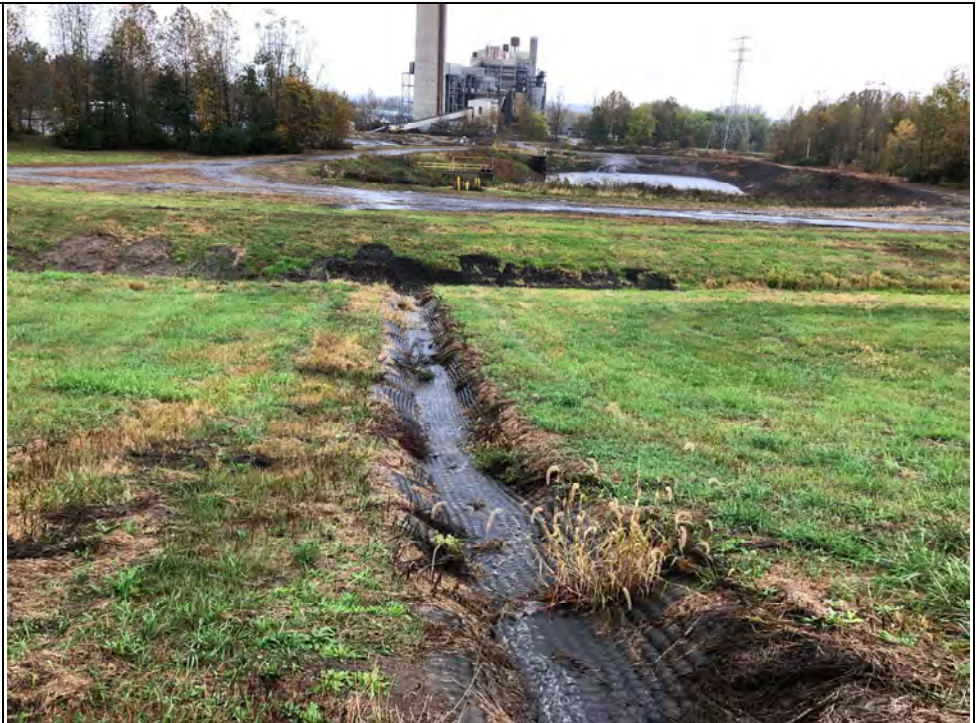
Image: 3711
Date: 10/22/2019
Time: 8:36 AM
Direction: South

Non-contact stormwater downchute is clear of obstructions. Gabion energy dissipator is installed at the junction with the stormwater (non-contact water) perimeter ditch.

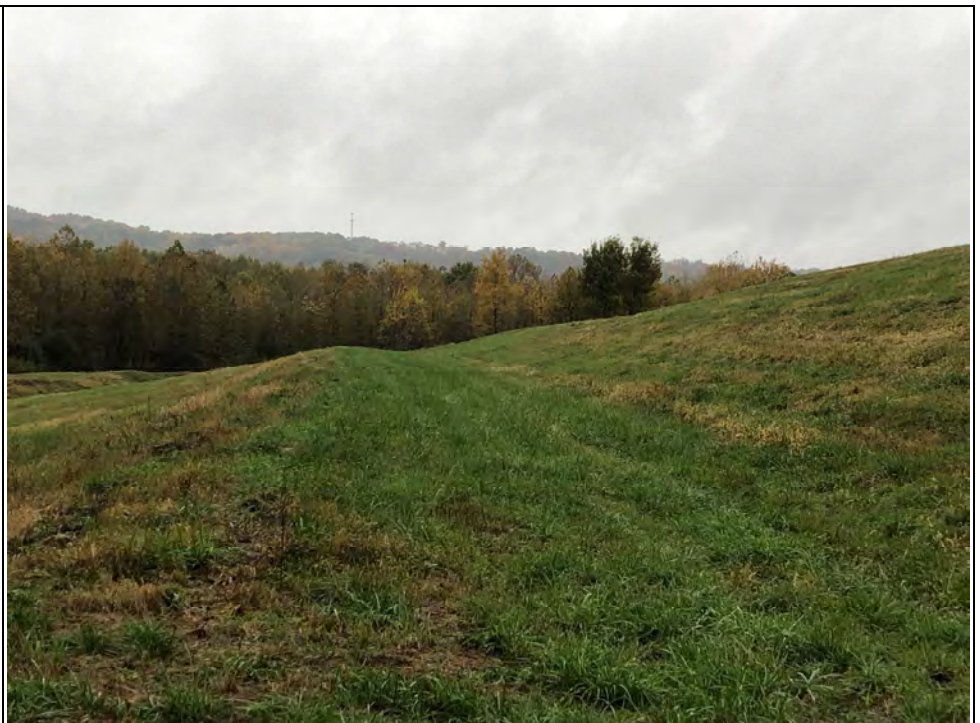
Image: 3713
Date: 10/22/2019
Time: 8:37 AM
Direction: West

Final cover sideslopes and terrace berm. Good condition, no evidence of animal burrows, erosion, or sloughing. Photograph shows area where minor erosion had been repaired in 2018. Repair location has become fully vegetated and appears stable.

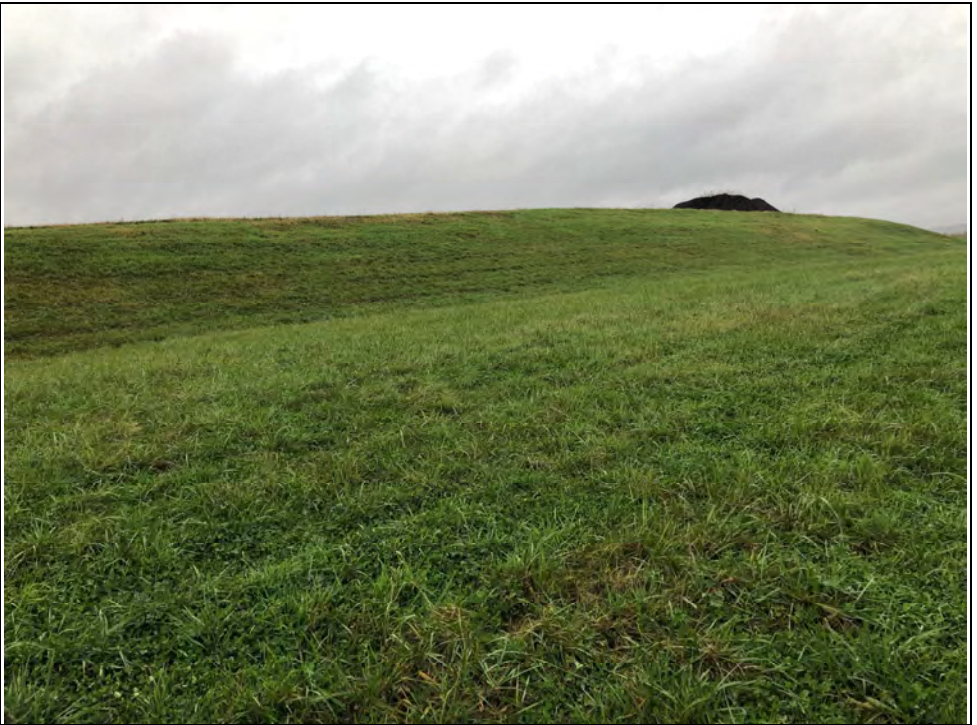
Image: 3715
Date: 10/22/2019
Time: 8:39 AM
Direction: Northwest

Stage 6 final cover. Vegetation is healthy and well maintained. No evidence of animal burrows, erosion, or stability.

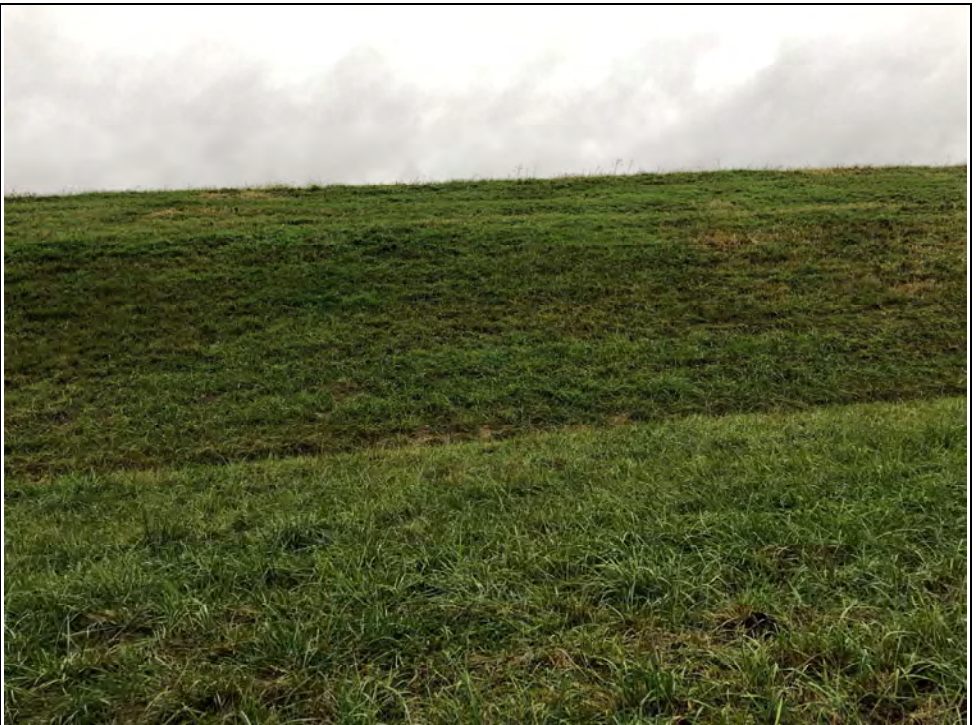
Image: 3719
Date: 10/22/2019
Time: 8:39 AM
Direction: West

Stage 6 final cover and transition slope to Stage 4. Vegetation is healthy and well maintained. No evidence of animal burrows, erosion, or stability.

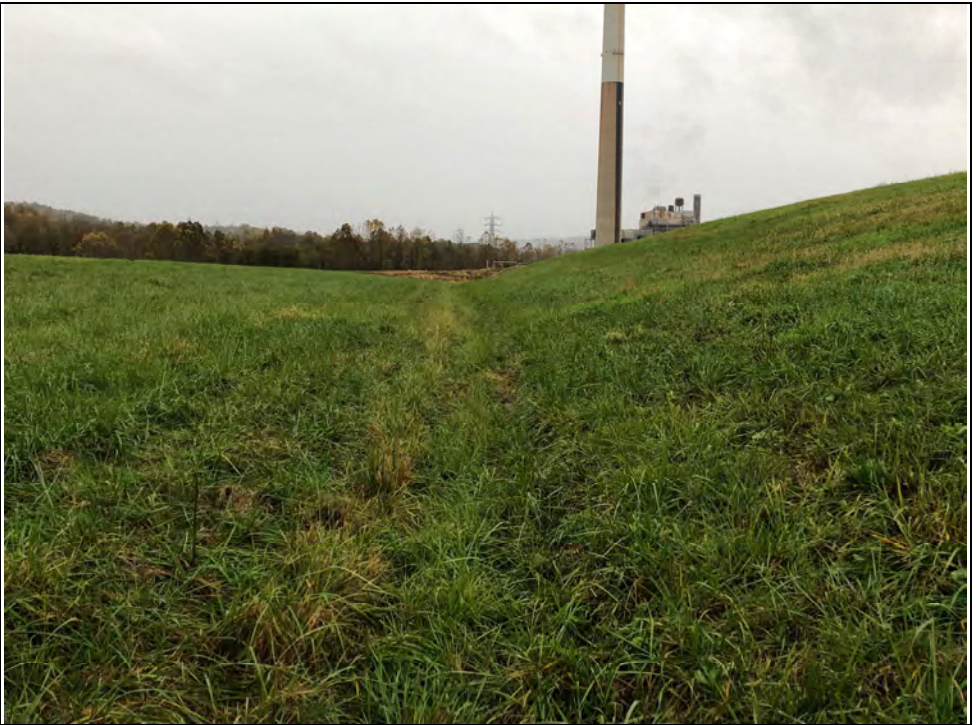
Image: 3721
Date: 10/22/2019
Time: 8:40 AM
Direction: South

Stage 6 final cover (left) and transition slope to Stage 4 (right). Vegetation is healthy and well maintained. No evidence of animal burrows, erosion, or stability.

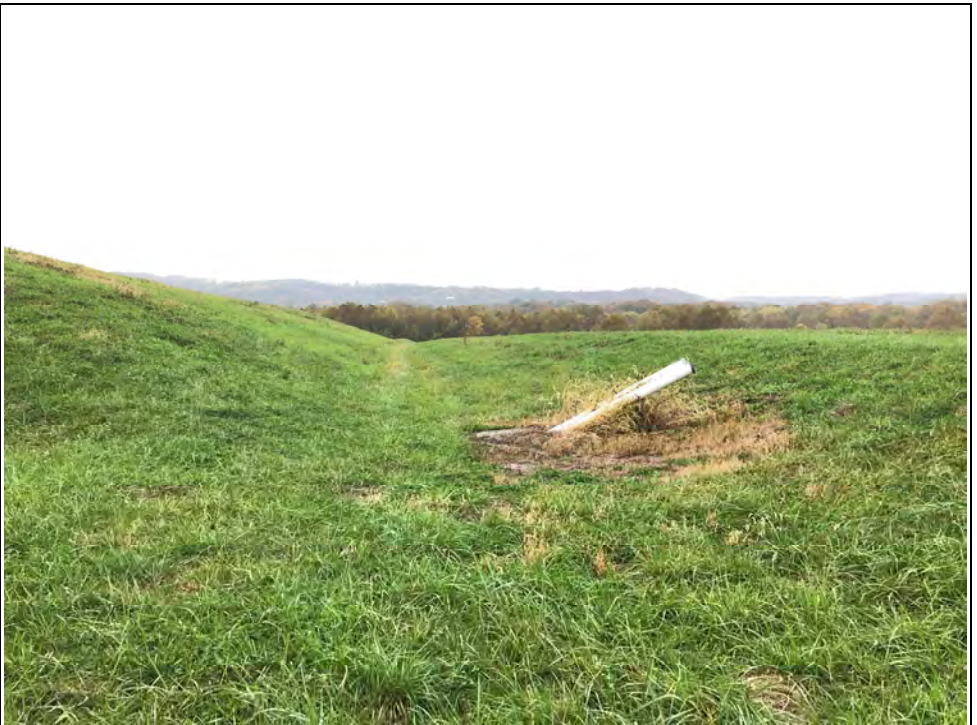
Image: 3723
Date: 10/22/2019
Time: 8:40 AM
Direction: West

Stage 4 leachate cleanout access.

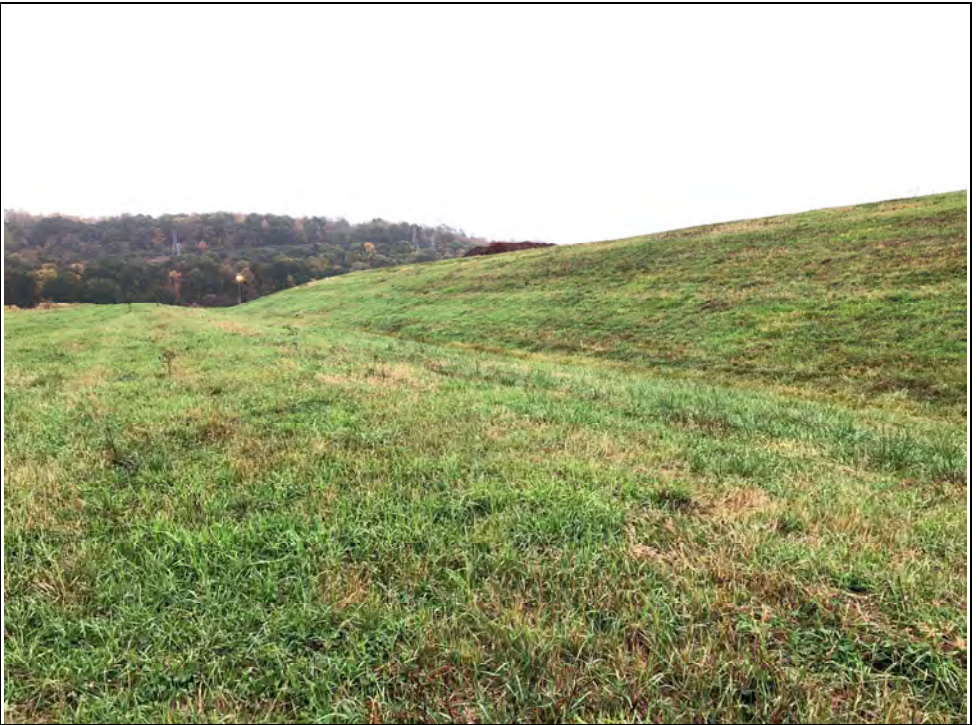
Image: 3727
Date: 10/22/2019
Time: 8:42 AM
Direction: East

Stage 5 final cover. Vegetation is healthy and well maintained. No evidence of animal burrows, erosion, or stability.

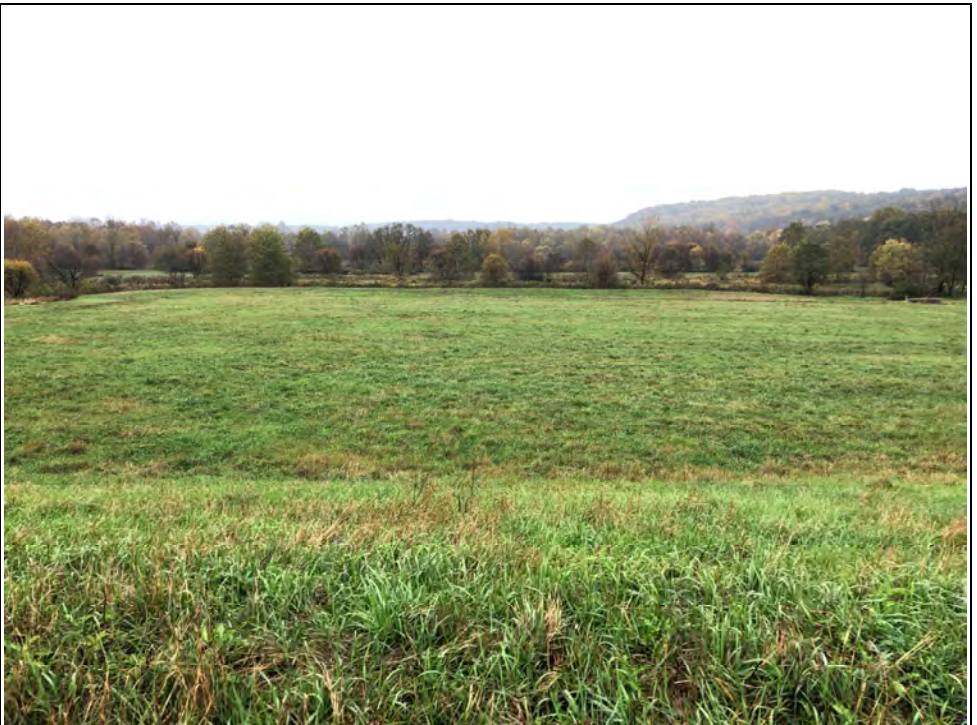
Image: 3729
Date: 10/22/2019
Time: 8:43 AM
Direction: Northeast

Stage 5 final cover. Vegetation is healthy and well maintained. No evidence of animal burrows, erosion, or stability.

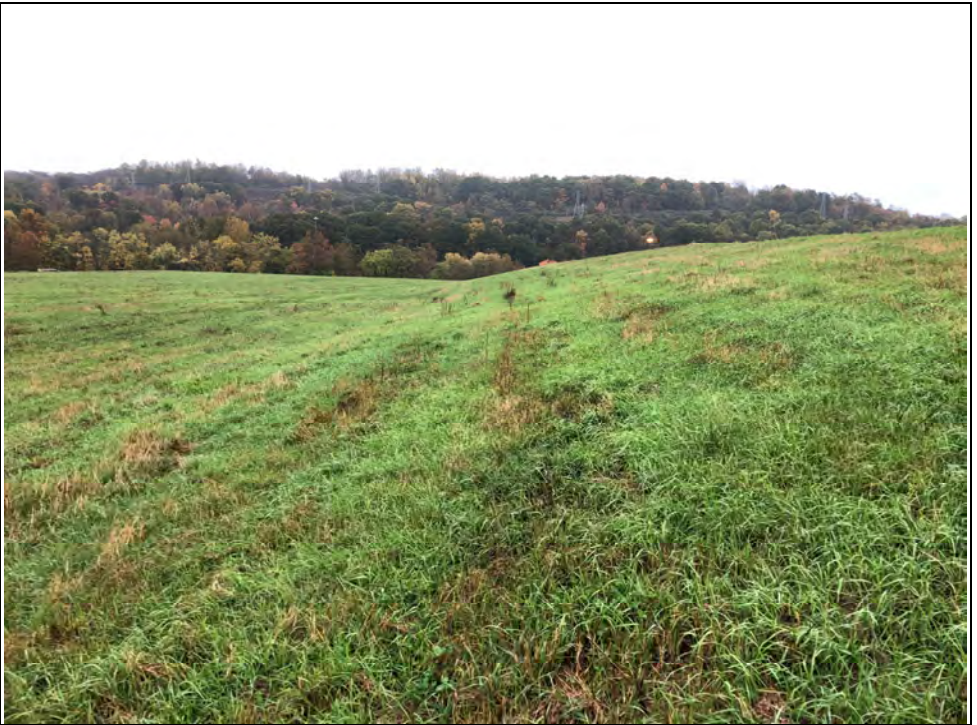
Image: 3731
Date: 10/22/2019
Time: 8:43 AM
Direction: East

Stage 5 final cover. Vegetation is healthy and well maintained. No evidence of animal burrows, erosion, or stability.

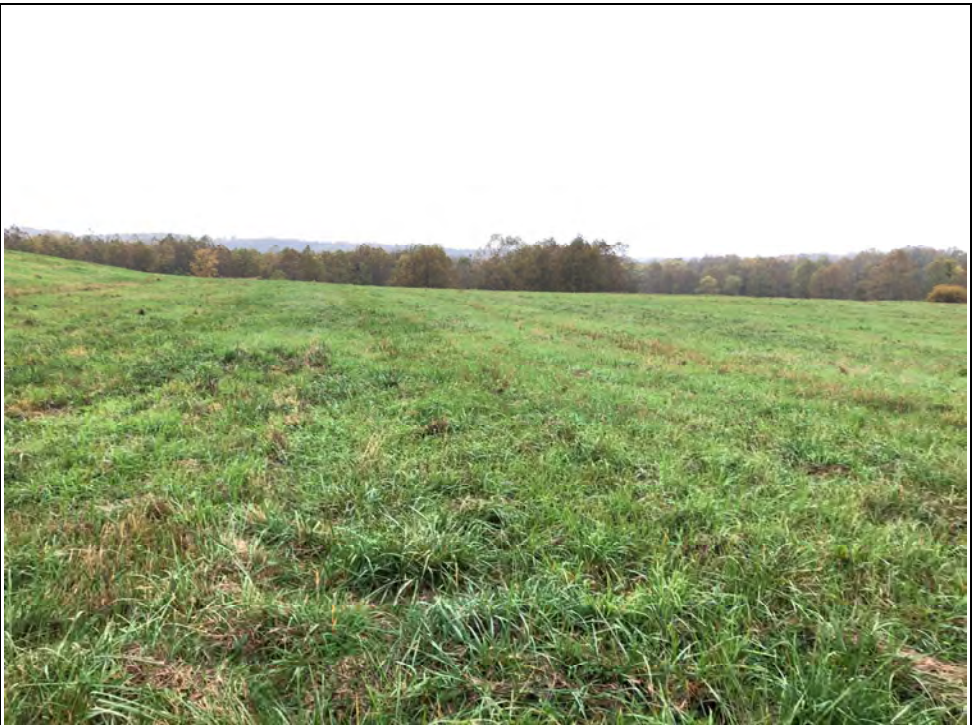
Image: 3733
Date: 10/22/2019
Time: 8:44 AM
Direction: West

Stage 5 final cover. Vegetation is healthy and well maintained. No evidence of animal burrows, erosion, or stability.

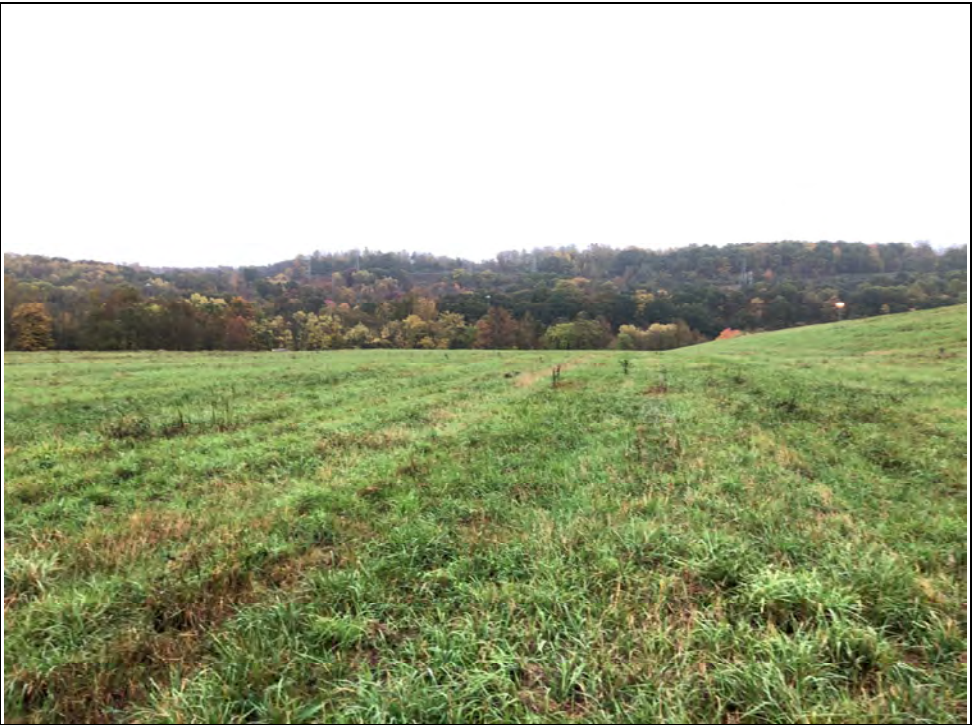
Image: 3735
Date: 10/22/2019
Time: 8:44 AM
Direction: East

Stage 5 final cover. Vegetation is healthy and well maintained. No evidence of animal burrows, erosion, or stability.

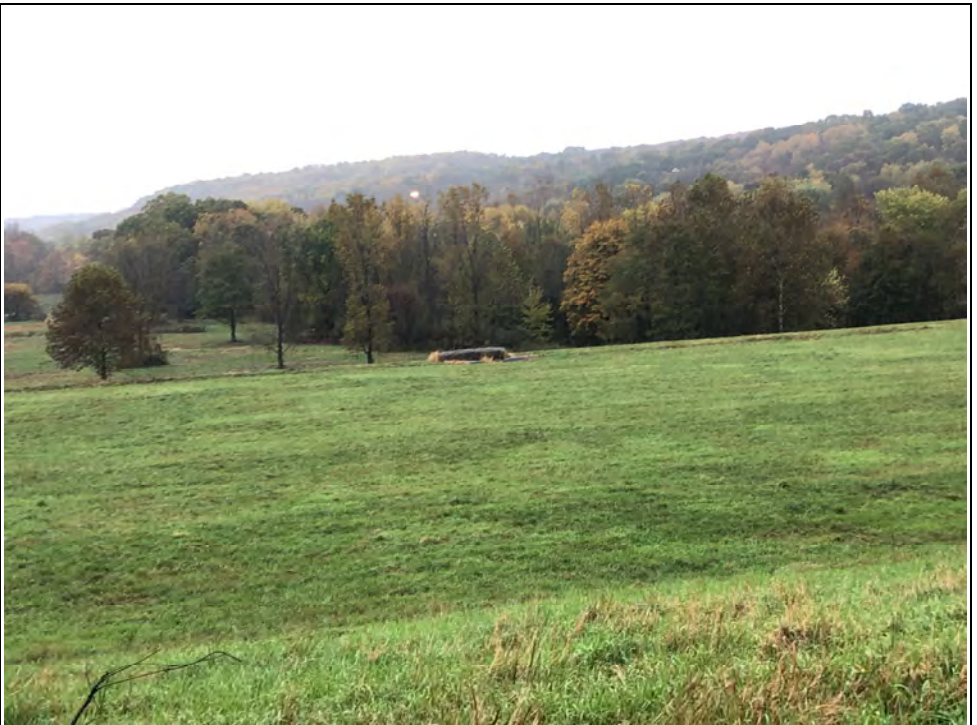
Image: 3737
Date: 10/22/2019
Time: 8:45 AM
Direction: Northeast

Stage 5 final cover. Vegetation is healthy and well maintained. No evidence of animal burrows, erosion, or stability.

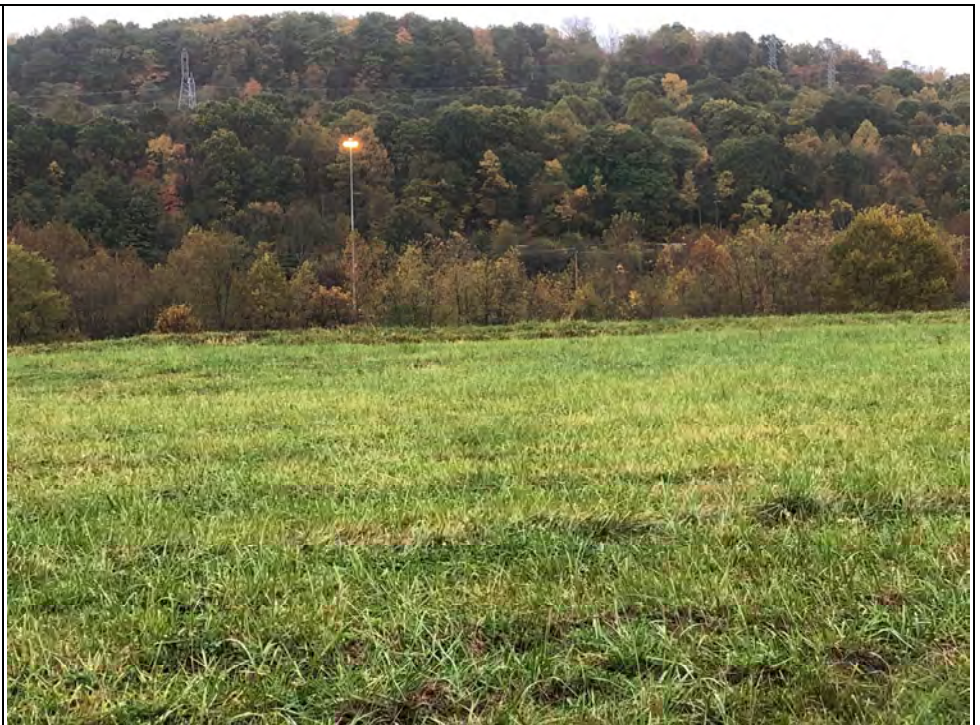
Image: 3739
Date: 10/22/2019
Time: 8:46 AM
Direction: Southeast

Stage 6 final cover. Vegetation is healthy and well maintained. No evidence of animal burrows, erosion, or stability.

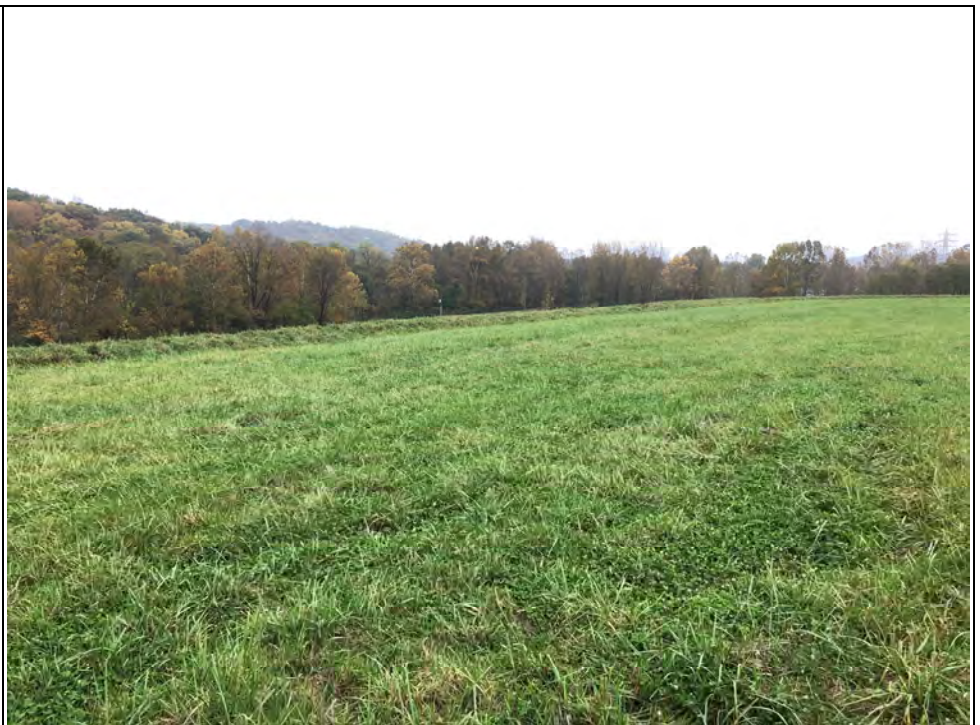
Image: 3741
Date: 10/22/2019
Time: 8:47 AM
Direction: Southeast

Stage 6 final cover. Vegetation is healthy and well maintained. No evidence of animal burrows, erosion, or stability.

Stormwater Control Berm can be seen along limits of landfill terrace.

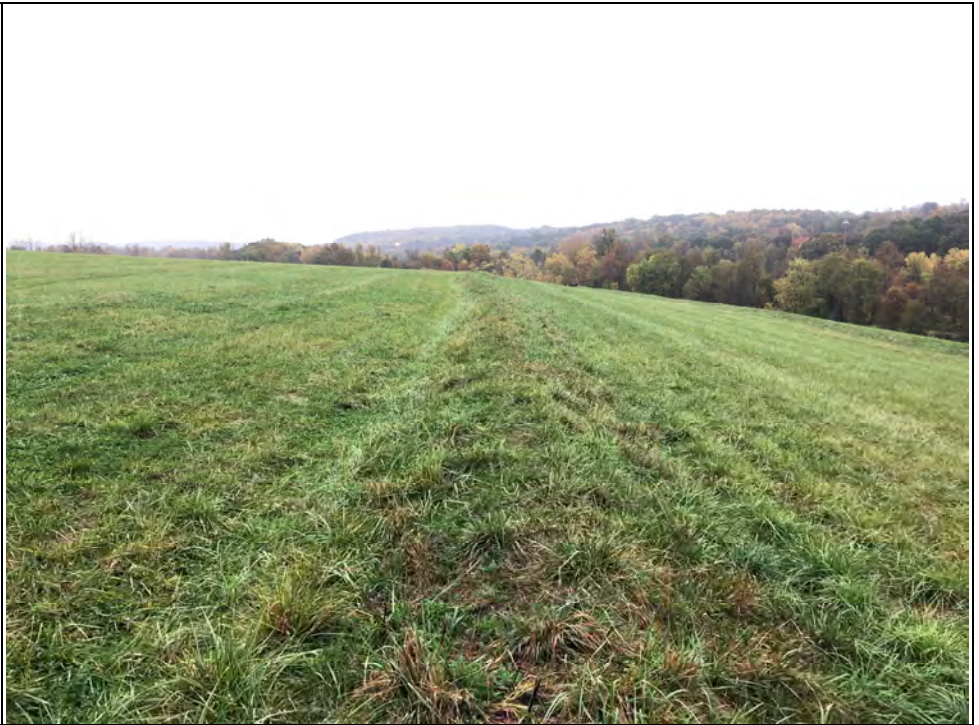
Image: 3743
Date: 10/22/2019
Time: 8:47 AM
Direction: North

Stage 6 Stormwater Control Berm used to direct stormwater to downchutes (letdown channels).

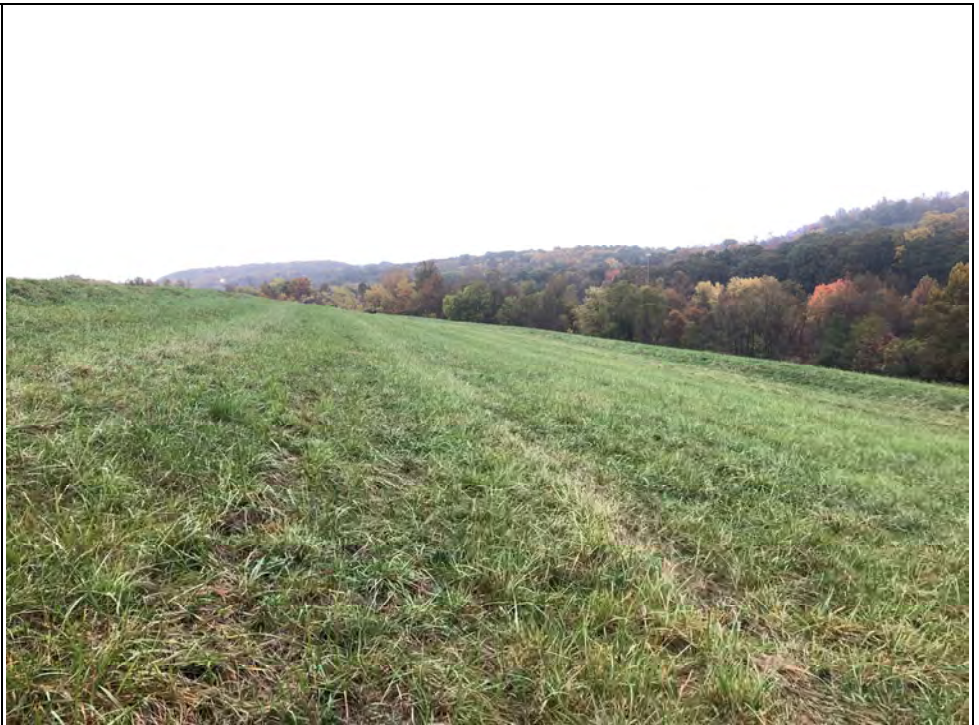
Image: 3745
Date: 10/22/2019
Time: 8:47 AM
Direction: North

Stage 6 final cover on sideslopes. Vegetation is healthy and well maintained. No evidence of animal burrows, erosion, or stability.

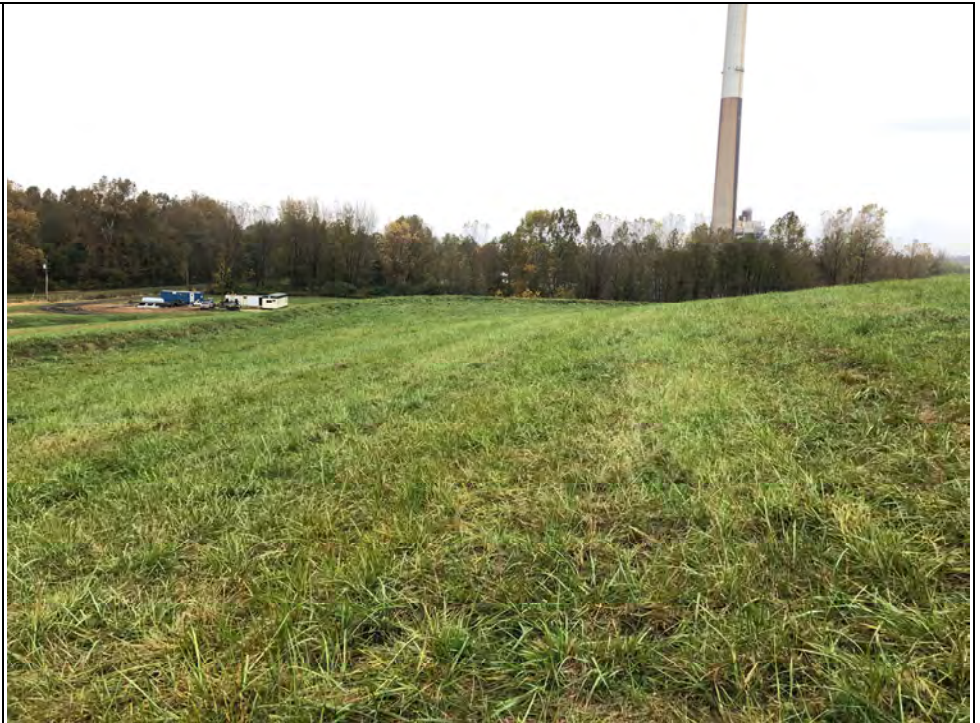
Image: 3747
Date: 10/22/2019
Time: 8:48 AM
Direction: South

Stage 6 final cover on sideslopes. Vegetation is healthy and well maintained. No evidence of animal burrows, erosion, or stability.

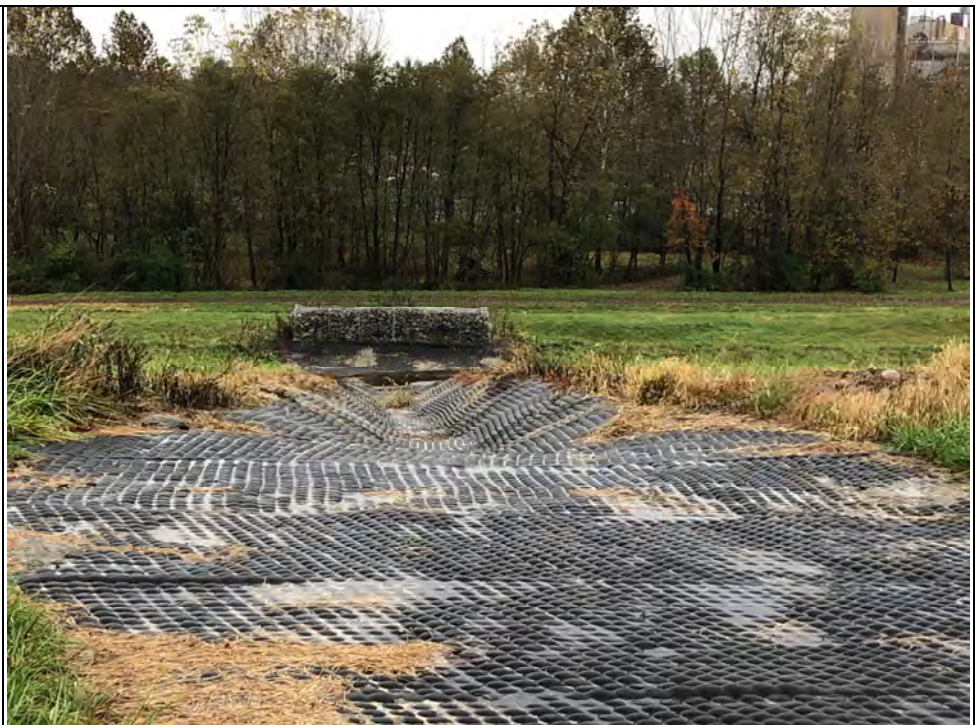
Image: 3749
Date: 10/22/2019
Time: 8:49 AM
Direction: South

Non-contact stormwater downchute is clear of obstructions. Gabion energy dissipator is installed at the junction with the stormwater (non-contact water) perimeter ditch.

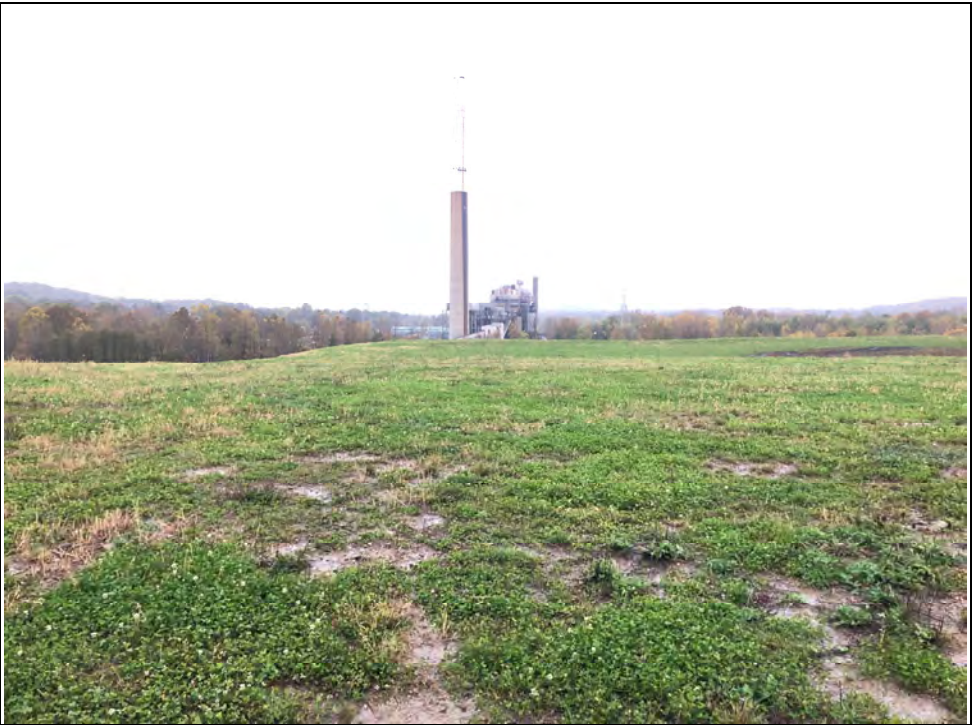
Image: 3751
Date: 10/22/2019
Time: 8:50 AM
Direction: Southeast

Stage 4 intermediate cover. Vegetation is sufficient to prevent fugitive dust emissions and minimize the potential for erosion.

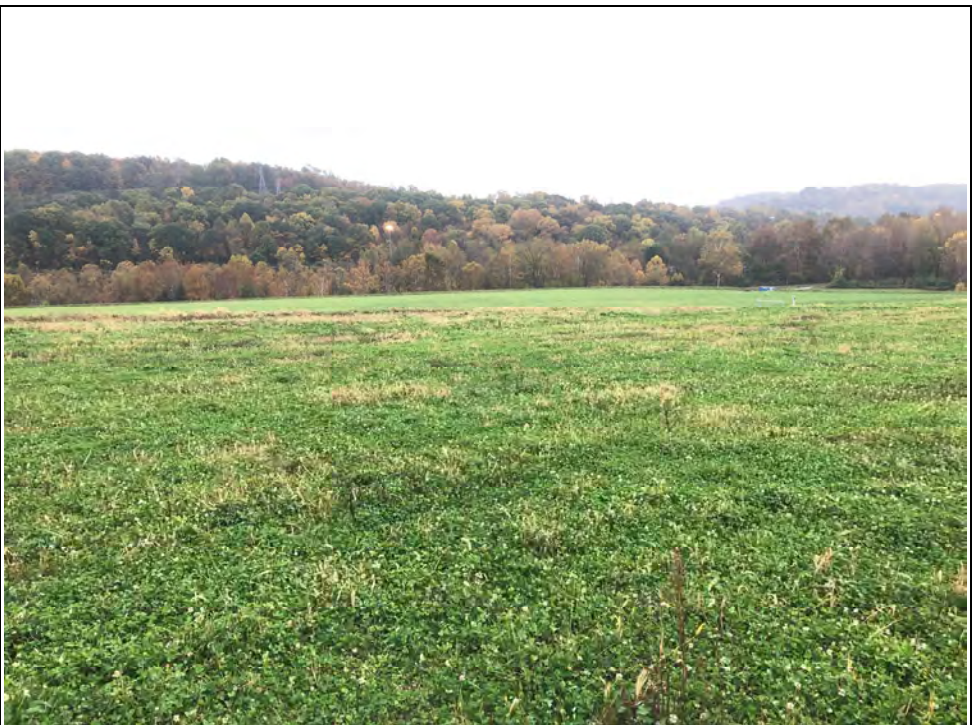
Image: 3753
Date: 10/22/2019
Time: 8:51 AM
Direction: East

Stage 4 intermediate cover. Vegetation is well established.

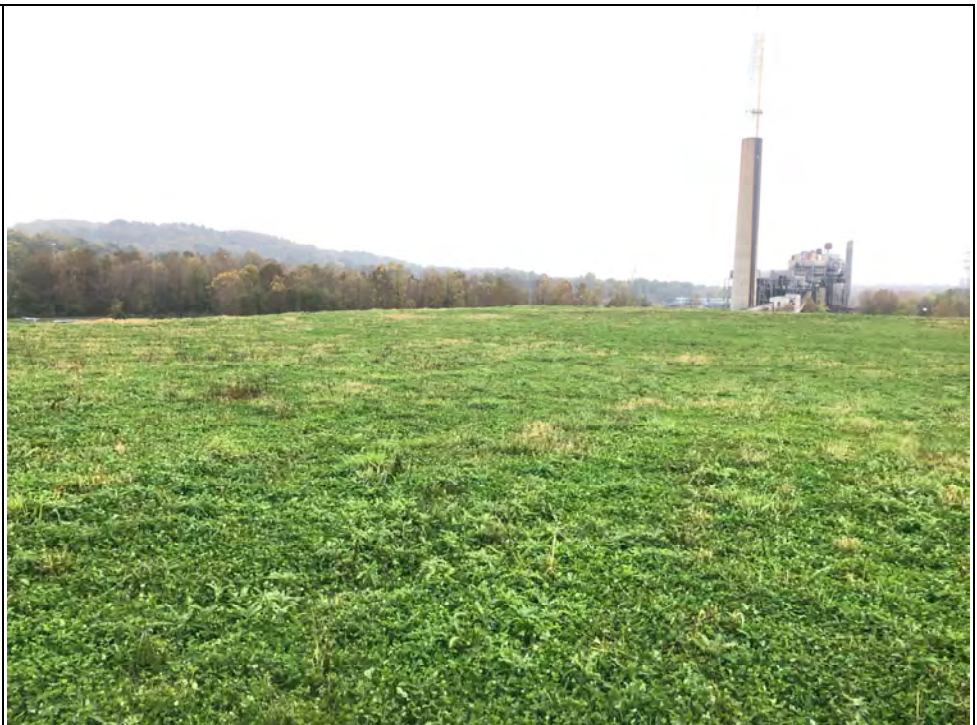
Image: 3755
Date: 10/22/2019
Time: 8:51 AM
Direction: Southeast

Stage 4 intermediate cover. Vegetation is well established.

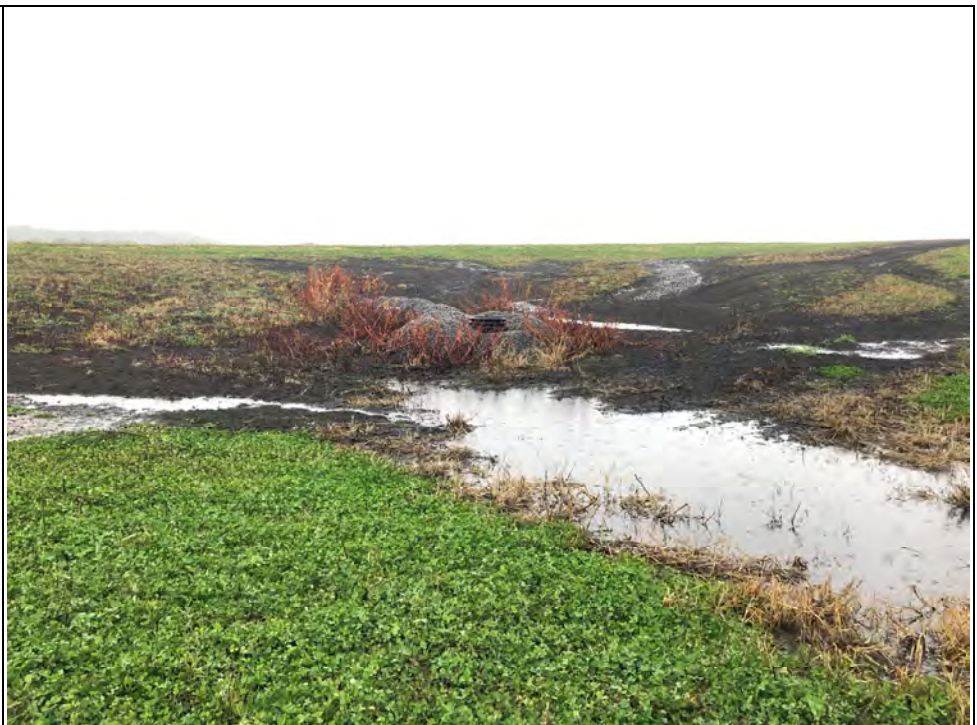
Image: 3757
Date: 10/22/2019
Time: 8:52 AM
Direction: Northwest

Stage 4 active area. Well graded and compacted. Some ponding is occurring during rainstorm; this water will be treated as contact water.

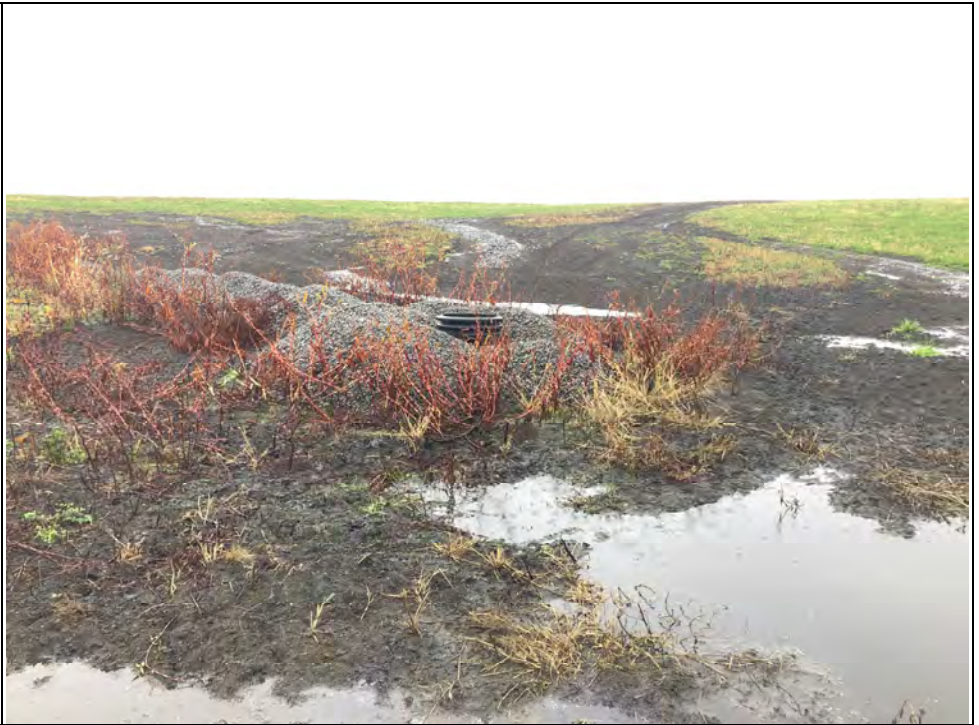
Image: 3759
Date: 10/22/2019
Time: 8:53 AM
Direction: North

Vertical leachate riser within active area. The ground is sloped to drain into this riser, with contact water treated as leachate.

Some ponding is occurring during rainstorm; this water will be treated as contact water.

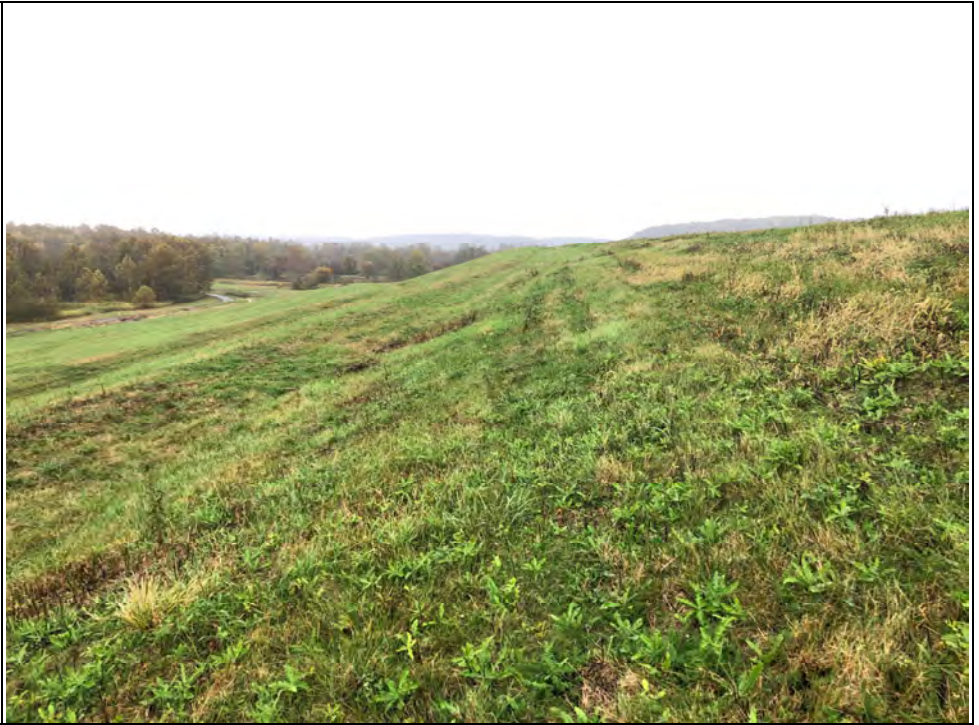
Image: 3761
Date: 10/22/2019
Time: 8:56 AM
Direction: North

Final cover on the sideslopes of Stage 4. Final cover vegetation is healthy and well established. No stability concerns evident.

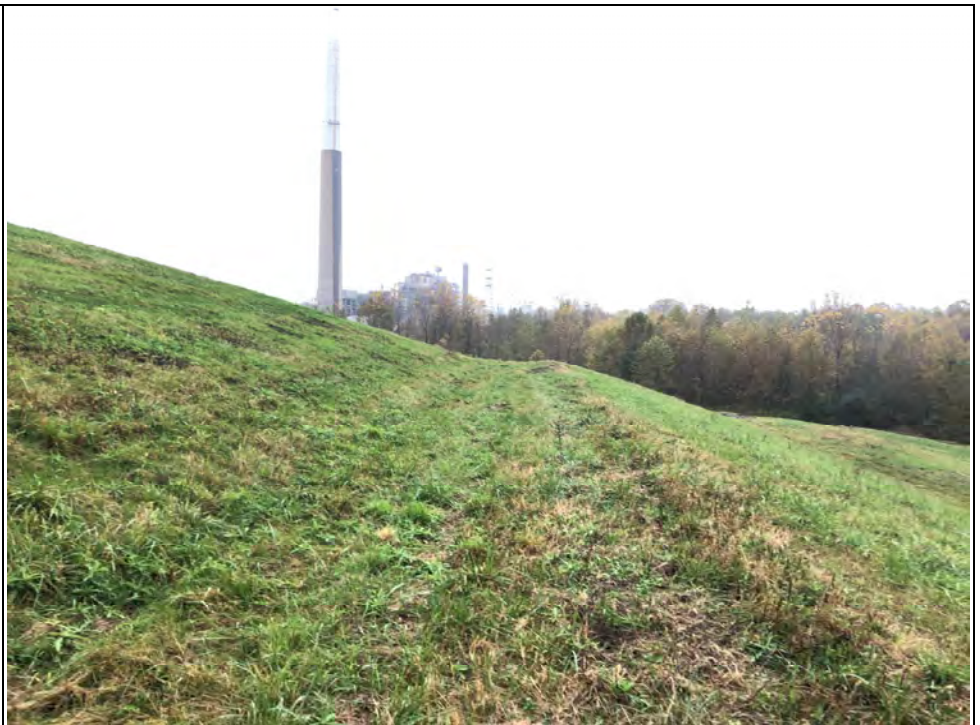
Image: 3763
Date: 10/22/2019
Time: 8:57 AM
Direction: South

Final cover and terrace on the sideslopes of Stage 4. Final cover vegetation is healthy and well established. No stability concerns evident. Terrace shows no indication of washout or evidence of erosive flow.

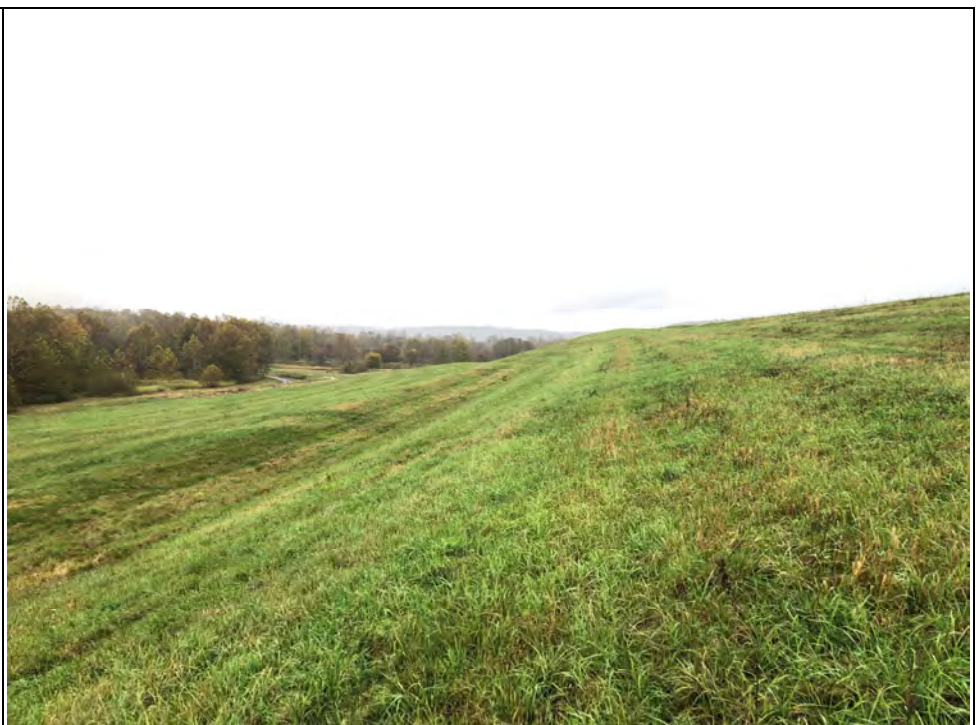
Image: 3765
Date: 10/22/2019
Time: 8:57 AM
Direction: North

Final cover on the sideslopes of Stage 4. Final cover vegetation is healthy and well established. No stability concerns evident.

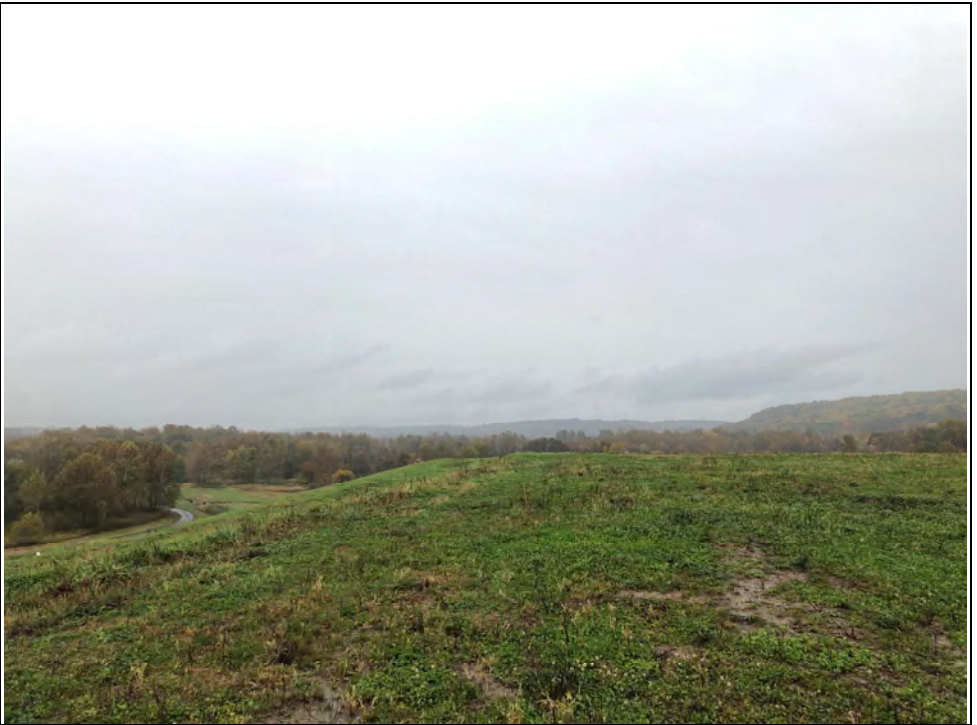
Image: 3767
Date: 10/22/2019
Time: 8:58 AM
Direction: Northeast

Stage 4 intermediate cover. Vegetation is well established.

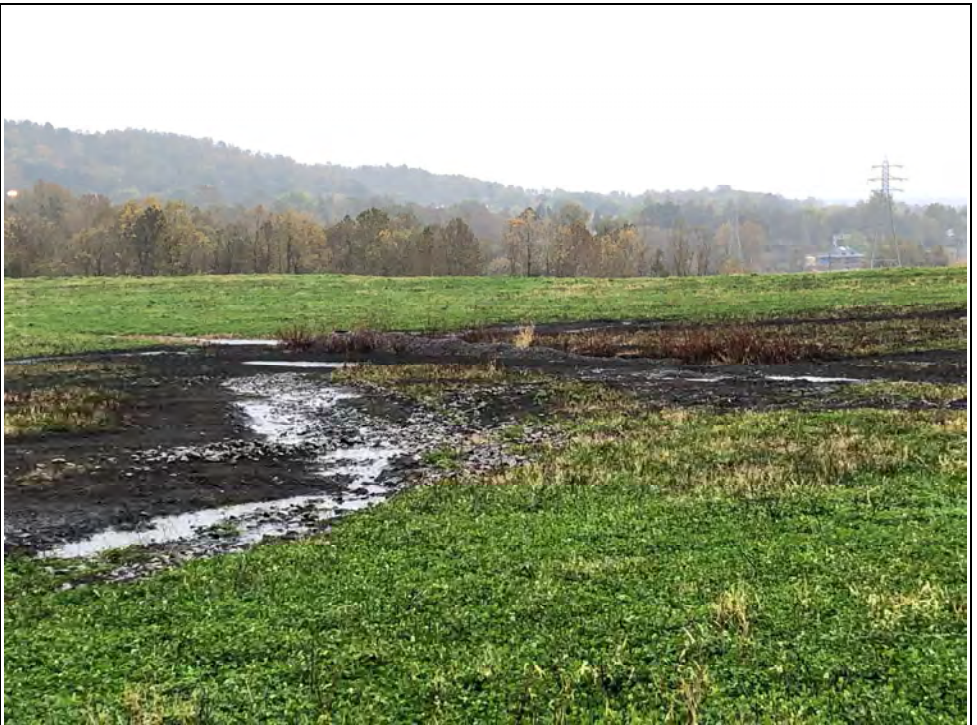
Image: 3769
Date: 10/22/2019
Time: 8:58 AM
Direction: Southeast

Stage 4 active area. Well graded and compacted. Some ponding is occurring during rainstorm; this water will be treated as contact water.
