Inspection Report

To: Brian Baierl (New Castle Generating Station)
From: Richard Southorn, P.E., P.G.
Re: New Castle Plant Ash Landfill–Annual CCR Unit Inspection Report
Inspection Date: October 22, 2019
Report Date: January 16, 2020

**NEW CASTLE GENERATING STATION
WEST PITTSBURG, PENNSYLVANIA**

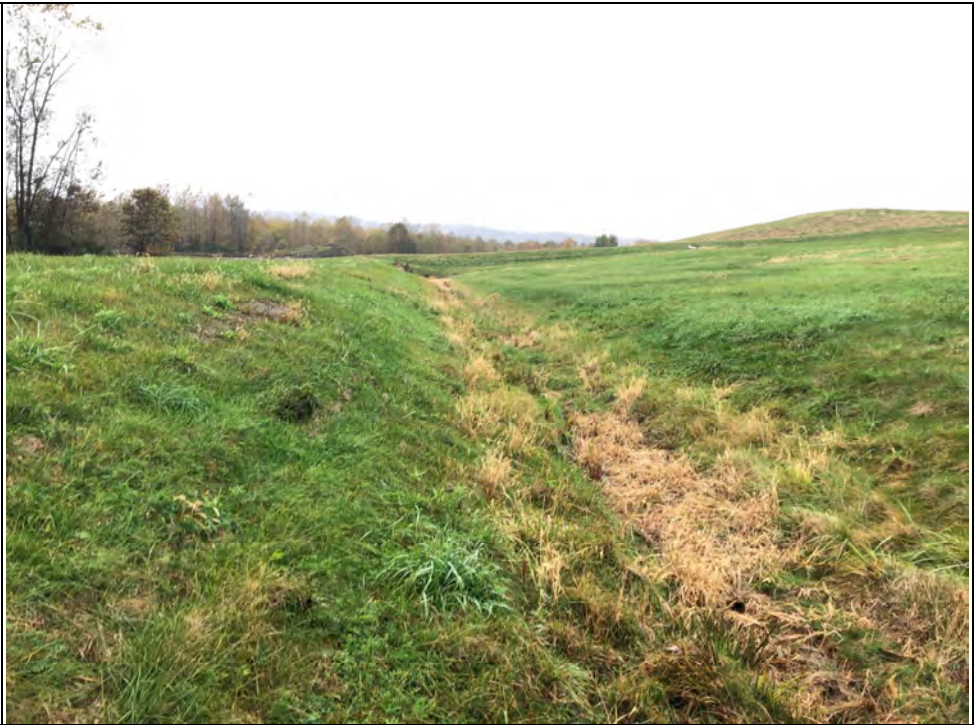
Image: 3775
Date: 10/22/2019
Time: 9:02 AM
Direction: West

Non-contact stormwater ditch along Stage 6 is free of obstructions and does not exhibit scour or erosion issues.

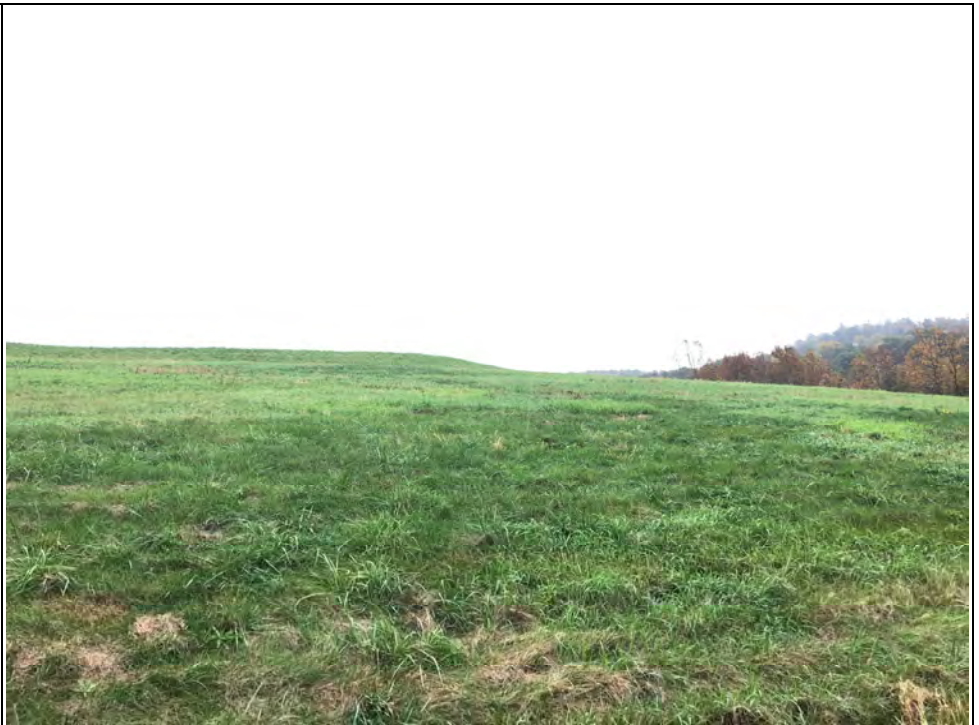
Image: 3777
Date: 10/22/2019
Time: 9:03 AM
Direction: North

Final cover on the sideslopes of Stage 6. Final cover vegetation is healthy and well established. No stability concerns evident.

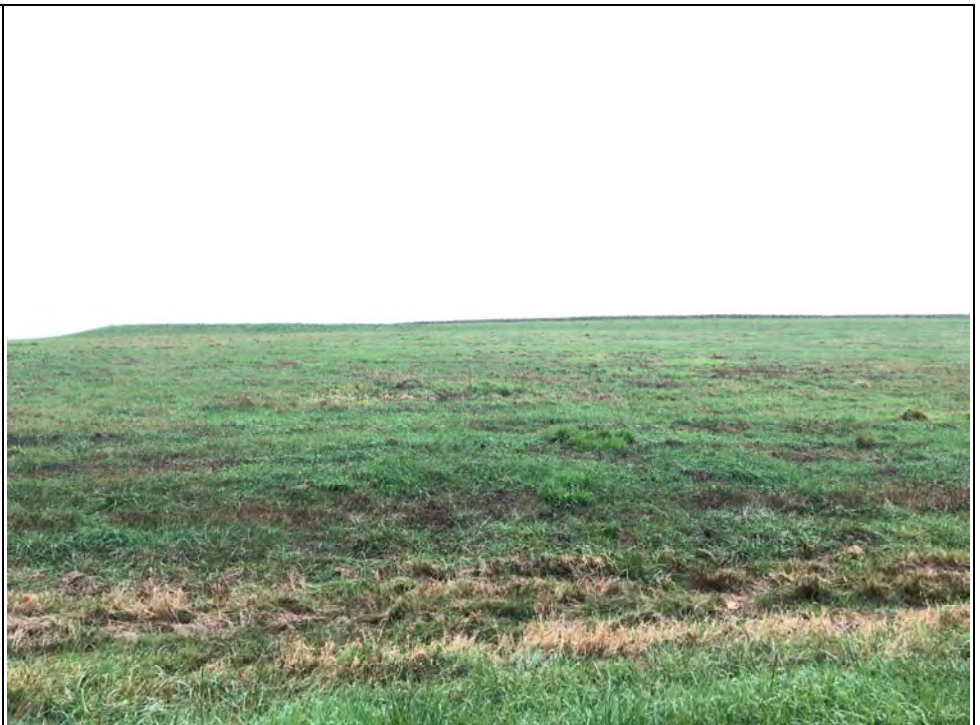
Image: 3779
Date: 10/22/2019
Time: 9:04 AM
Direction: Northwest

Final cover on the sideslopes of Stage 6. Final cover vegetation is healthy and well established. No stability concerns evident.

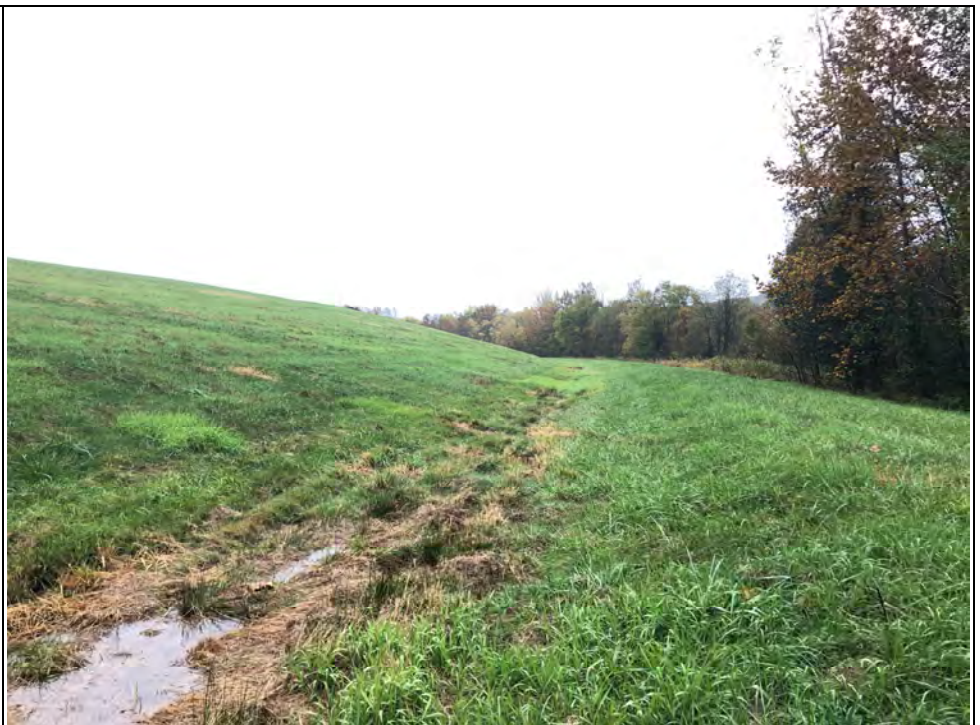
Image: 3781
Date: 10/22/2019
Time: 9:05 AM
Direction: North

Non-contact stormwater ditch along Stage 6 is free of obstructions and does not exhibit scour or erosion issues.

No stability issues are noted along the sideslope or toe of slope (sloughing, bulging, etc).

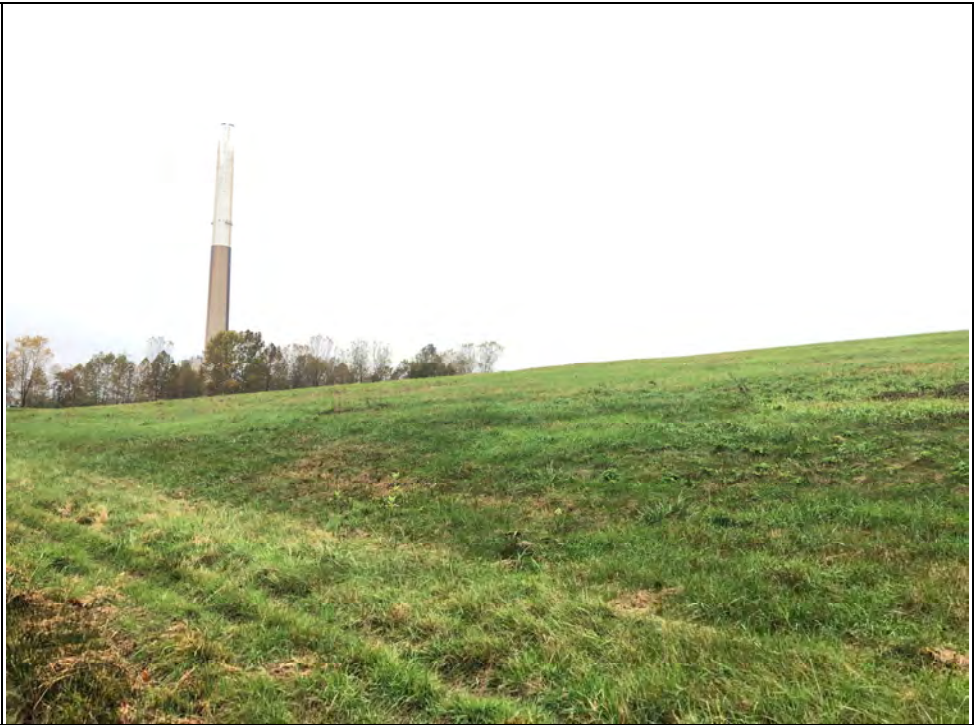
Image: 3783
 Date: 10/22/2019
 Time: 9:05 AM
 Direction: Southwest

Final cover on the sideslopes of Stage 6. Final cover vegetation is healthy and well established. No stability concerns evident.

Non-contact stormwater ditch along Stage 6 is free of obstructions and does not exhibit scour or erosion issues.

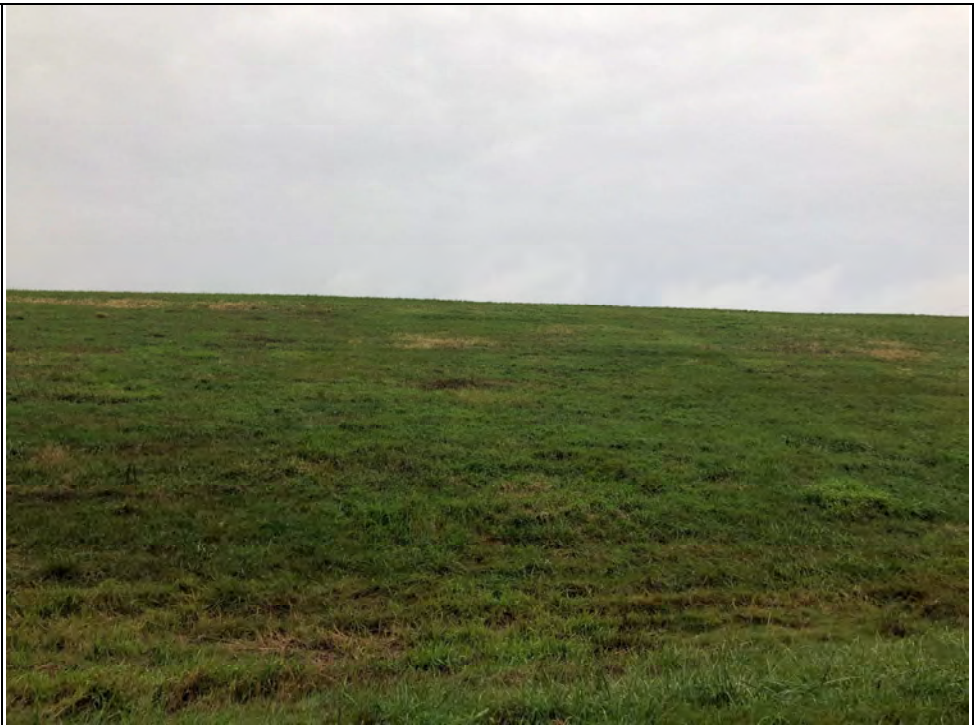
Image: 3785
 Date: 10/22/2019
 Time: 9:06 AM
 Direction: West

Final cover on the sideslopes of Stage 6. Final cover vegetation is healthy and well established. No stability concerns evident.

No stability issues are noted along the sideslope or toe of slope (sloughing, bulging, etc).

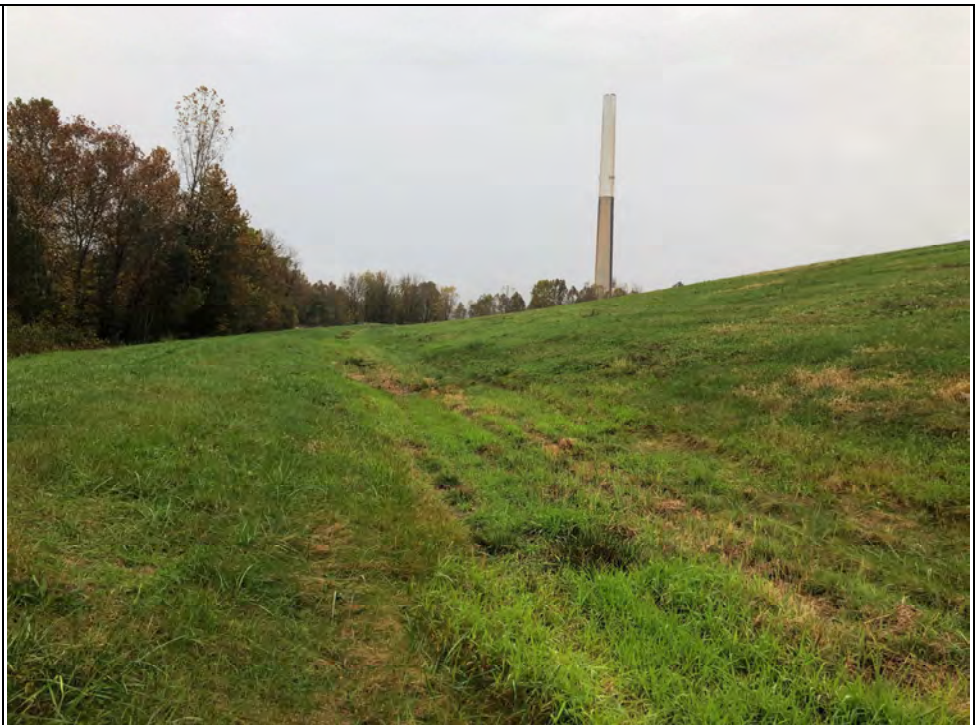
Image: 3787
Date: 10/22/2019
Time: 9:07 AM
Direction: Northwest

Non-contact stormwater ditch along Stage 5 is free of obstructions and does not exhibit scour or erosion issues.

No stability issues are noted along the sideslope or toe of slope (sloughing, bulging, etc).

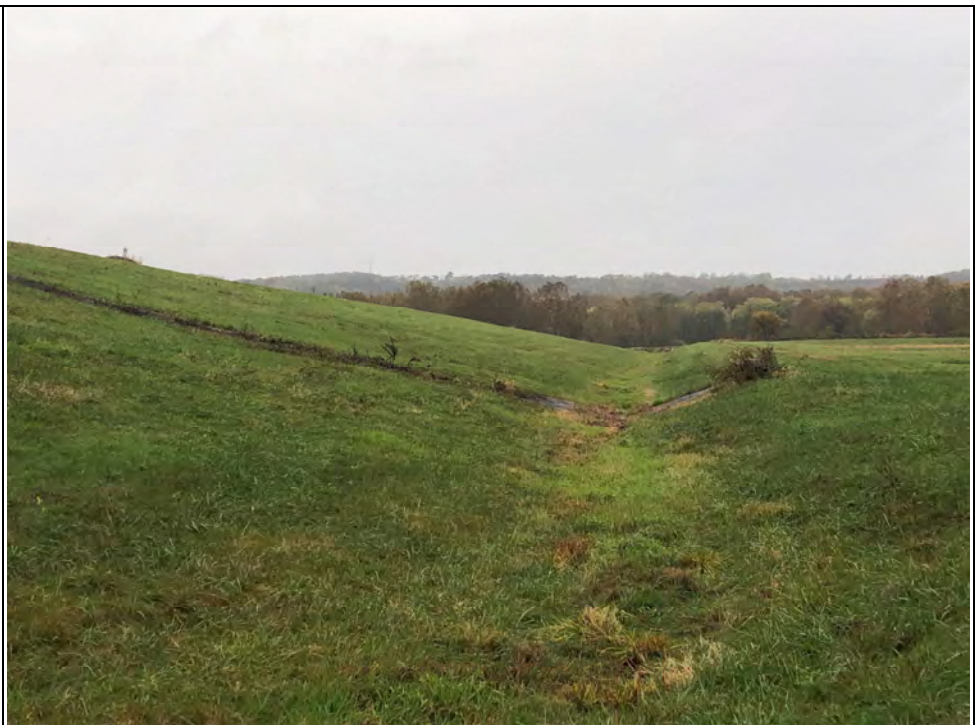
Image: 3791
Date: 10/22/2019
Time: 9:08 AM
Direction: West

Non-contact stormwater ditch along Stage 5 is free of obstructions and does not exhibit scour or erosion issues.

No stability issues are noted along the sideslope or toe of slope (sloughing, bulging, etc).

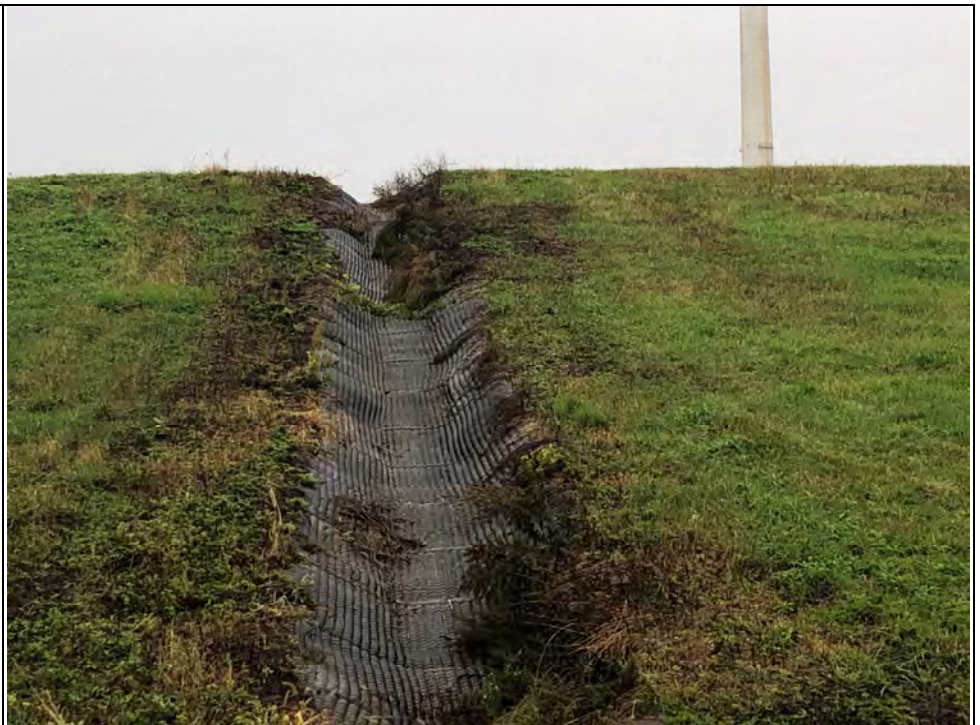
Image: 3793
Date: 10/22/2019
Time: 9:09 AM
Direction: South

Non-contact stormwater downchute. Clear of obstructions. Revetment is in good condition. Functioning as intended.

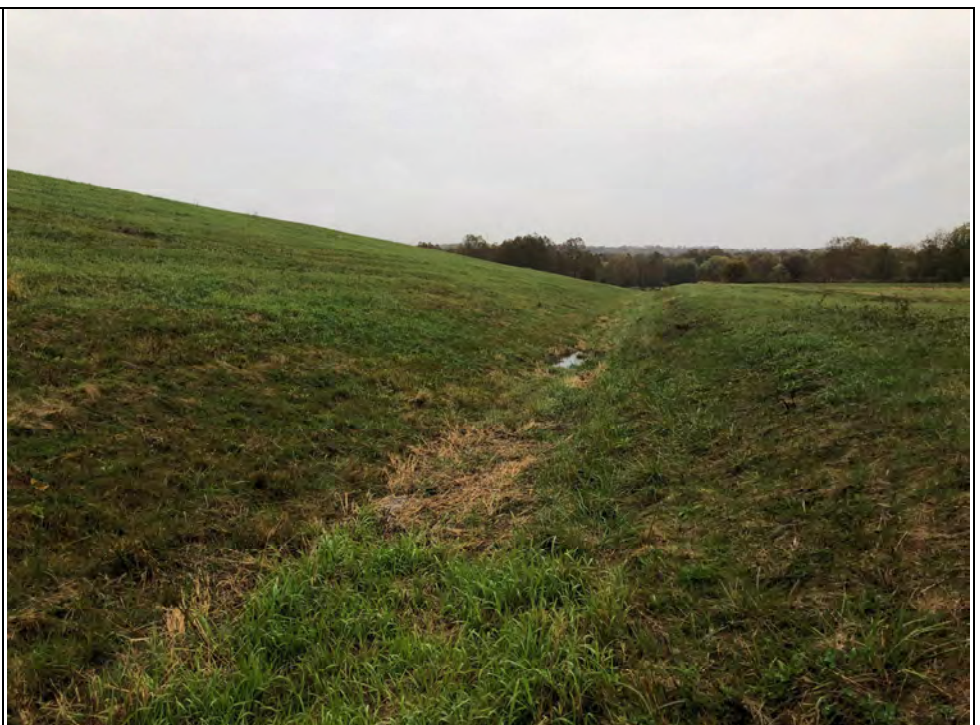
Image: 3795
Date: 10/22/2019
Time: 9:10 AM
Direction: West

No stability issues are noted along the sideslope or toe of slope (sloughing, bulging, etc).

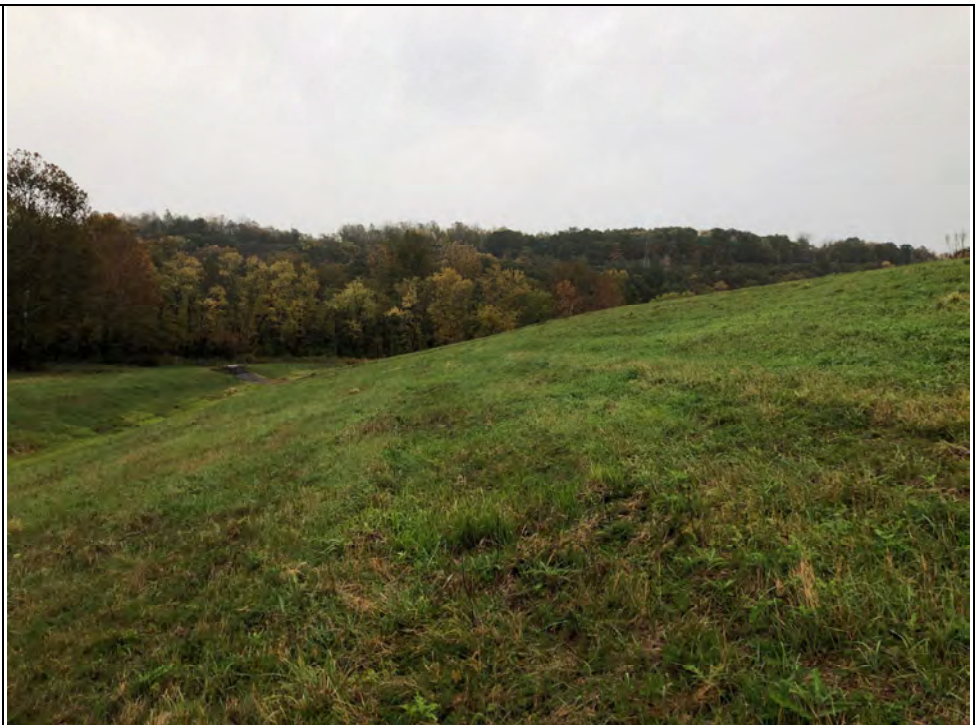
Image: 3797
Date: 10/22/2019
Time: 9:10 AM
Direction: East

Vegetation is well established. No stability issues are noted along the sideslope or toe of slope (sloughing, bulging, etc).

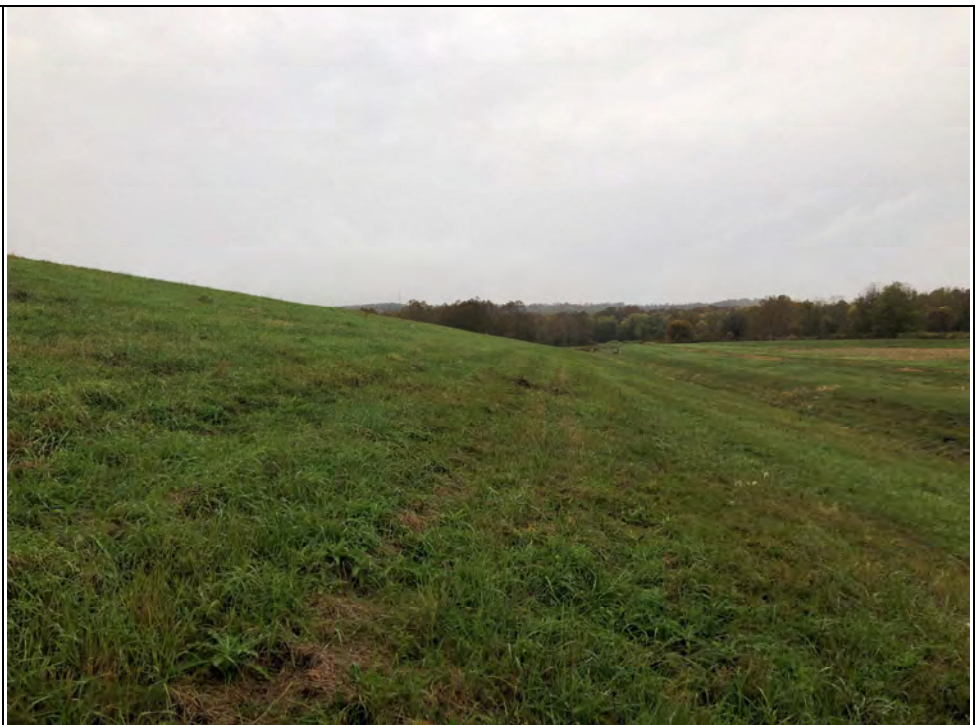
Image: 3799
Date: 10/22/2019
Time: 9:10 AM
Direction: West

Vegetation is well established. No stability issues are noted along the sideslope or toe of slope (sloughing, bulging, etc).

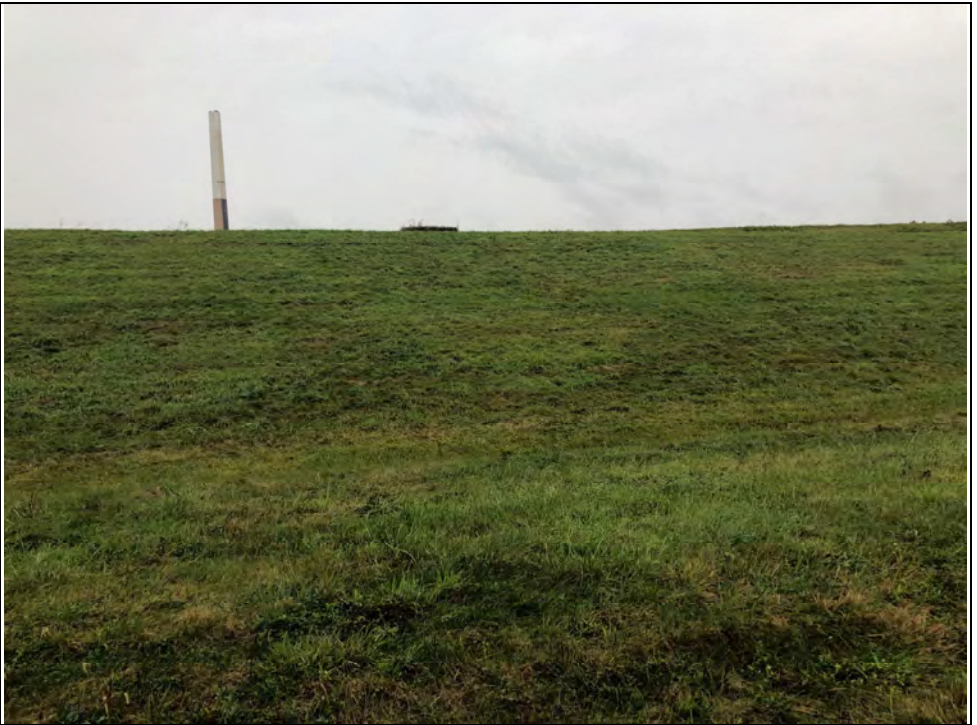
Image: 3801
Date: 10/22/2019
Time: 9:11 AM
Direction: South

Vegetation is well established. No stability issues are noted along the sideslope or toe of slope (sloughing, bulging, etc).

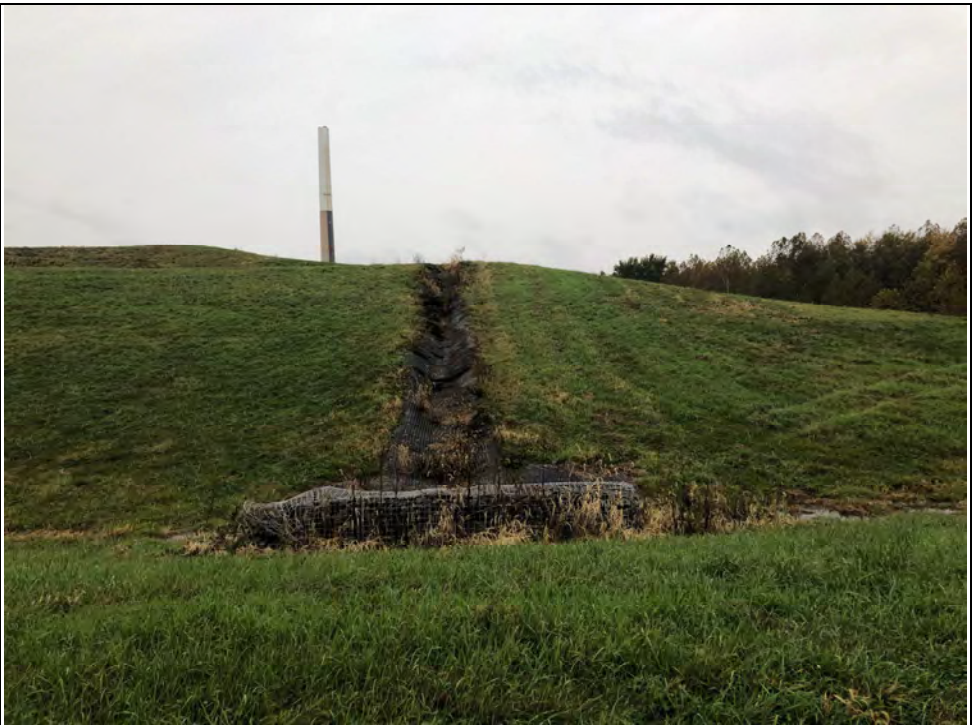
Image: 3803
Date: 10/22/2019
Time: 9:12 AM
Direction: South

Non-contact stormwater downchute. Clear of obstructions. Revetment is in good condition. Functioning as intended.

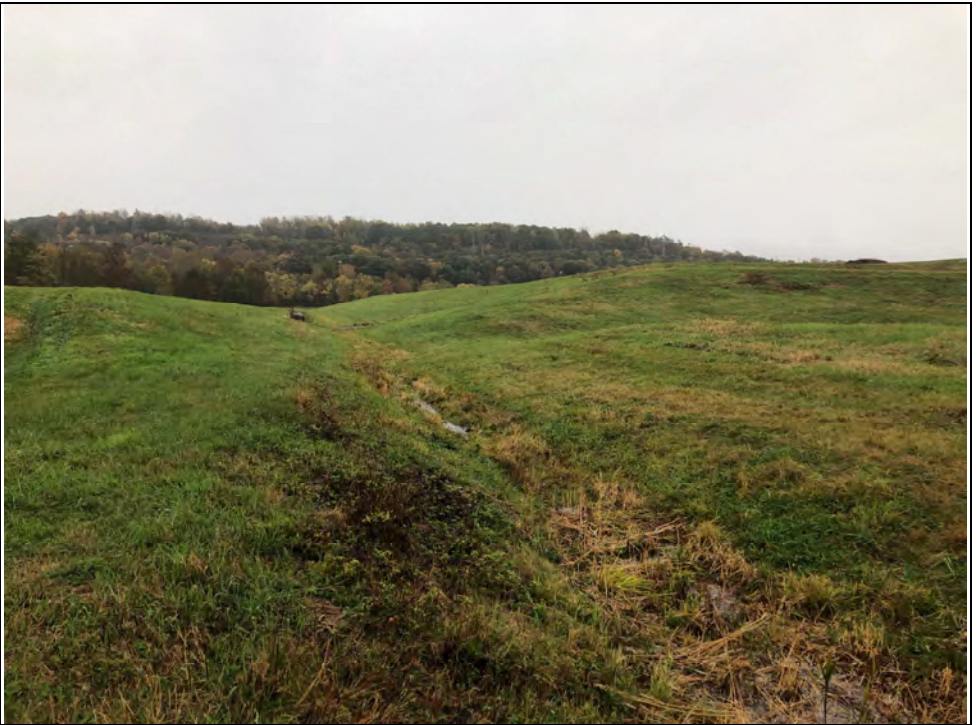
Image: 3805
Date: 10/22/2019
Time: 9:13 AM
Direction: East

Non-contact stormwater ditch along Stage 5 is free of obstructions and does not exhibit scour or erosion issues.

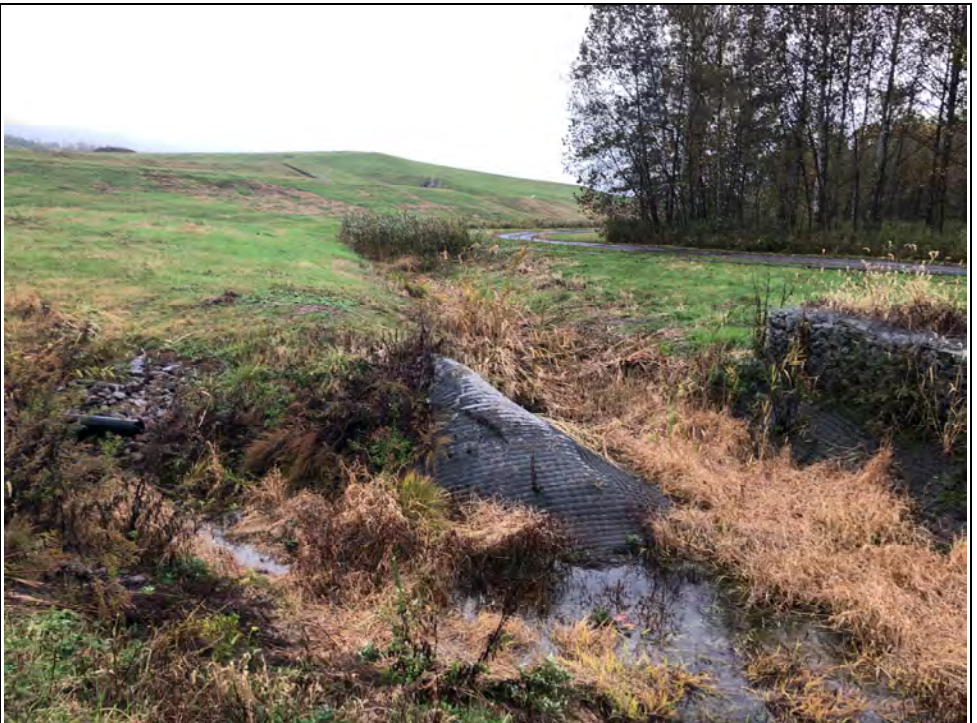
Image: 3807
Date: 10/22/2019
Time: 9:13 AM
Direction: Southeast

Stormwater ditch is in good working order.

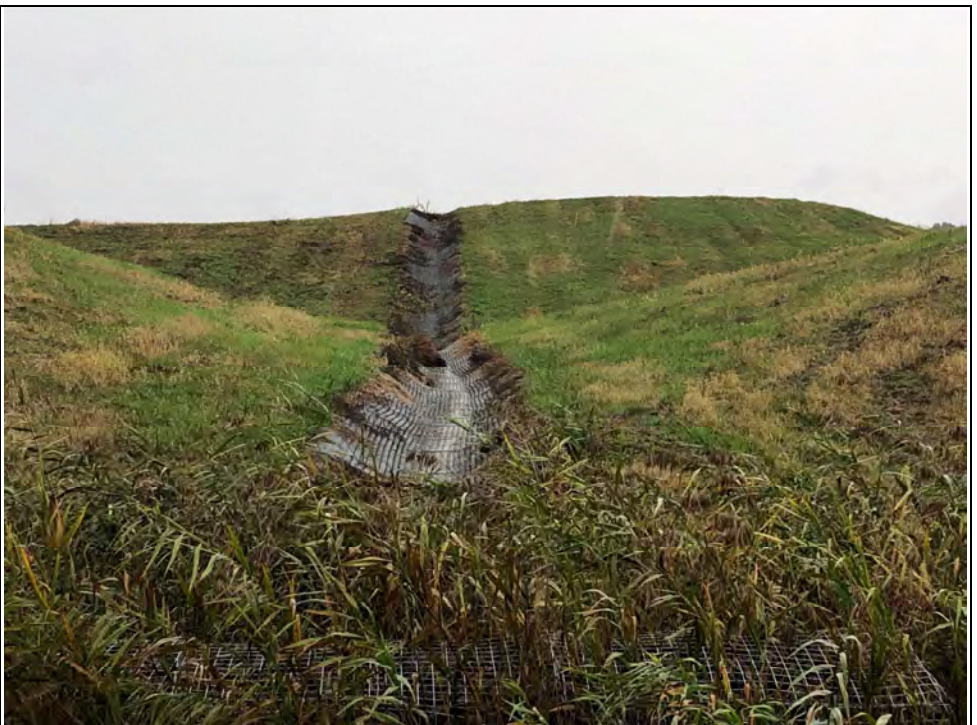
Image: 3815
Date: 10/22/2019
Time: 9:18 AM
Direction: East

Non-contact stormwater downchute. Clear of obstructions. Revetment is in good condition. Functioning as intended

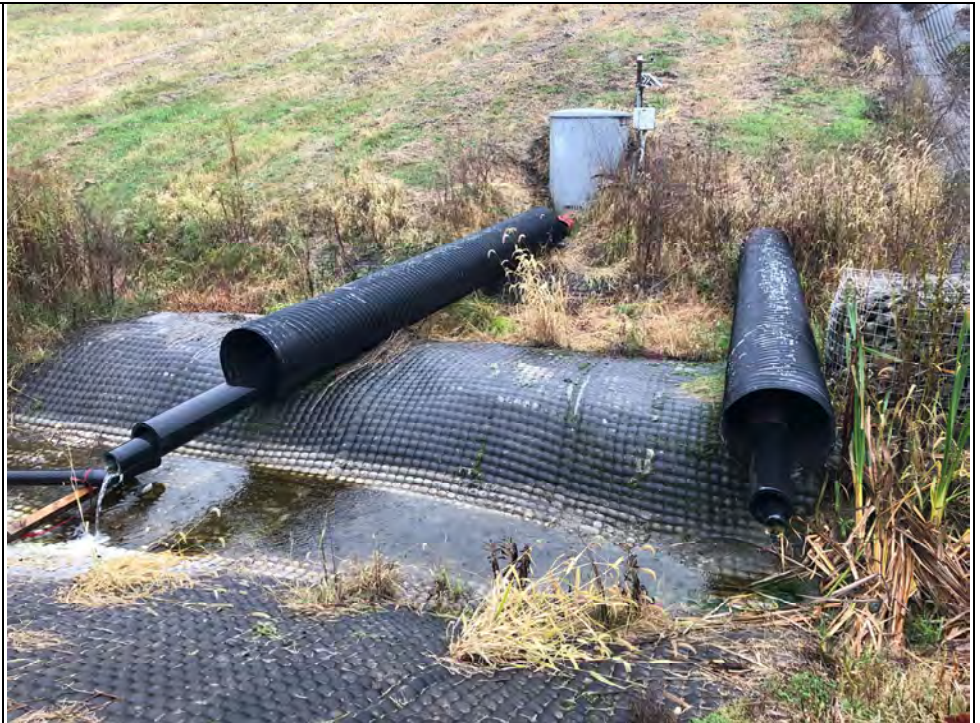
Image: 3819
 Date: 10/22/2019
 Time: 9:19 AM
 Direction: East

Leachate pipe (on left) discharging into contact water ditch, which ultimately flows to Leachate Pond. Leak detection pipe (on right) which was not flowing, demonstrating that the liner is not leaking. Ditch is clear of obstructions.

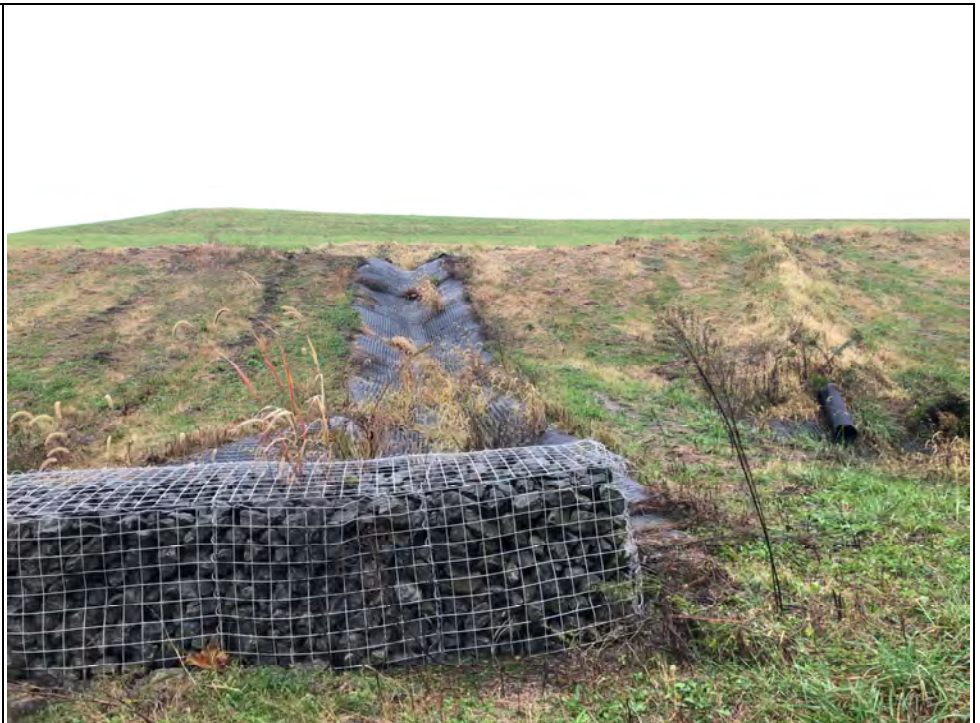
Image: 3823
 Date: 10/22/2019
 Time: 9:21 AM
 Direction: East

Non-contact stormwater downchute into non-contact water ditch. A gabion basket energy dissipator reduces energy from stormwater as it enters the ditch (shown in foreground).

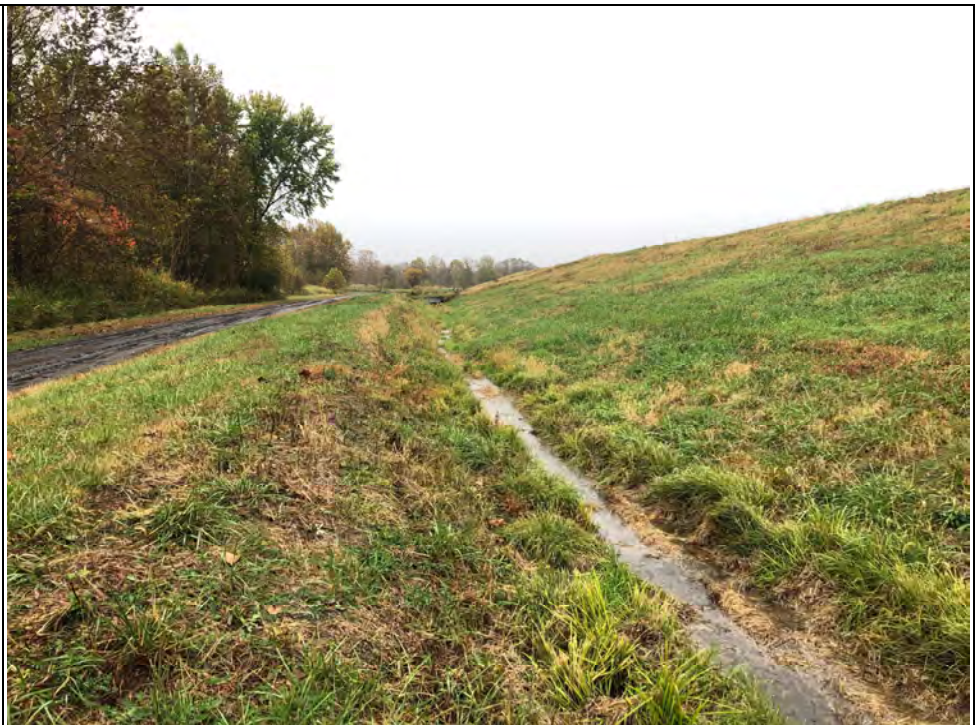
Image: 3825
Date: 10/22/2019
Time: 9:22 AM
Direction: North

Non-contact stormwater ditch along Stage 4 is free of obstructions and does not exhibit scour or erosion issues.

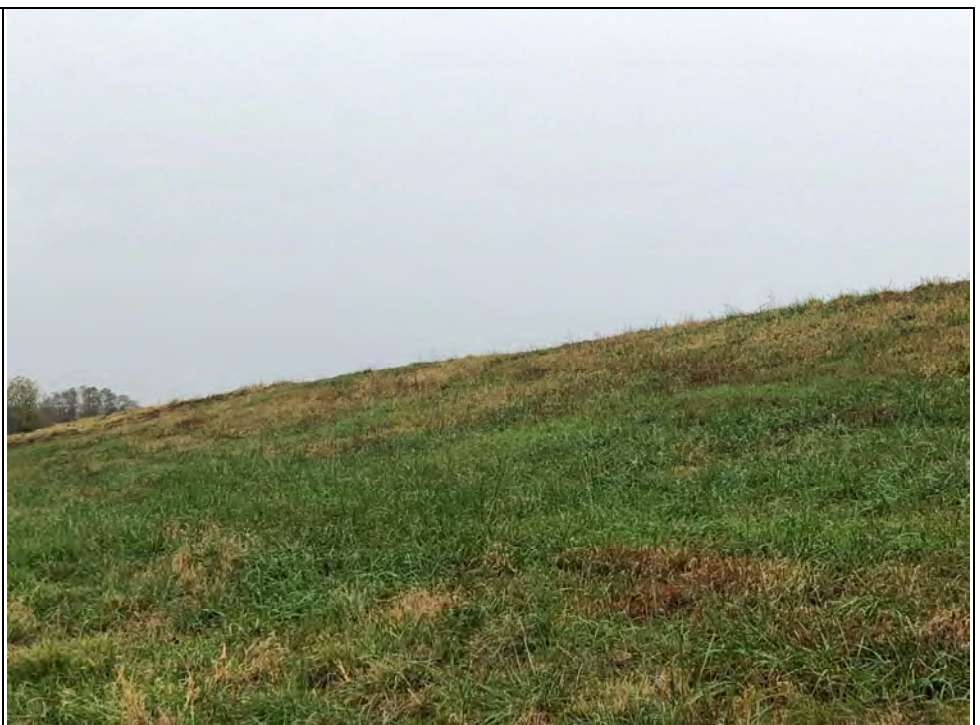
Image: 3827
Date: 10/22/2019
Time: 9:22 AM
Direction: North

Final Cover on Stage 4 sideslopes is in good condition with no evidence of damage from erosion, animals, or sloughing or stability issues.

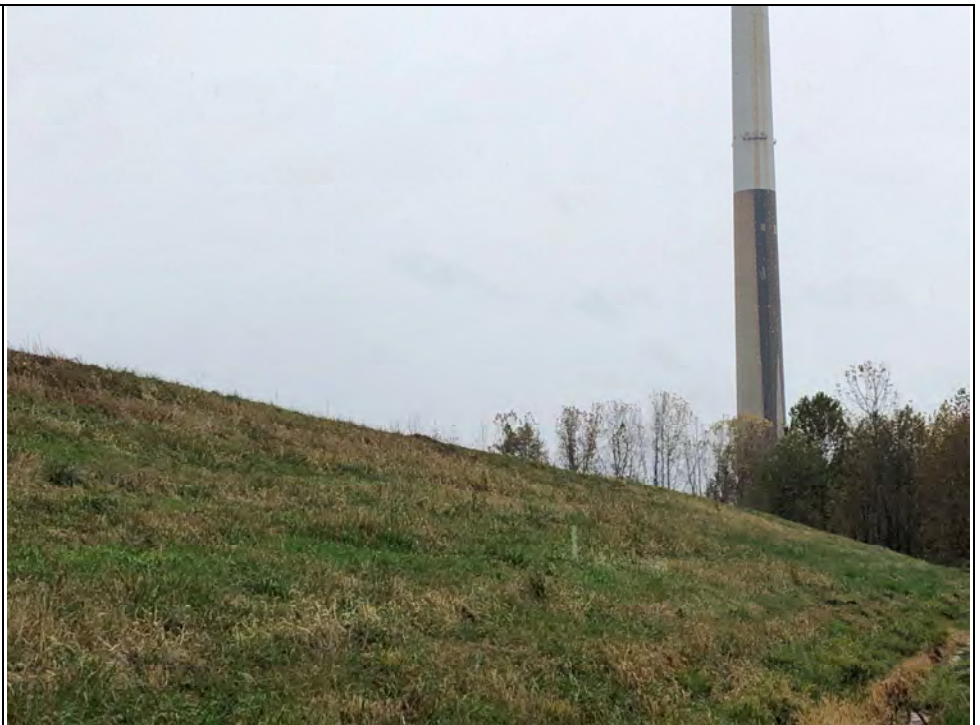
Image: 3829
Date: 10/22/2019
Time: 9:22 AM
Direction: Southeast

Final Cover on Stage 4 sideslopes is in good condition with no evidence of damage from erosion, animals, or sloughing or stability issues.

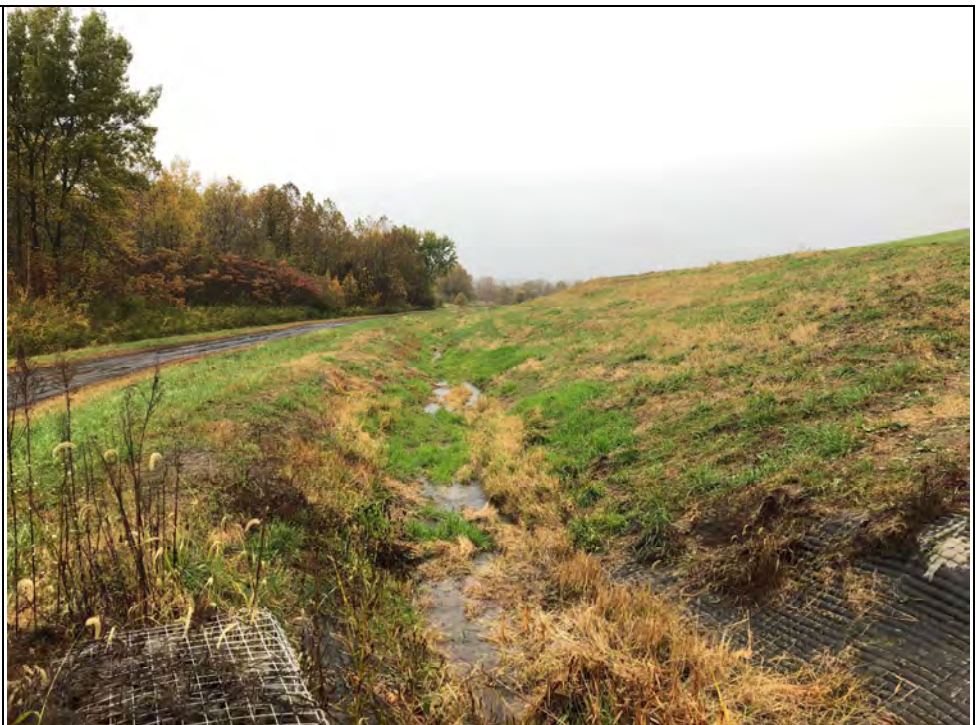
Image: 3831
Date: 10/22/2019
Time: 9:24 AM
Direction: North

Non-contact stormwater ditch at corner of landfill. Ditch is in good condition, well lined with vegetation, and does not have any noted obstructions.

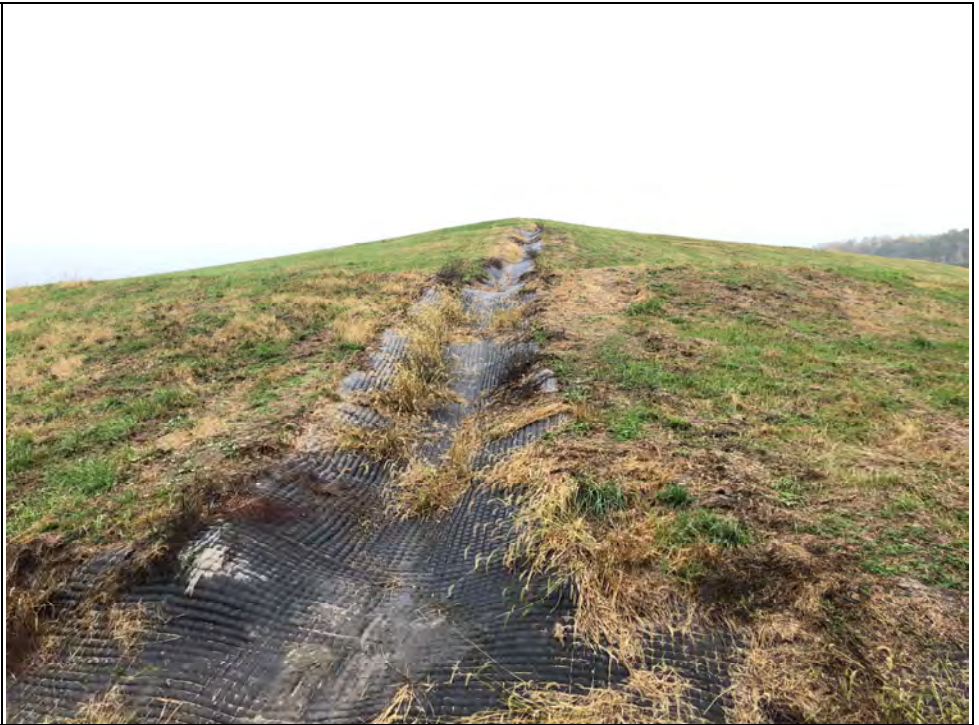
Image: 3833
Date: 10/22/2019
Time: 9:24 AM
Direction: Northeast

Non-contact stormwater downchute is free of obstructions and in good condition.

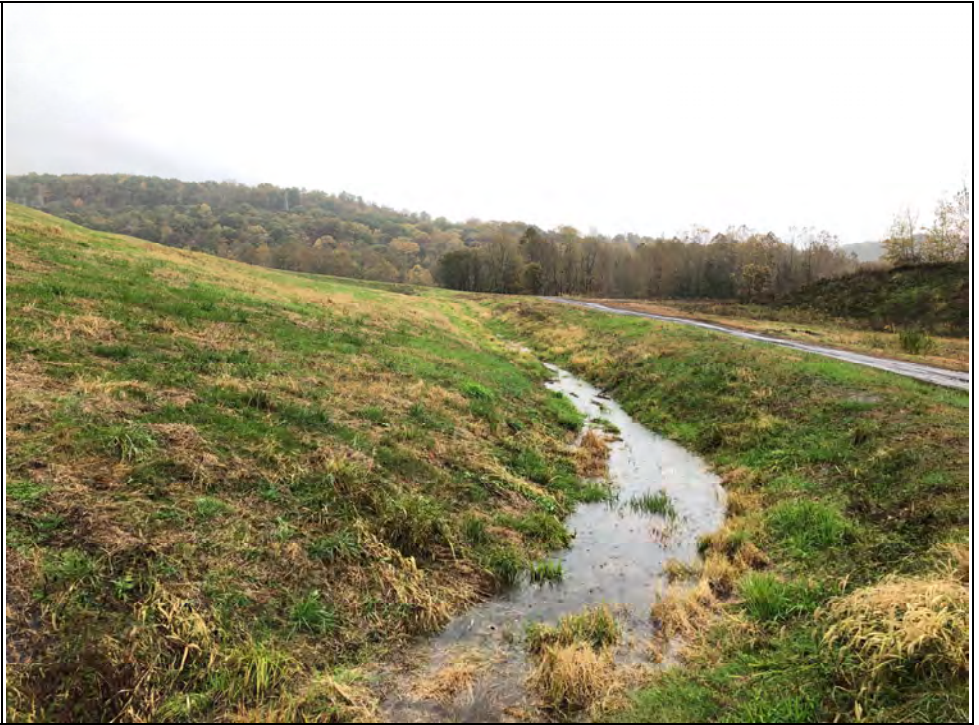
Image: 3835
Date: 10/22/2019
Time: 9:24 AM
Direction: East

Non-contact stormwater ditch at corner of landfill. Ditch is in good condition, well lined with vegetation, and does not have any noted obstructions.
