**ANNUAL CCR UNIT INSPECTION REPORT
2021**

**CHESWICK ASH DISPOSAL SITE
INDIANA TOWNSHIP, ALLEGHENY COUNTY, PENNSYLVANIA**

**INSPECTION DATE: 12/28/2021
REPORT DATE: 1/14/2022**

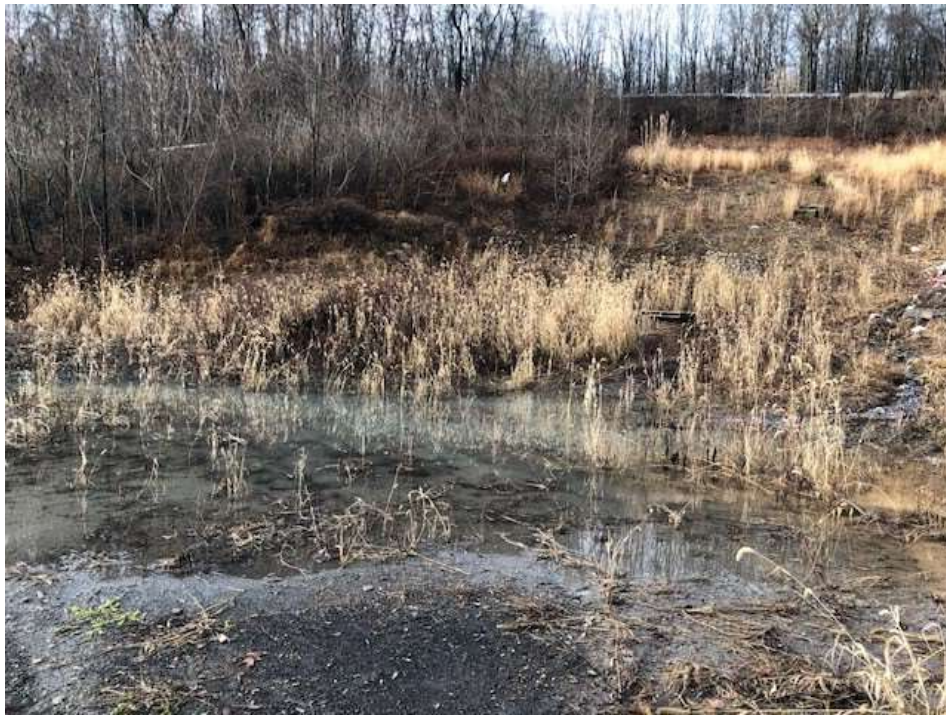
Photograph 1: Non-contact stormwater junction box riser installed in 2020 located northwest of landfill.

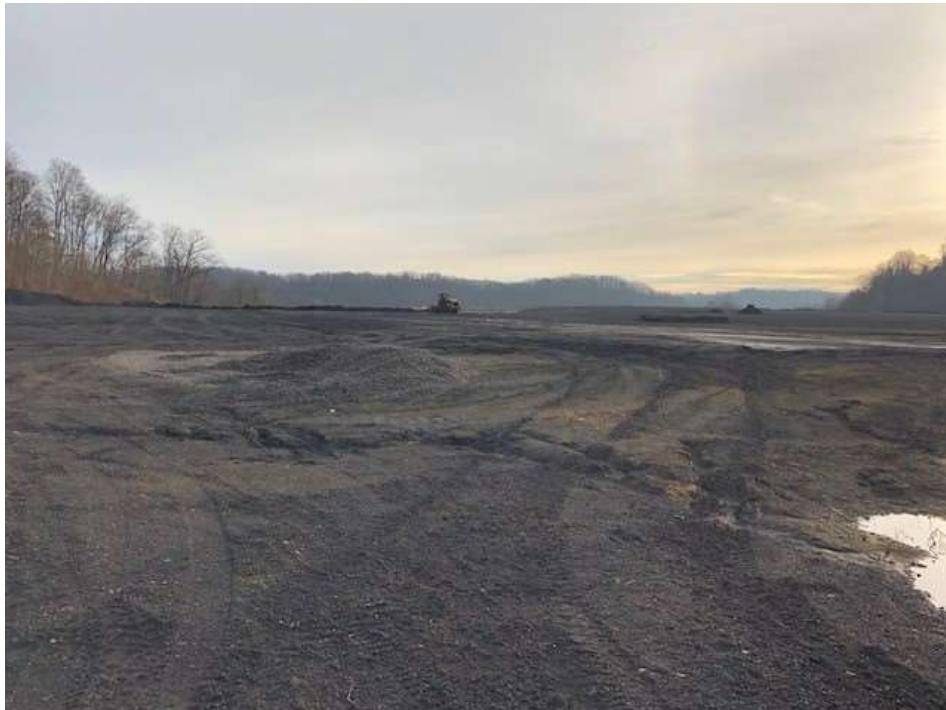
Photograph 2: Eastern view of active area. Material is graded and compacted.

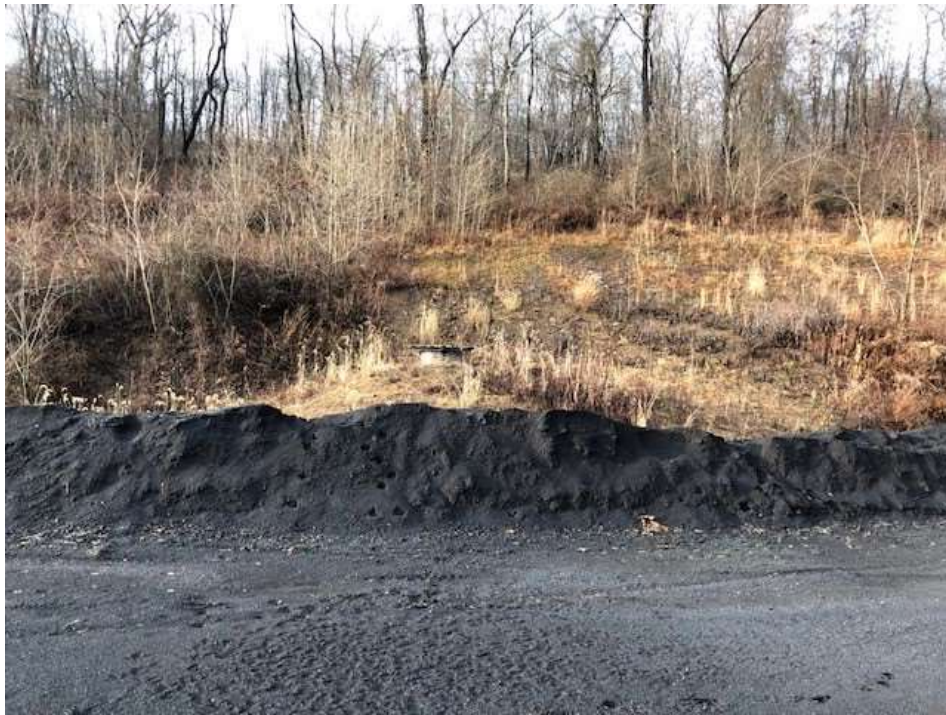
Photograph 3: Non-contact stormwater junction box riser located southwest of landfill.

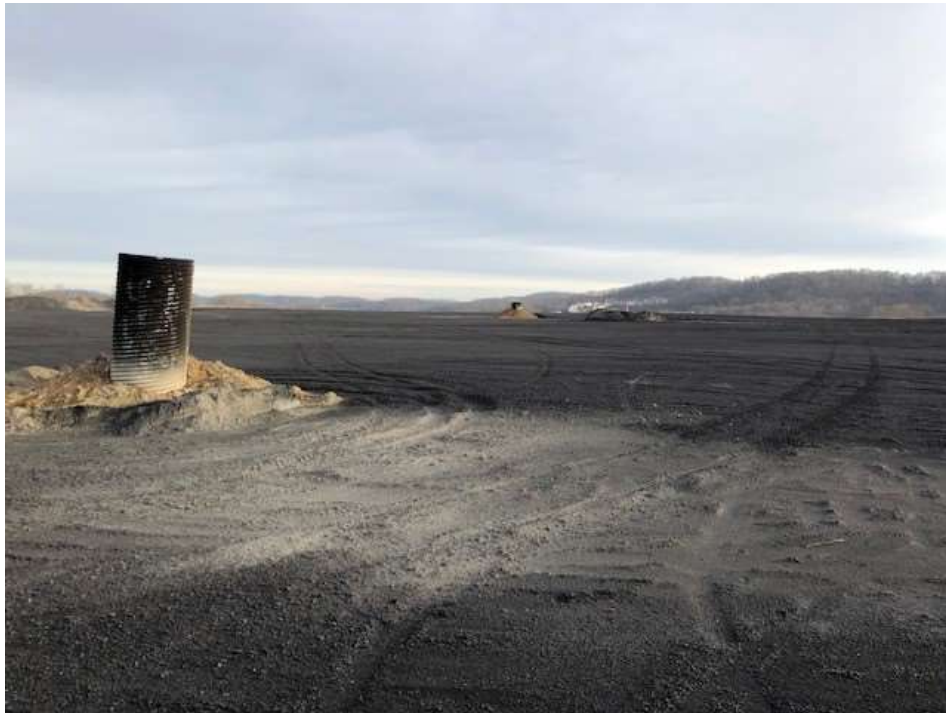
Photograph 4: Eastern view of active area and non-contact stormwater risers.

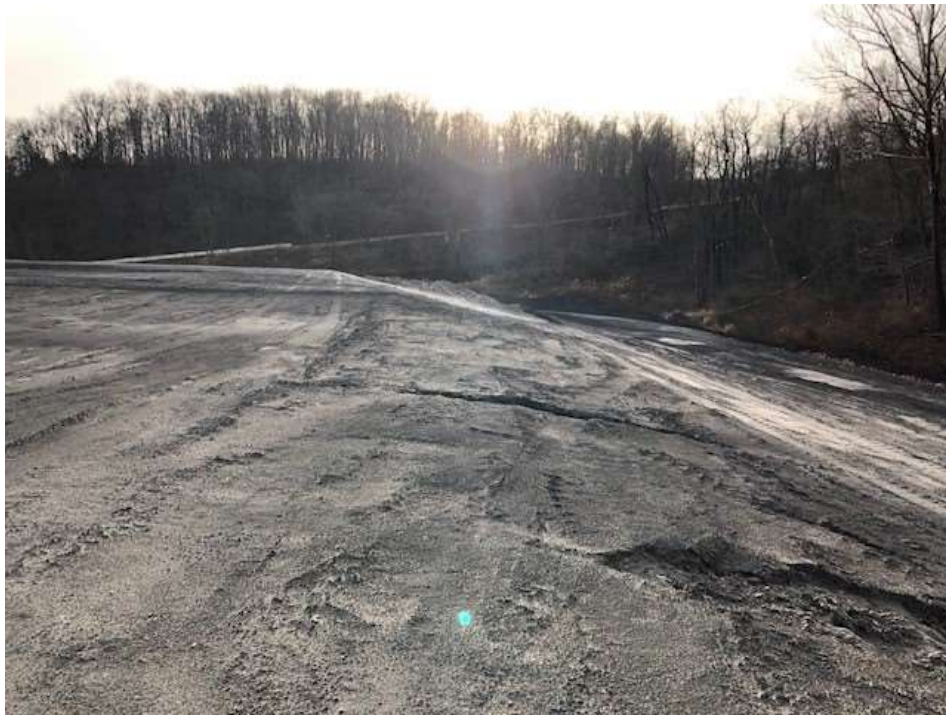
Photograph 5: South view of active area outside west slope. Contact water (leachate) drains to leachate collection layer.

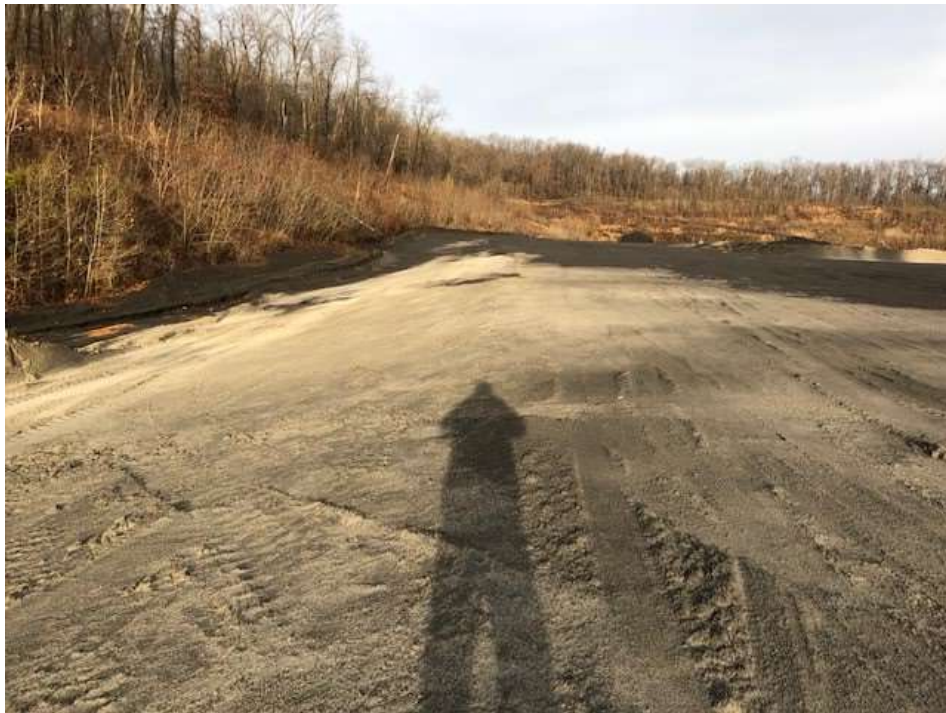
Photograph 6: North view of active area outside west slope. Contact water (leachate) drains to leachate collection layer.

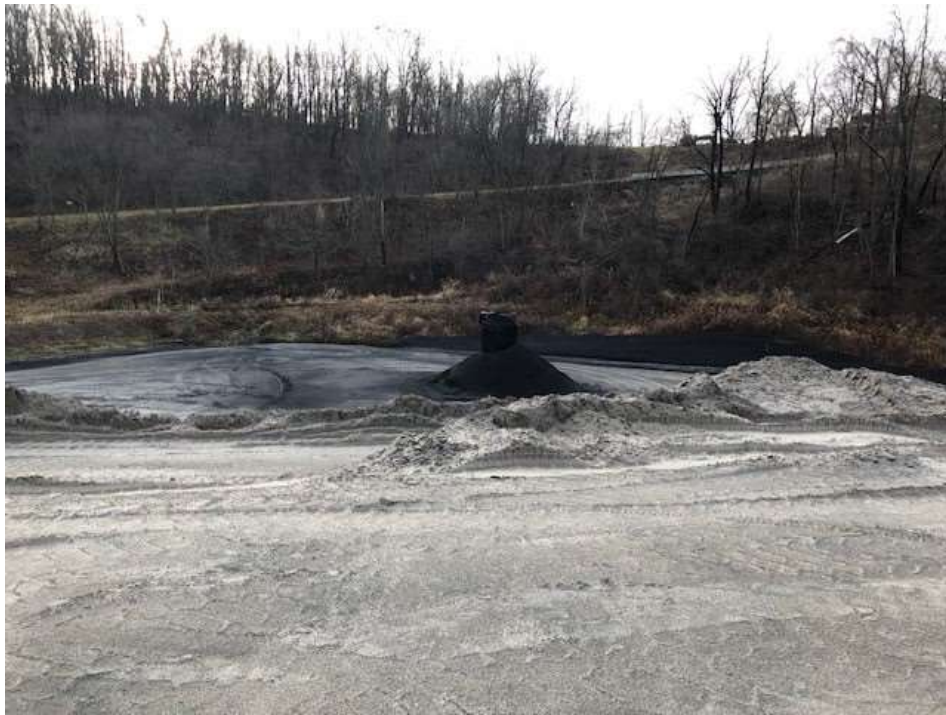
Photograph 7: View of contact water (leachate) riser located in southwest corner of landfill.

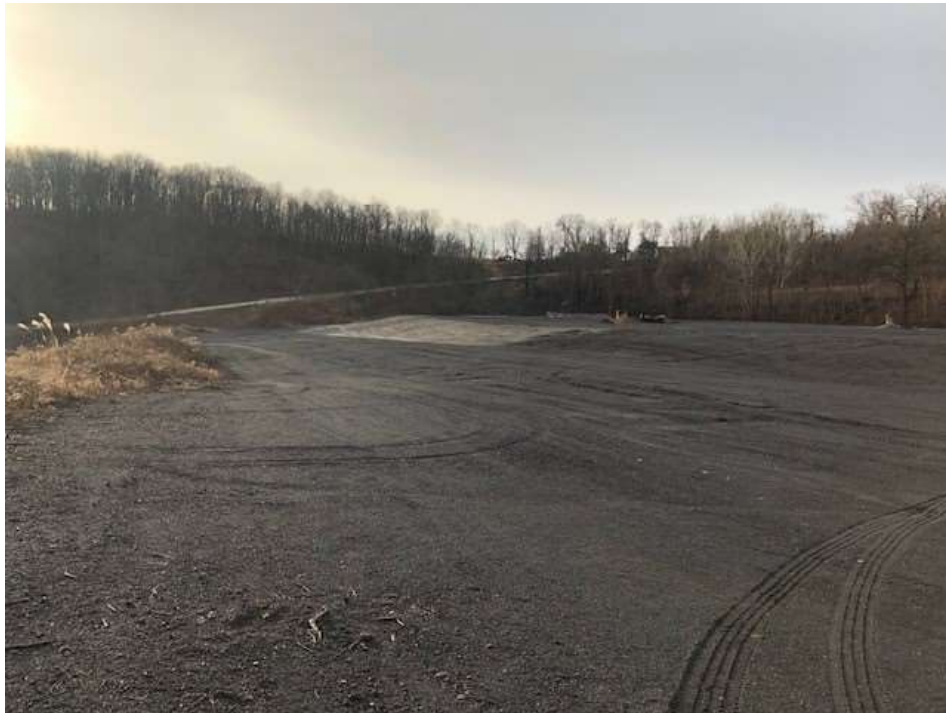
Photograph 8: Southwest view of active area. Material is graded and compacted.

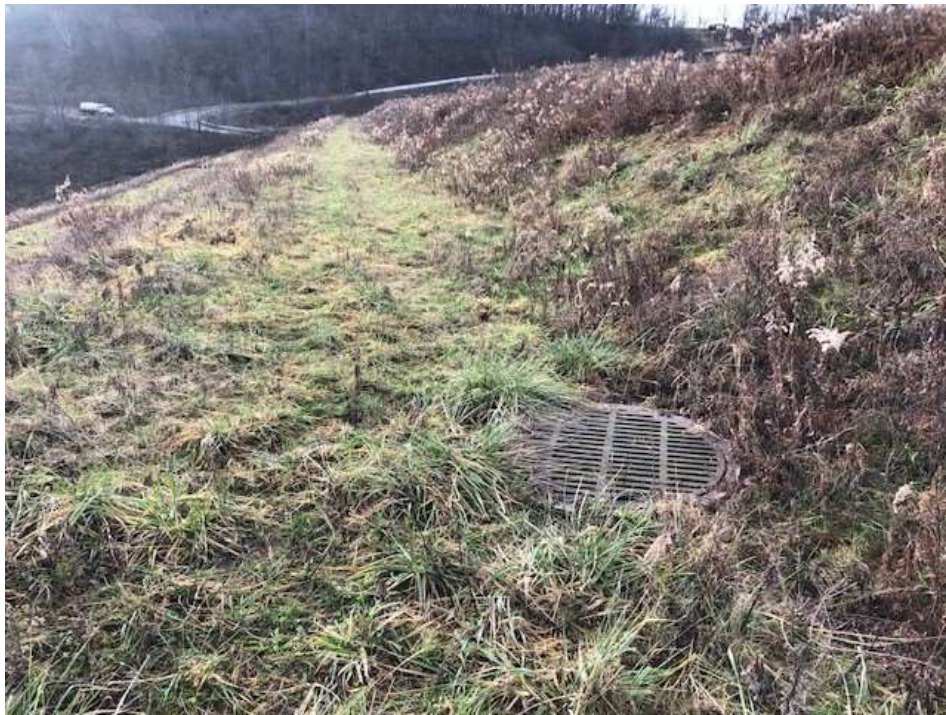
Photograph 9: South view of upper bench and non-contact stormwater inlet on east landfill slope. Vegetation is established with no indications of stability issues.

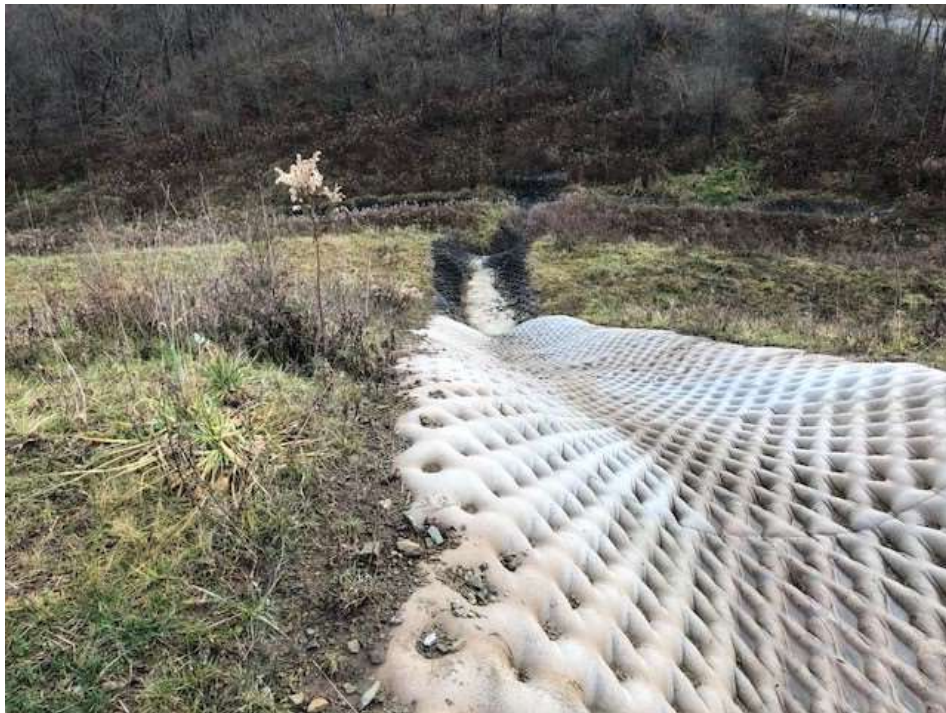
Photograph 10: View of revetment mat lined stormwater channel installed in 2020 at south end of upper bench on east landfill slope.

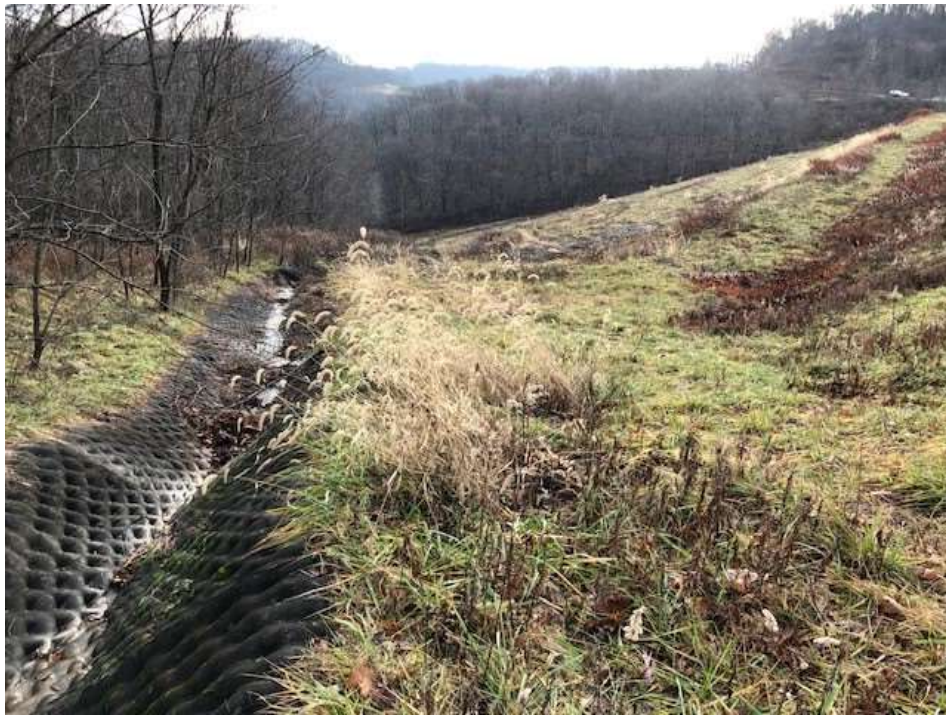
Photograph 11: Eastern view of north revetment matt lined stormwater channel on east landfill slope.

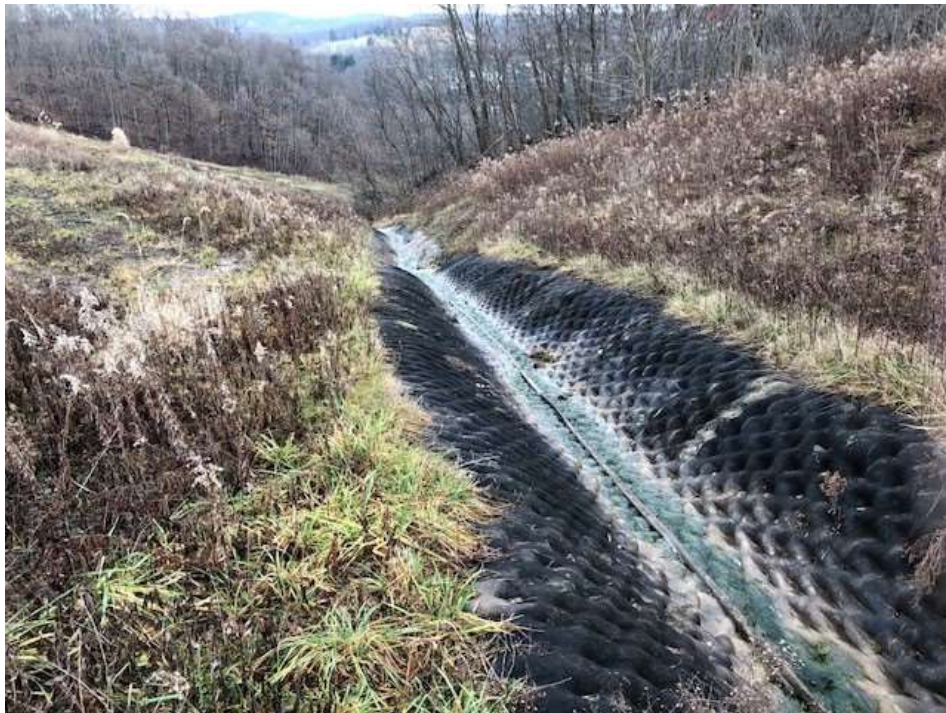
Photograph 12: Eastern view of south revetment matt lined stormwater channel on east landfill slope.

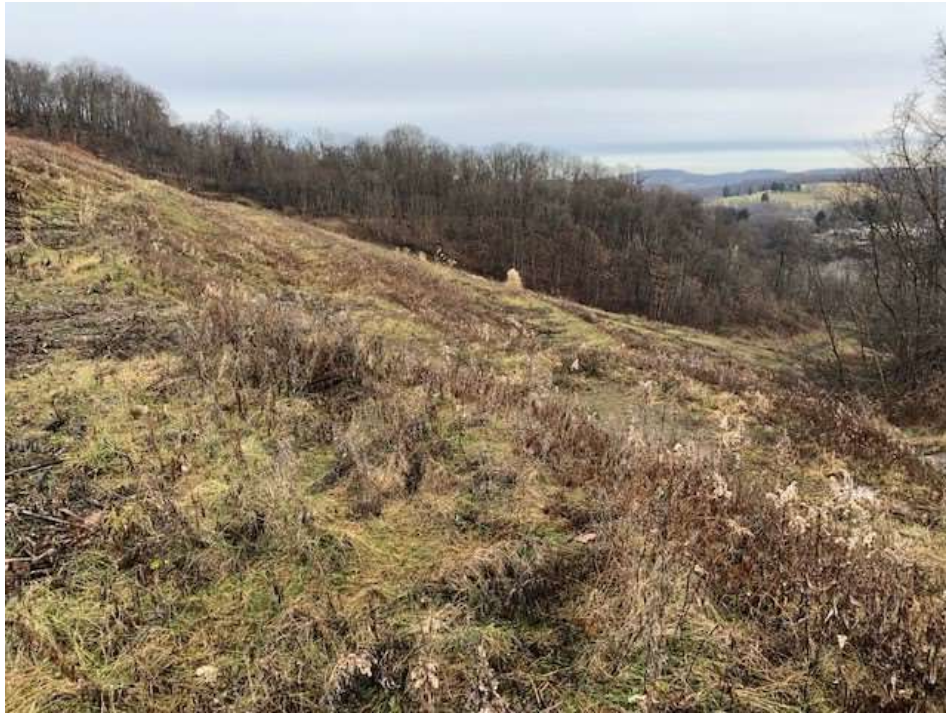
Photograph 13: North view of upper east landfill slope. Vegetation is established. Benches have been mowed. Woody vegetation has been cut. No indications of stability issues.

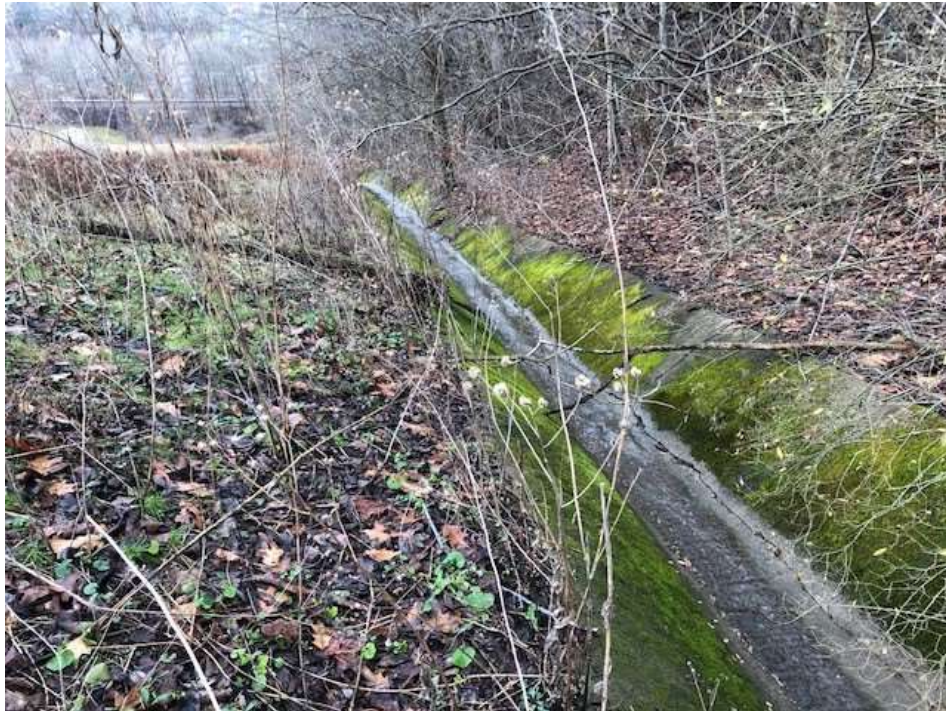
Photograph 14: Eastern view of south concrete lined stormwater channel on east landfill slope.

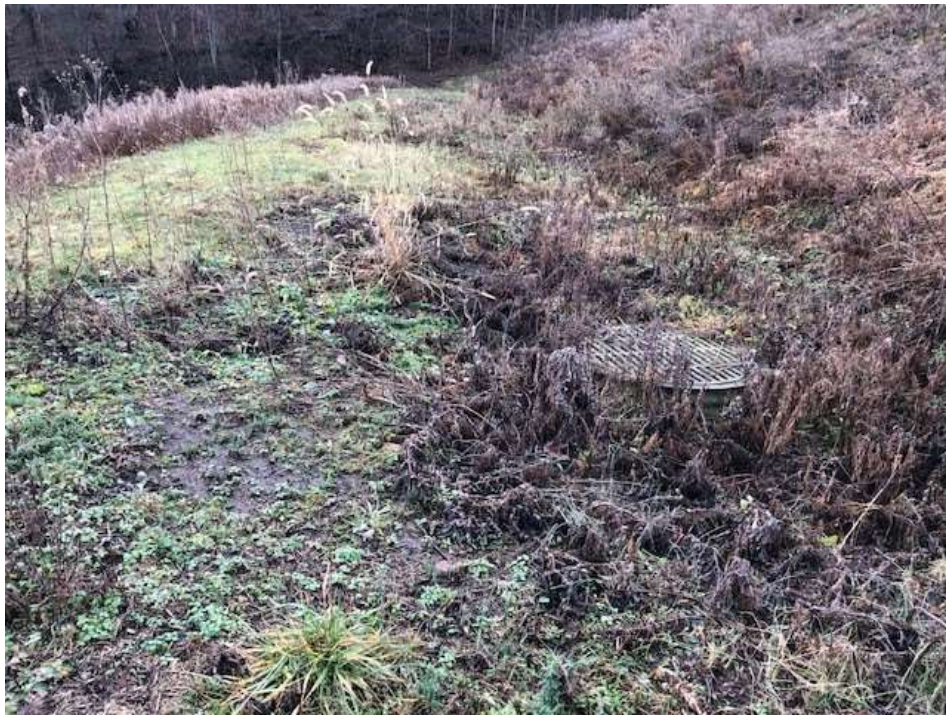
Photograph 15: South view of mid-slope bench and non-contact stormwater inlet on east landfill slope. Vegetation is established with no indications of stability issues.

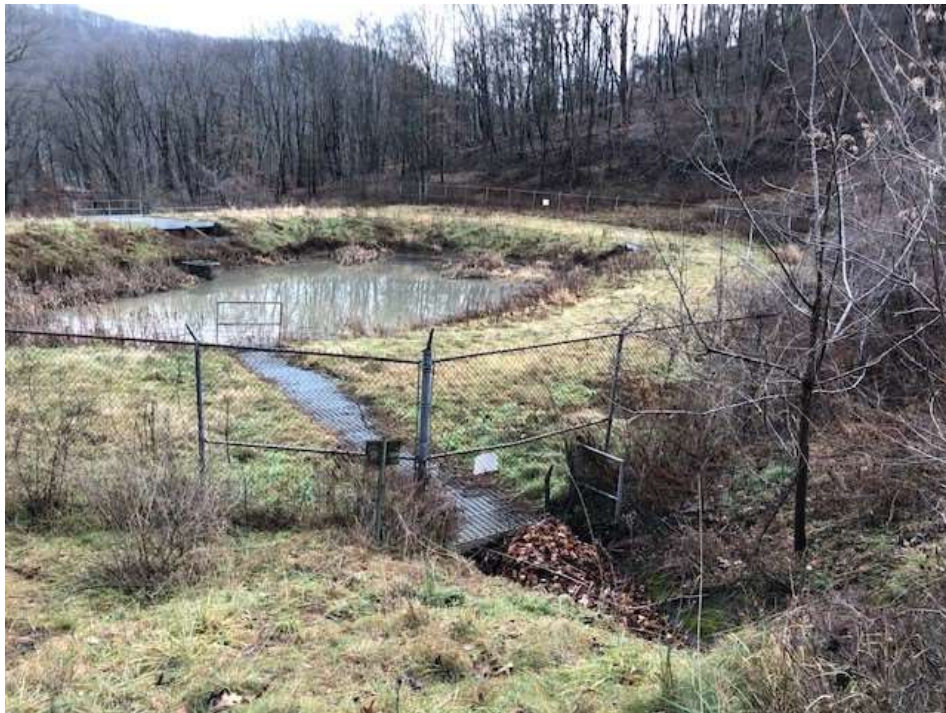
Photograph 16: View of northeast non-contact stormwater inlet to Sedimentation Pond. Some leaves and debris are present, which is regularly removed as needed. Stormwater is flowing freely and is not impeded by the leaves and debris.

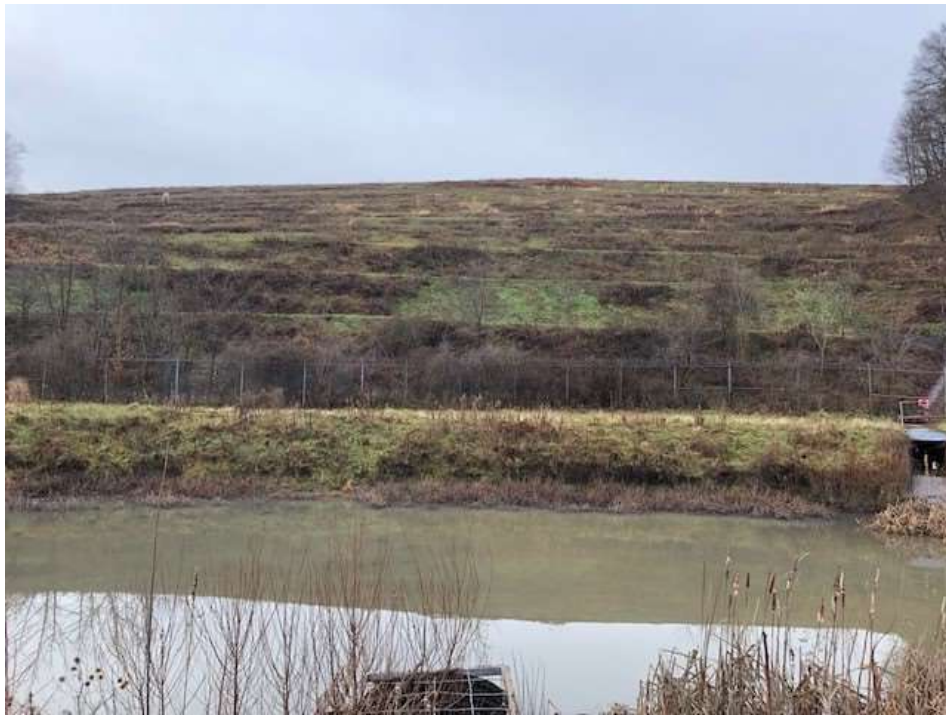
Photograph 17: West view of east landfill slope from Sedimentation Pond spillway.

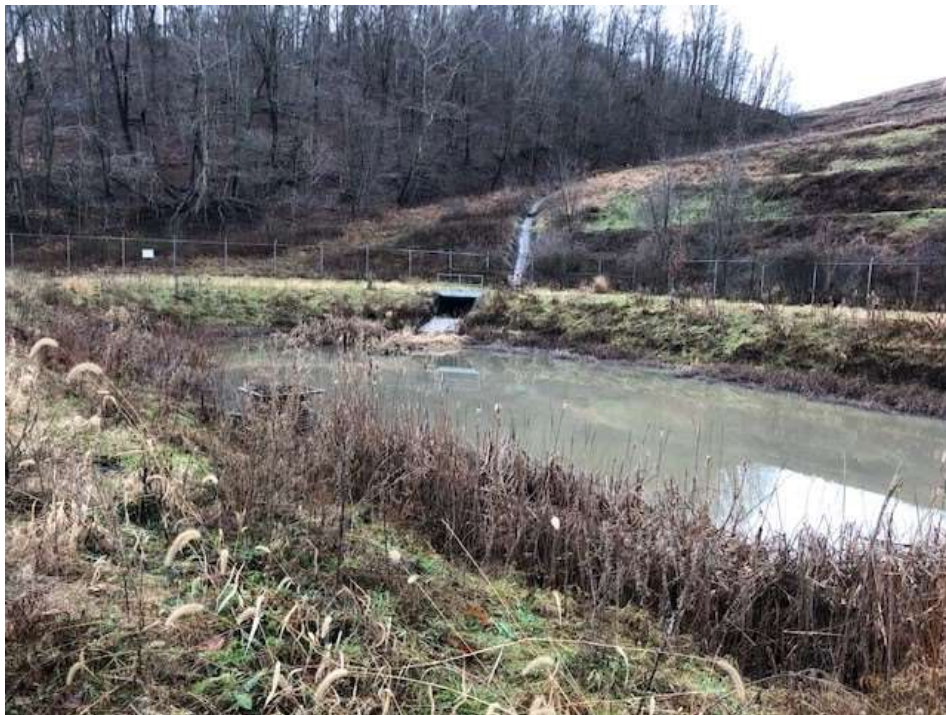
Photograph 18: View of southeast non-contact stormwater inlet to Sedimentation Pond.

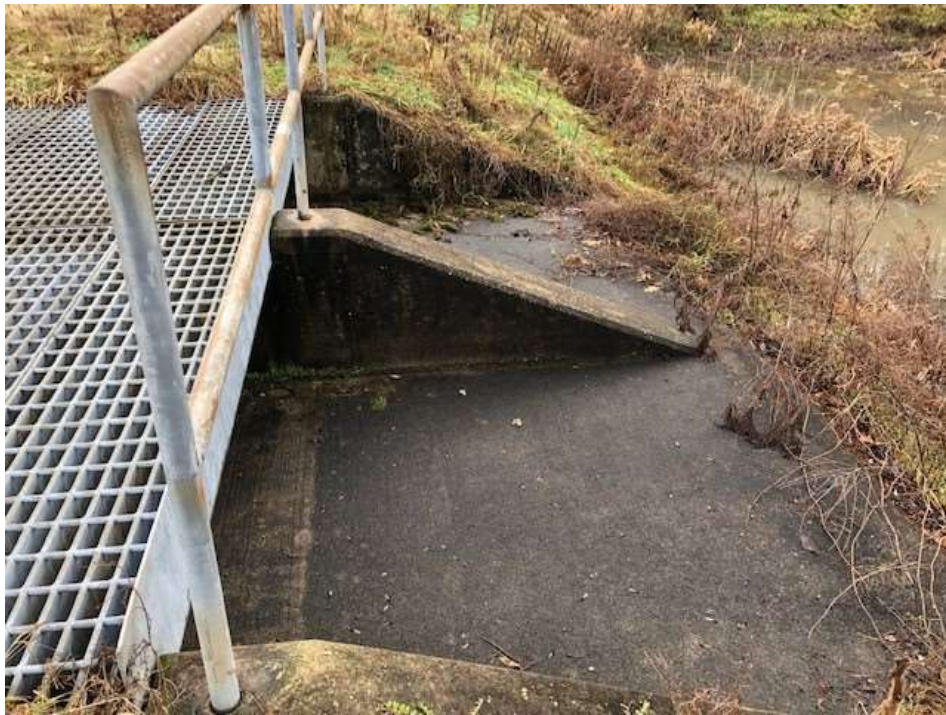
Photograph 19: View of Sedimentation Pond emergency spillway inlet.

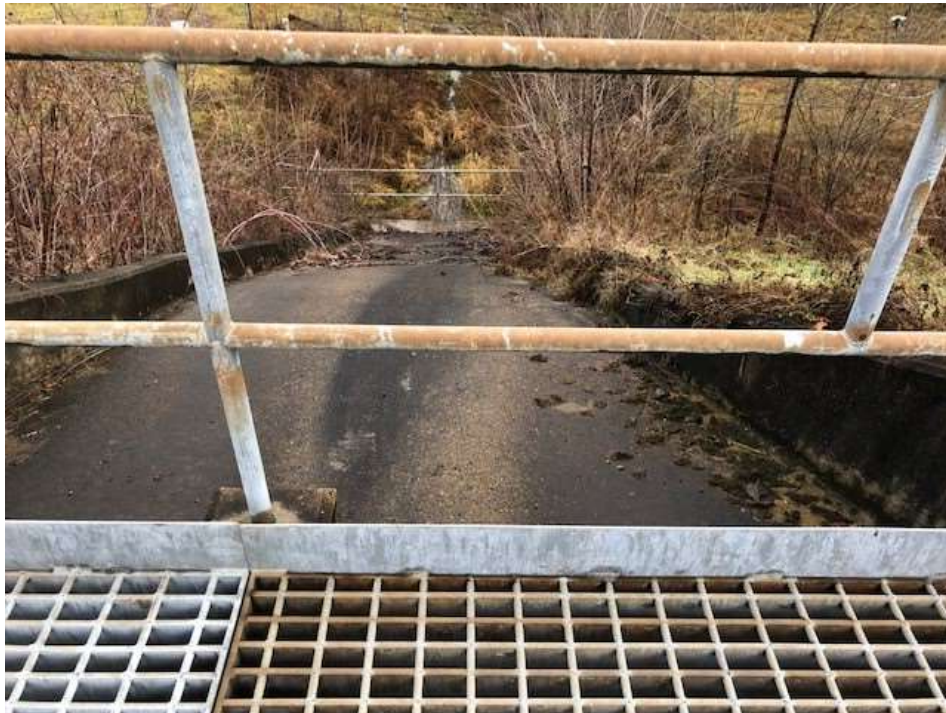
Photograph 20: View of Sedimentation Pond emergency spillway outlet.

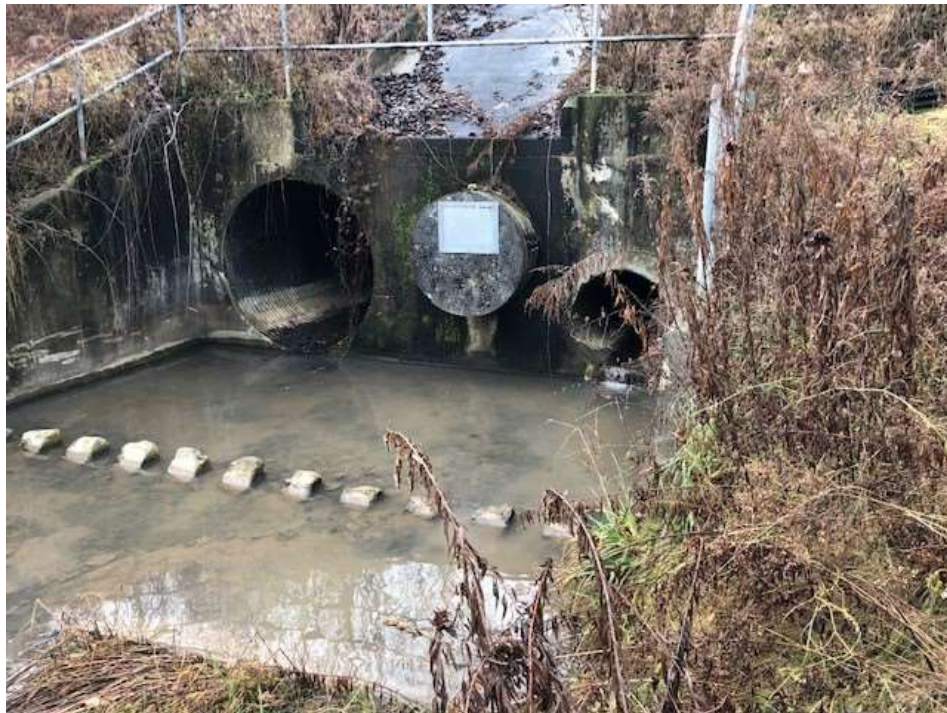
Photograph 21: View of Sedimentation Pond emergency spillway outlet, non-contact stormwater outlet pipes, and capped contact stormwater (leachate) pipe. Contact stormwater drains to pump station.

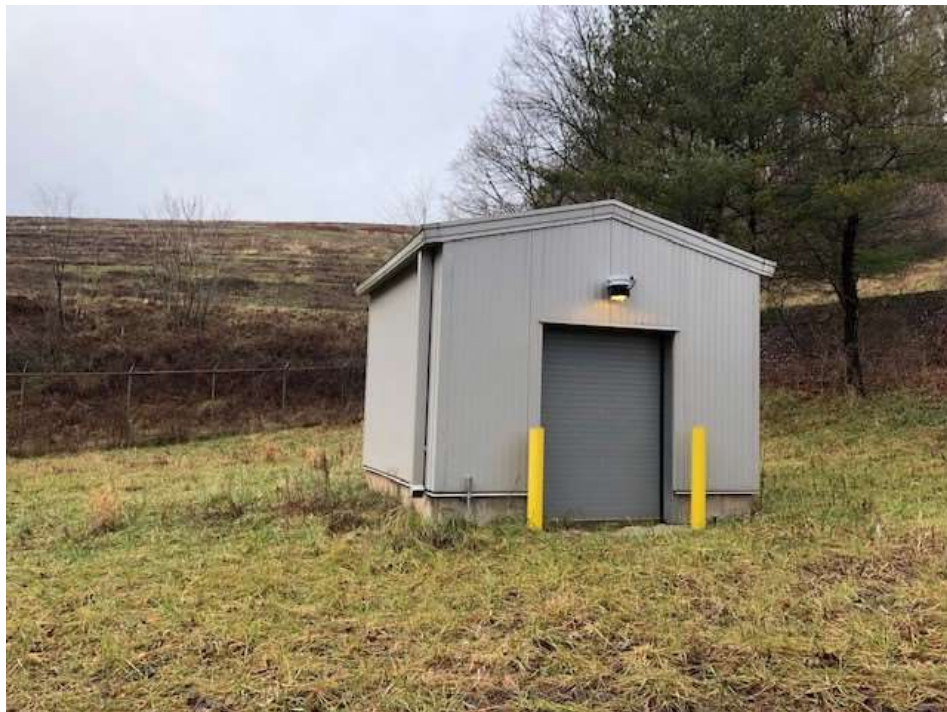
Photograph 22: View of leachate pump station.
