Inspection Report

To: Brian Baierl (New Castle Generating Station)
From: Richard Southorn, P.E., P.G.
Re: New Castle Plant Ash Landfill—Annual CCR Unit Inspection Report
Inspection Date: November 12, 2020
Report Date: January 15, 2021

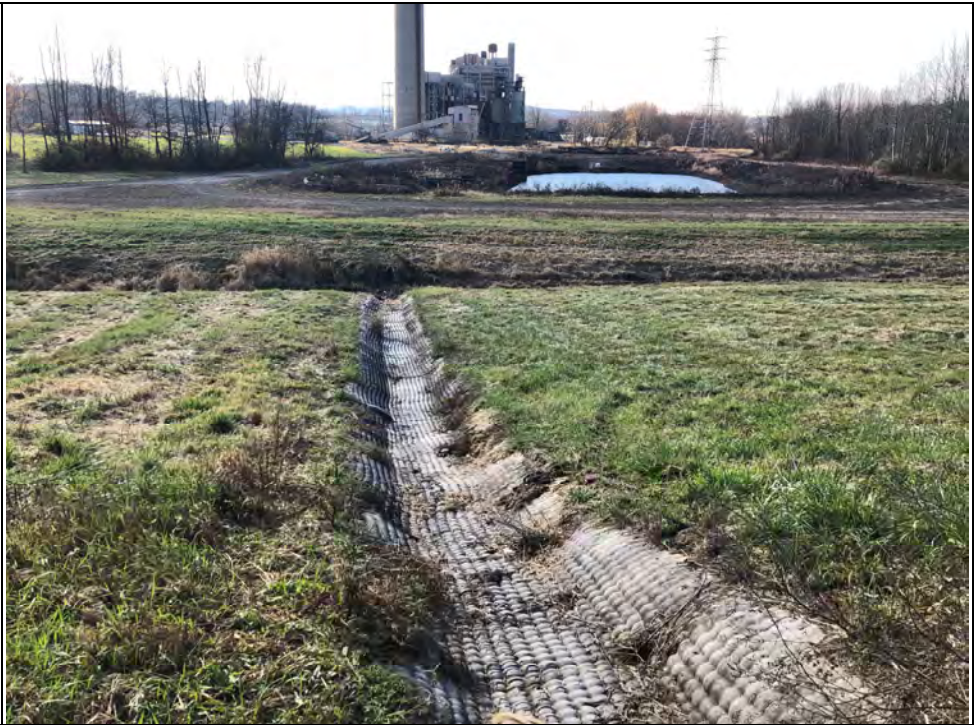
Image: 8078
Date: 11/12/2020
Time: 9:21 AM
Direction: South

Non-contact stormwater downchute. Clear of obstructions. Revetment is in good condition. Functioning as intended.

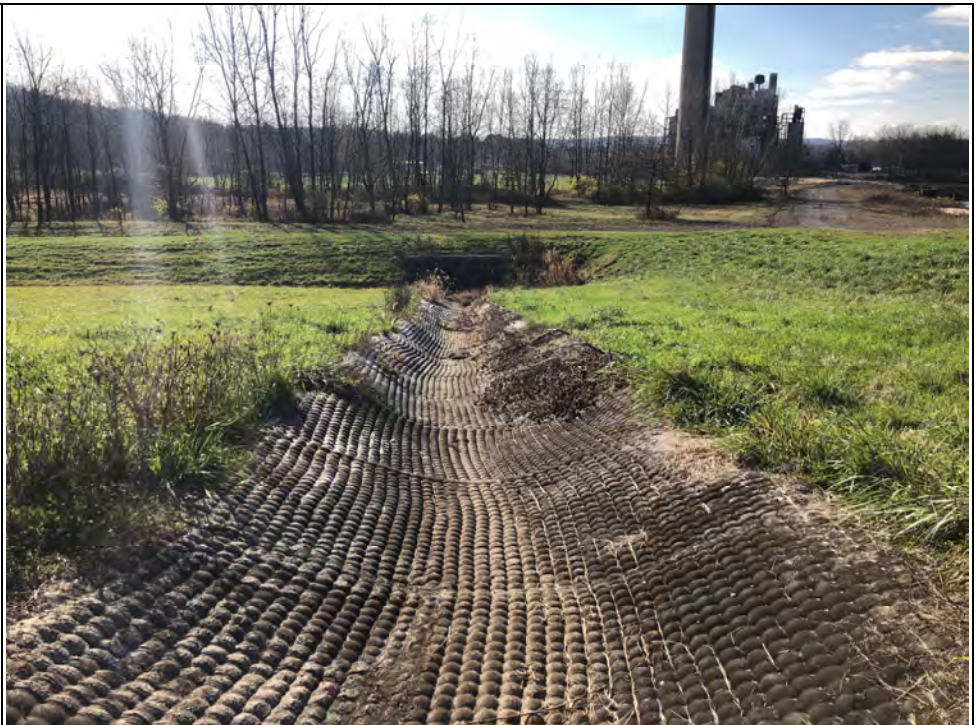
Image: 8080
Date: 11/12/2020
Time: 9:22 AM
Direction: South

Non-contact stormwater downchute is clear of obstructions. Gabion energy dissipator is installed at the junction with the stormwater (non-contact water) perimeter ditch.

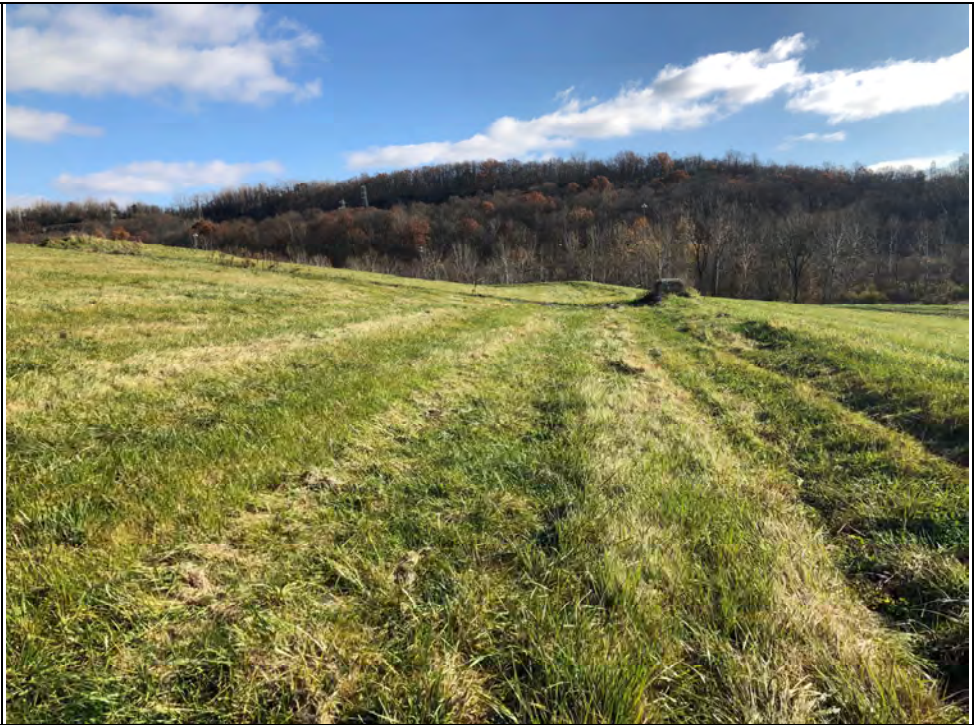
Image: 8082
Date: 11/12/2020
Time: 9:22 AM
Direction: East-Northeast

Final cover sideslopes and terrace berm. Good condition, no evidence of animal burrows, erosion, or sloughing.

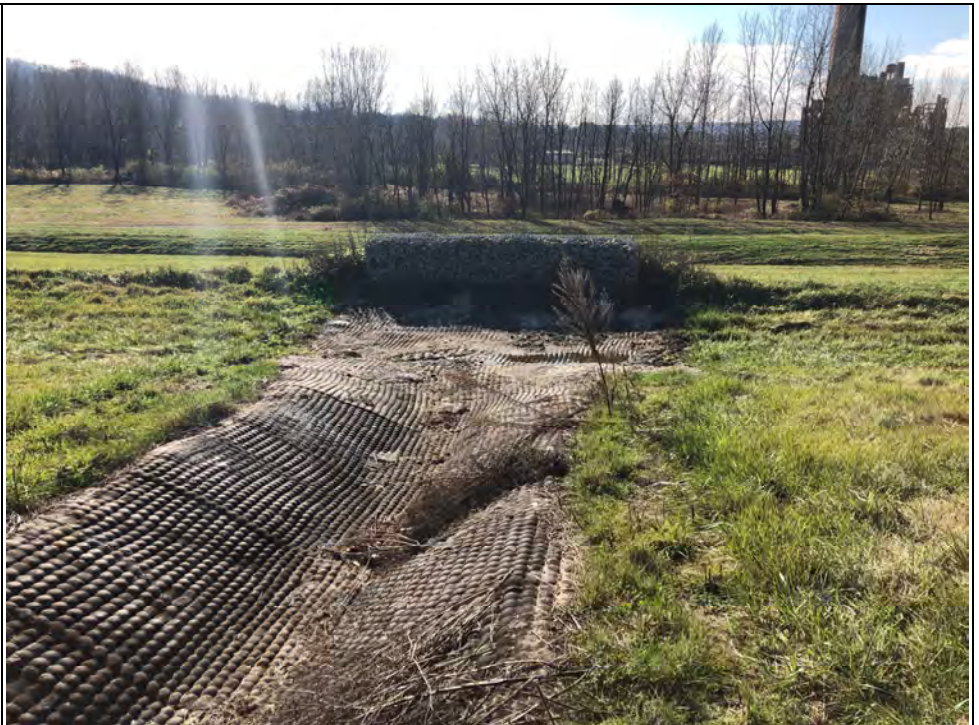
Image: 8084
Date: 11/12/2020
Time: 9:23 AM
Direction: South

Non-contact stormwater downchute is clear of obstructions. Gabion energy dissipator is installed at the junction with the stormwater (non-contact water) perimeter ditch.

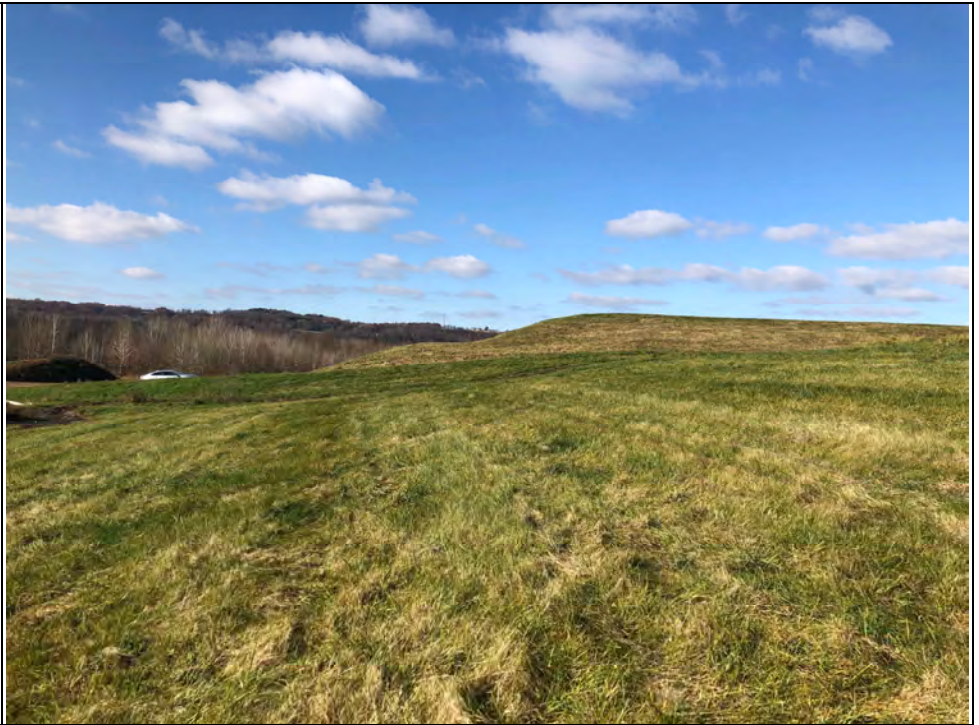
Image: 8086
Date: 11/12/2020
Time: 9:23 AM
Direction: West

Stage 6 final cover vegetation is healthy and well maintained. No evidence of animal burrows, erosion, or stability.

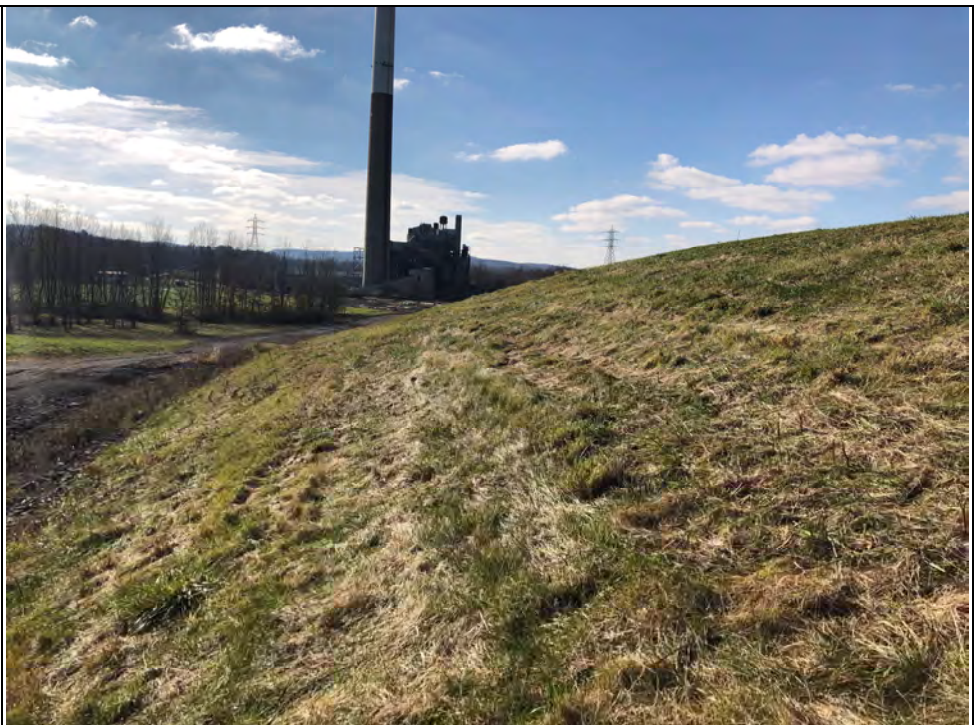
Image: 8088
Date: 11/12/2020
Time: 9:25 AM
Direction: Southwest

Stage 6 final cover vegetation is healthy and well maintained. No evidence of animal burrows, erosion, or stability.

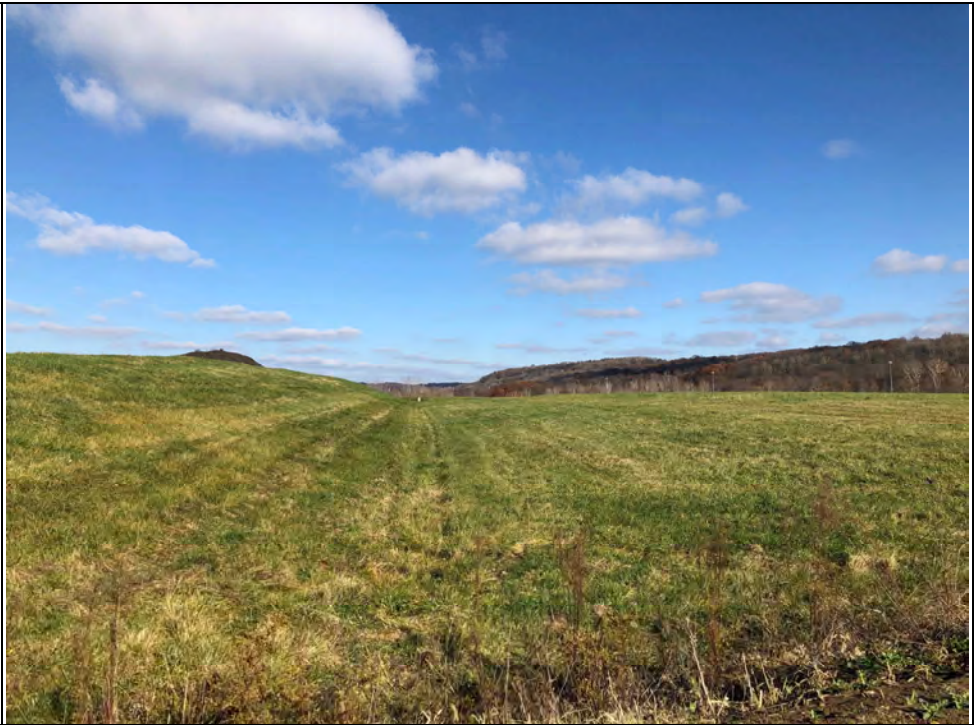
Stage 6 final cover (right) and transition slope to Stage 4 (left). Vegetation is healthy and well maintained. No evidence of animal burrows, erosion, or stability.

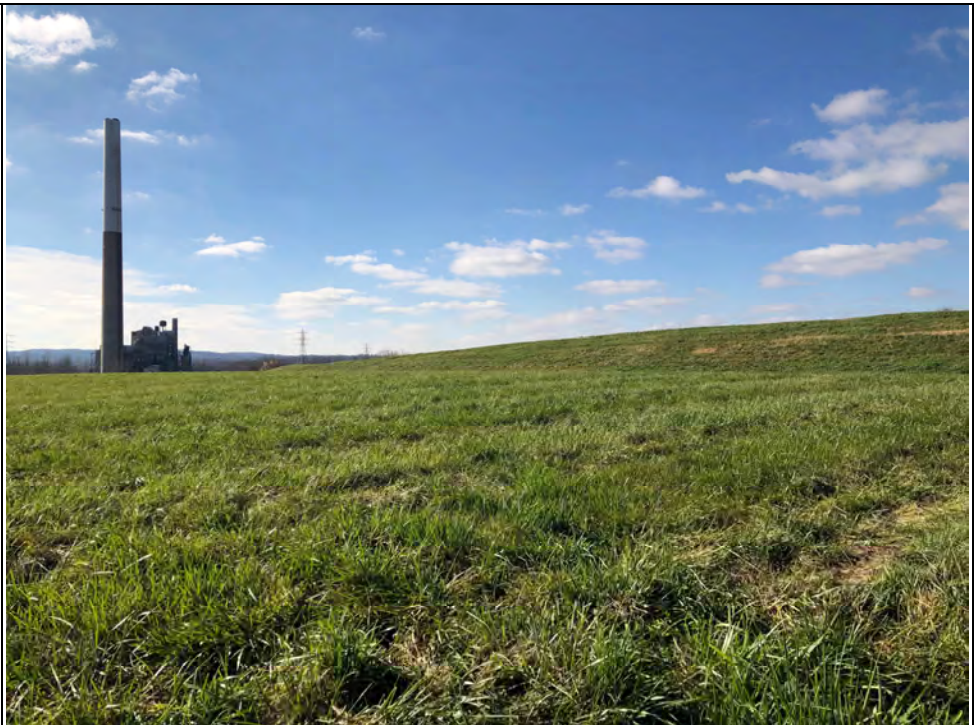
Image: 8094
Date: 11/12/2020
Time: 9:27 AM
Direction: South

Stage 6 final cover. Vegetation is healthy and well maintained. No evidence of animal burrows, erosion, or stability.

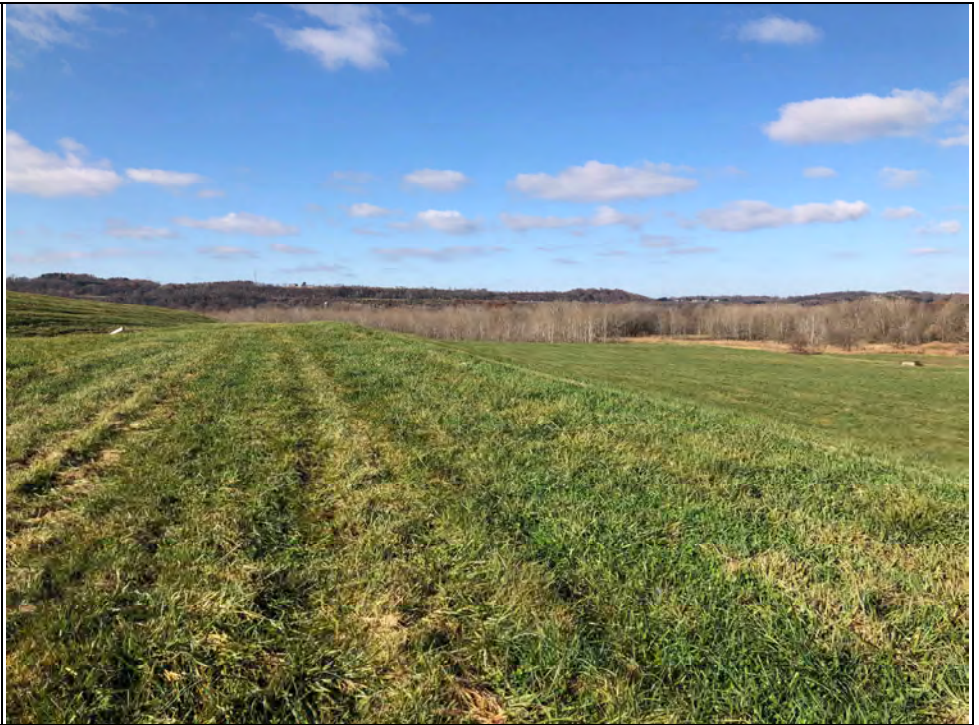
Stage 5 final cover. Vegetation is healthy and well maintained. No evidence of animal burrows, erosion, or stability.

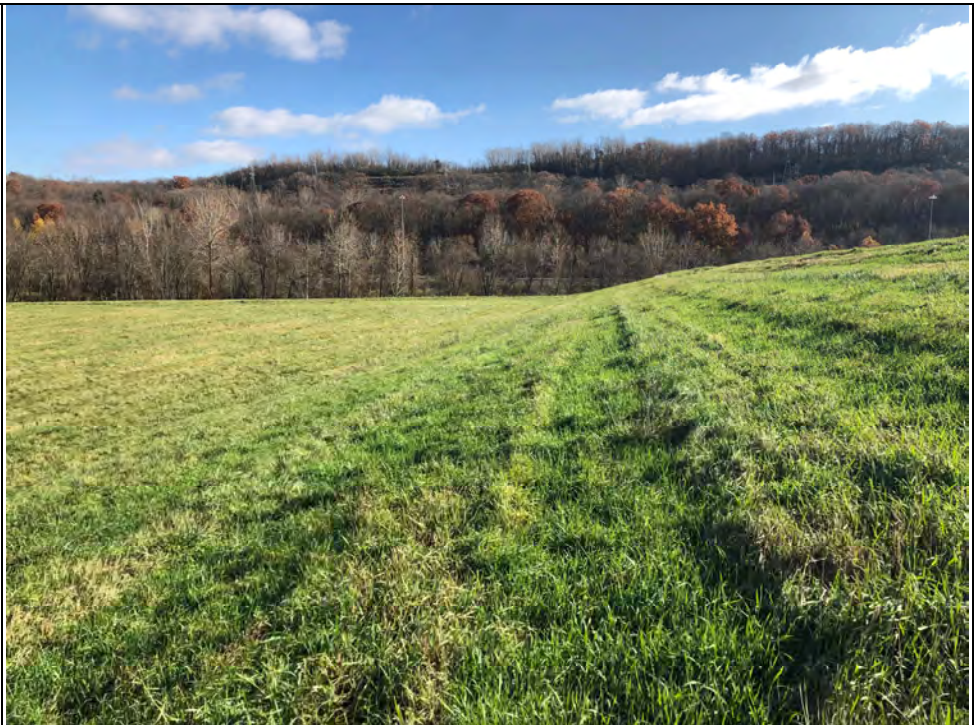
Image: 8098
Date: 11/12/2020
Time: 9:28 AM
Direction: East

Stage 5 final cover. Vegetation is healthy and well maintained. No evidence of animal burrows, erosion, or stability.

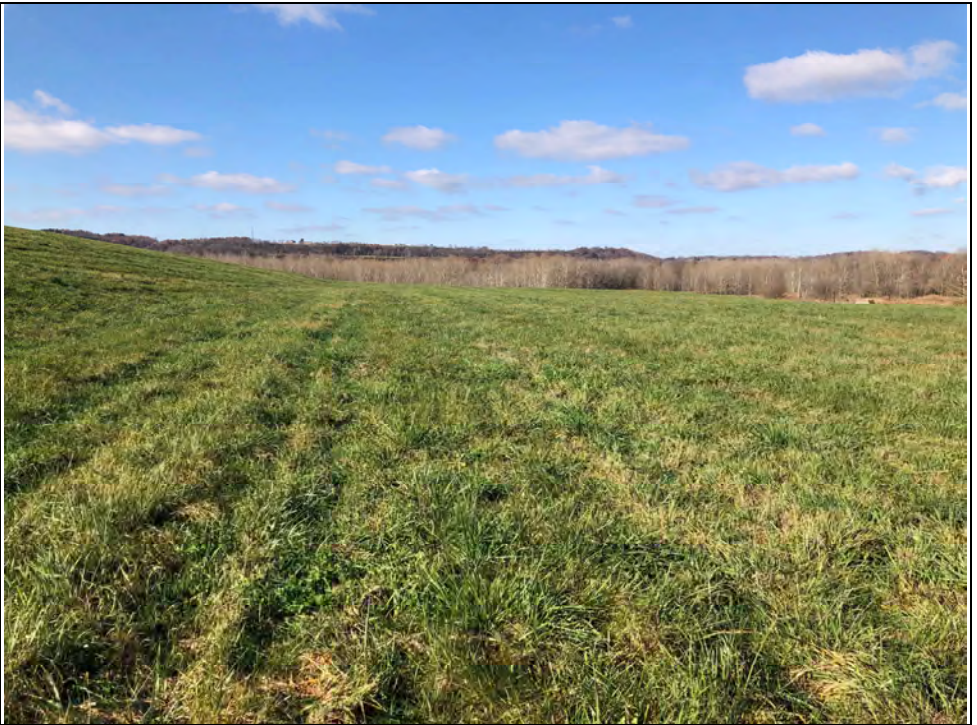
Stage 5 final cover. Vegetation is healthy and well maintained. No evidence of animal burrows, erosion, or stability.

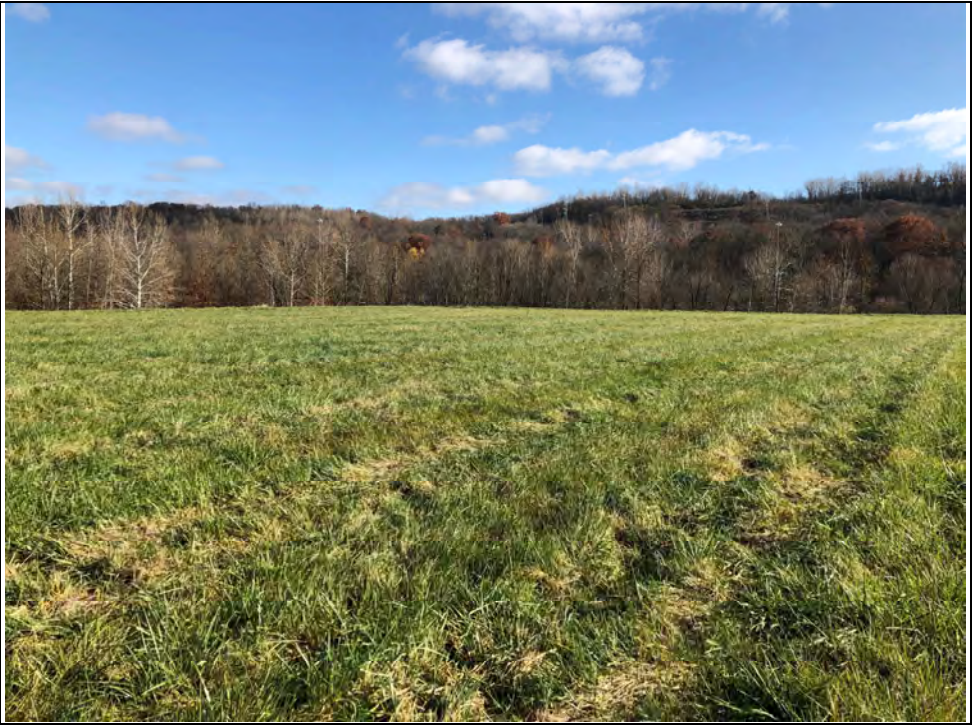
Image: 8102
Date: 11/12/2020
Time: 9:28 AM
Direction: East-Northeast

Stage 5 final cover. Vegetation is healthy and well maintained. No evidence of animal burrows, erosion, or stability.

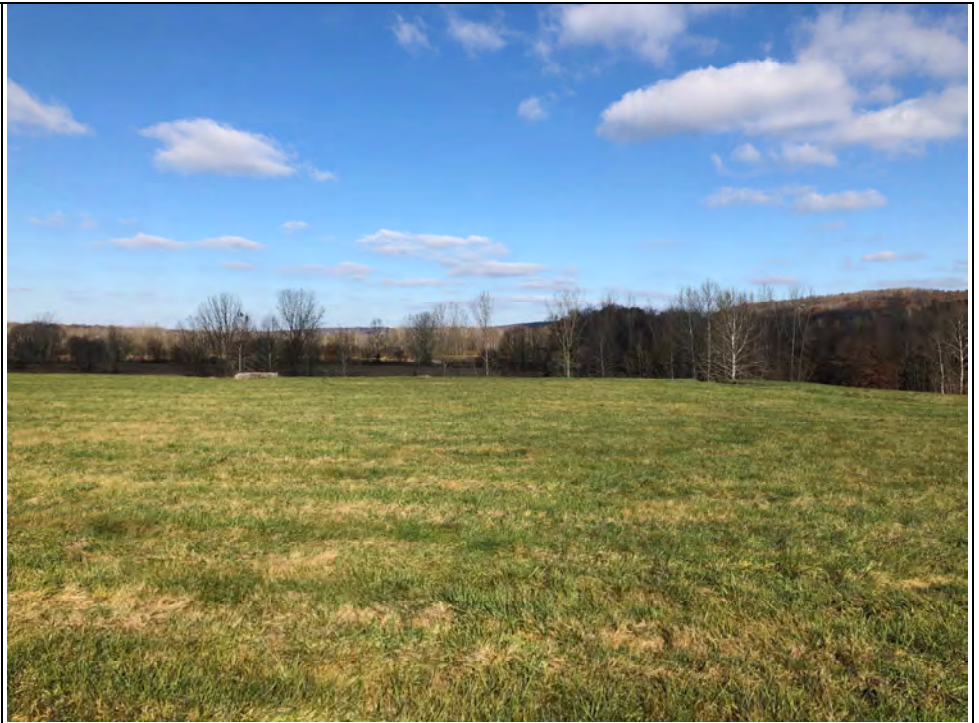
Stage 5 final cover. Vegetation is healthy and well maintained. No evidence of animal burrows, erosion, or stability.

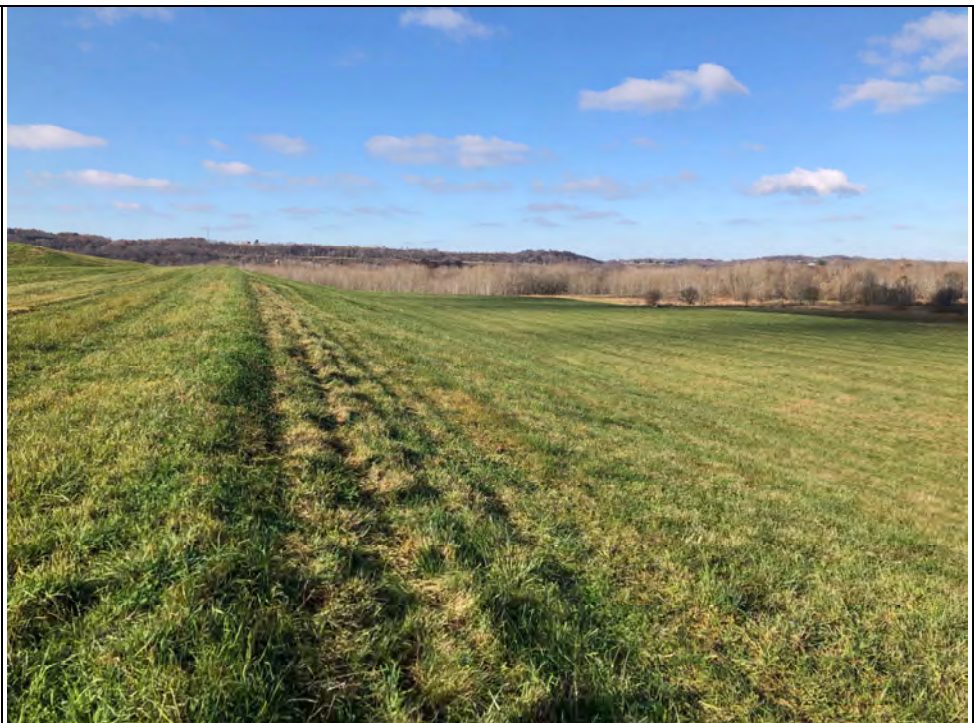
Image: 8106
Date: 11/12/2020
Time: 9:30 AM
Direction: Northwest

Stage 5 final cover. Vegetation is healthy and well maintained. No evidence of animal burrows, erosion, or stability.

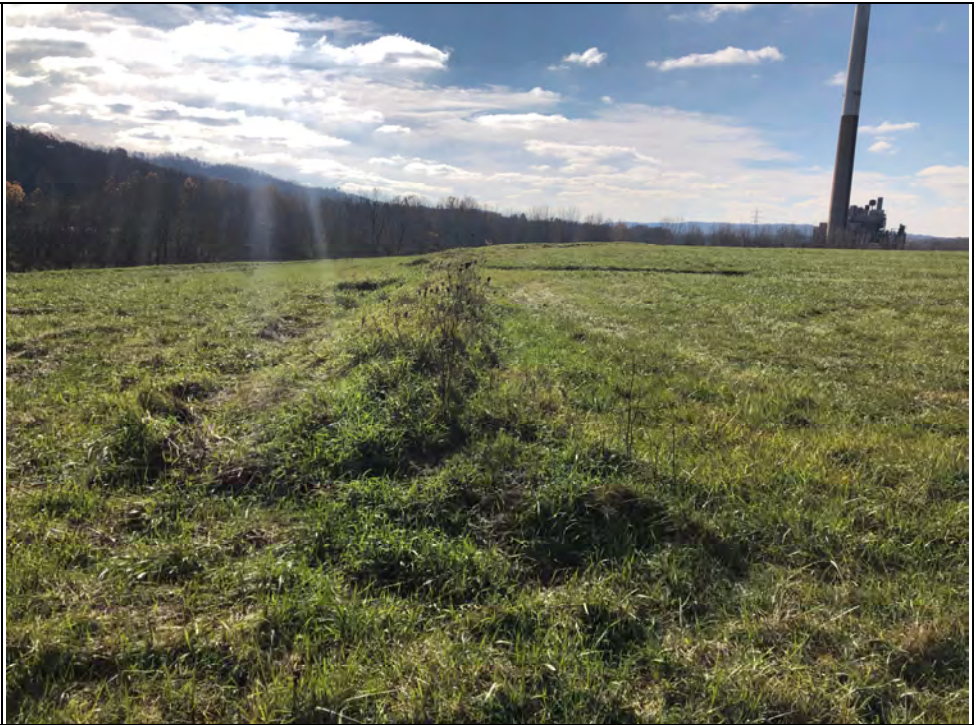
Stage 6 Stormwater Control Berm used to direct non-contact stormwater to downchutes (letdown channels).

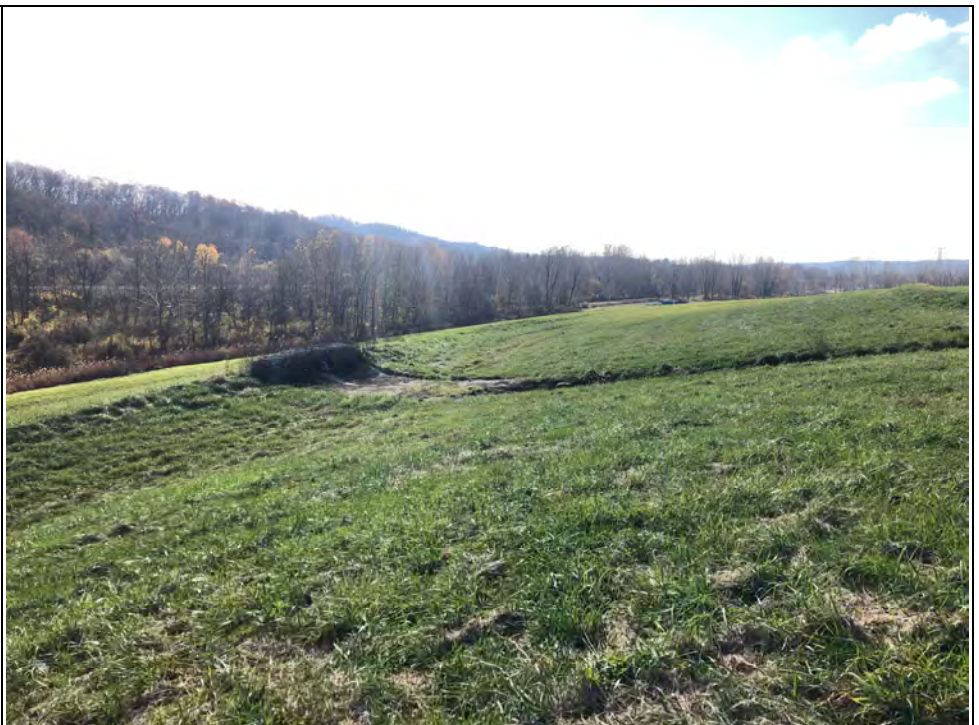
Image: 8110
Date: 11/12/2020
Time: 9:31 AM
Direction: South

Stage 6 energy dissipator in good condition.

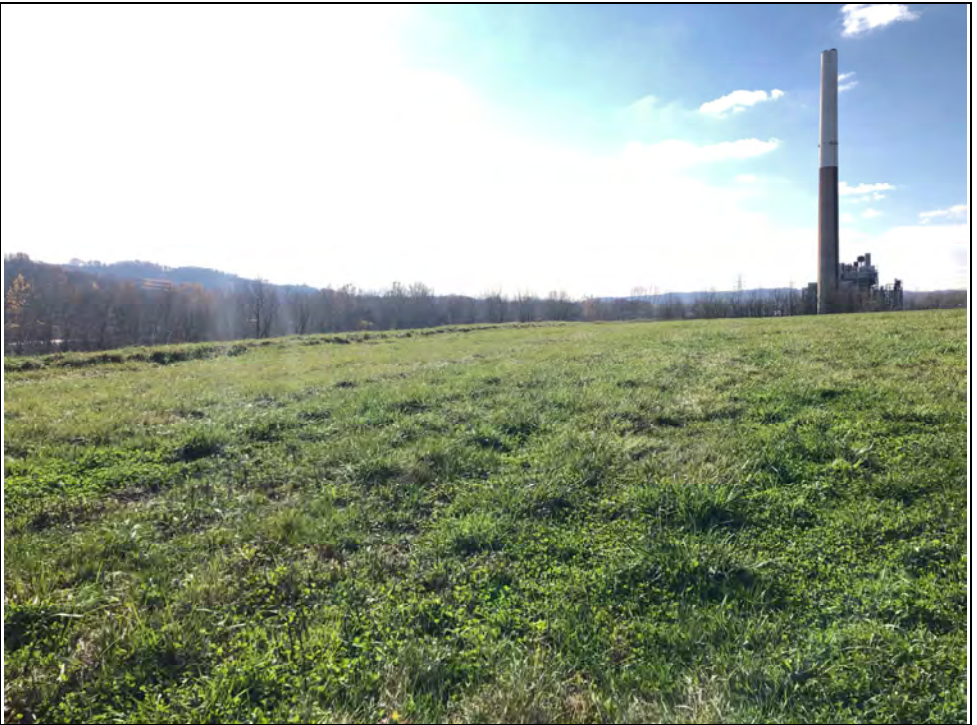
Stage 6 final cover. Vegetation is healthy and well maintained. No evidence of animal burrows, erosion, or stability.

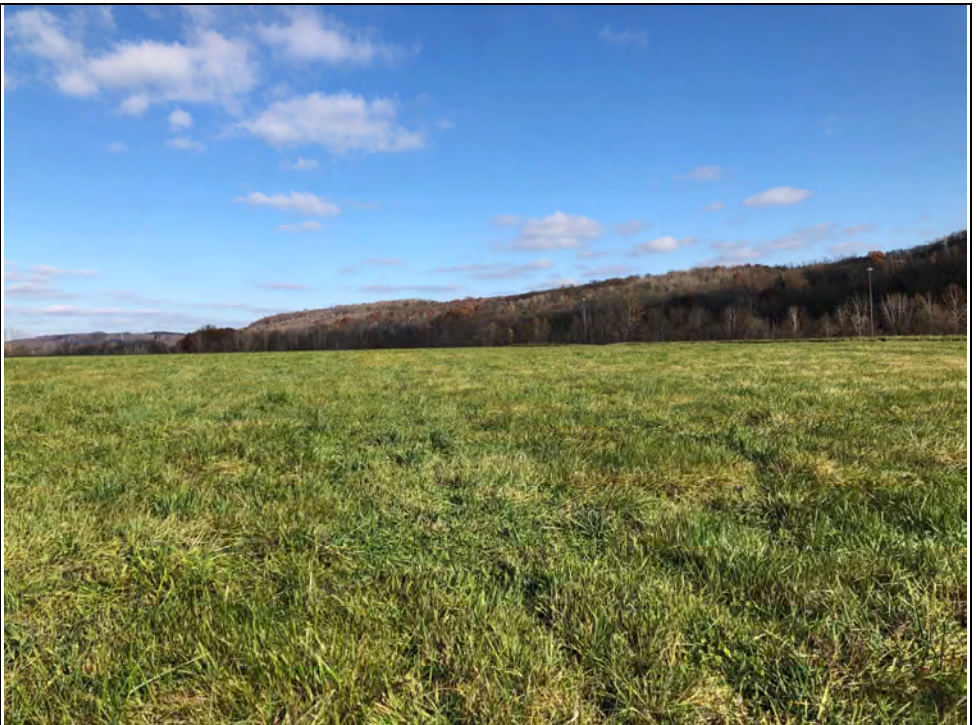
Image: 8116
Date: 11/12/2020
Time: 9:32 AM
Direction: Northeast

Stage 6 final cover. Vegetation is healthy and well maintained. No evidence of animal burrows, erosion, or stability.

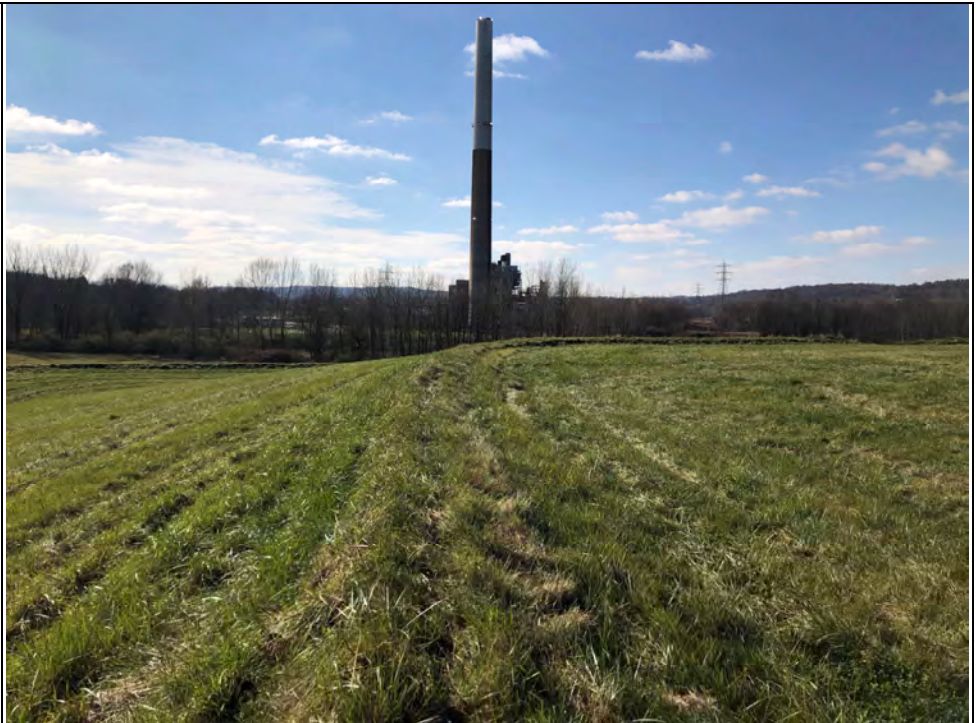
Stage 6 final cover plateau terrace berm to direct non-contact stormwater to downslope ditch. No evidence of erosion or scour. Vegetation is healthy and well maintained.

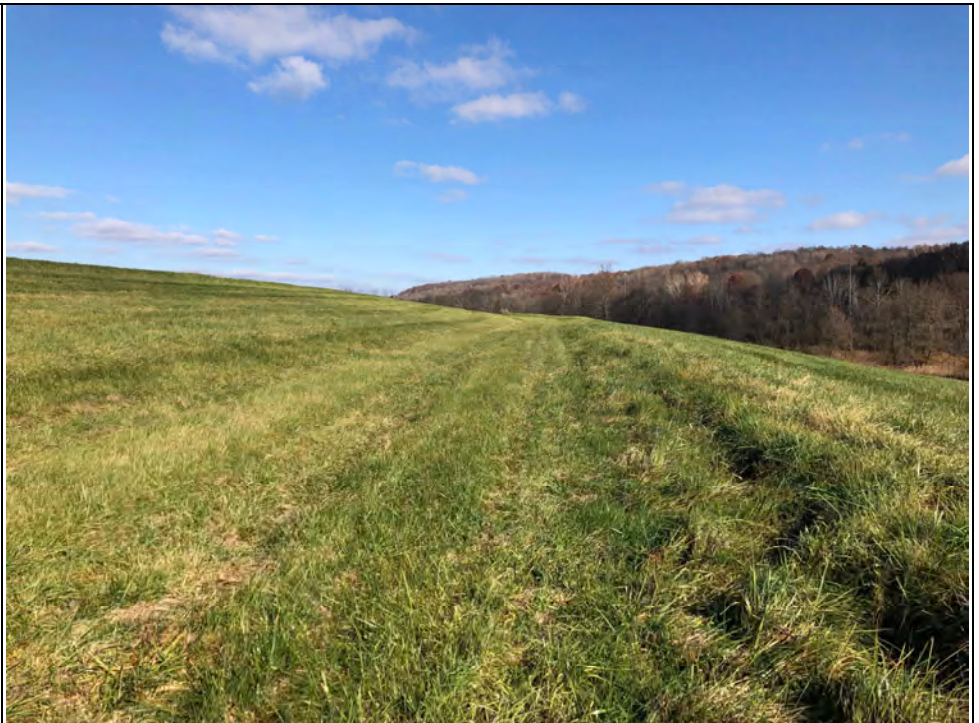
Image: 8120
Date: 11/12/2020
Time: 9:33 AM
Direction: North

Stage 6 final cover plateau terrace berm to direct non-contact water to downslope ditch. No evidence of erosion or scour. Vegetation is healthy and well maintained.

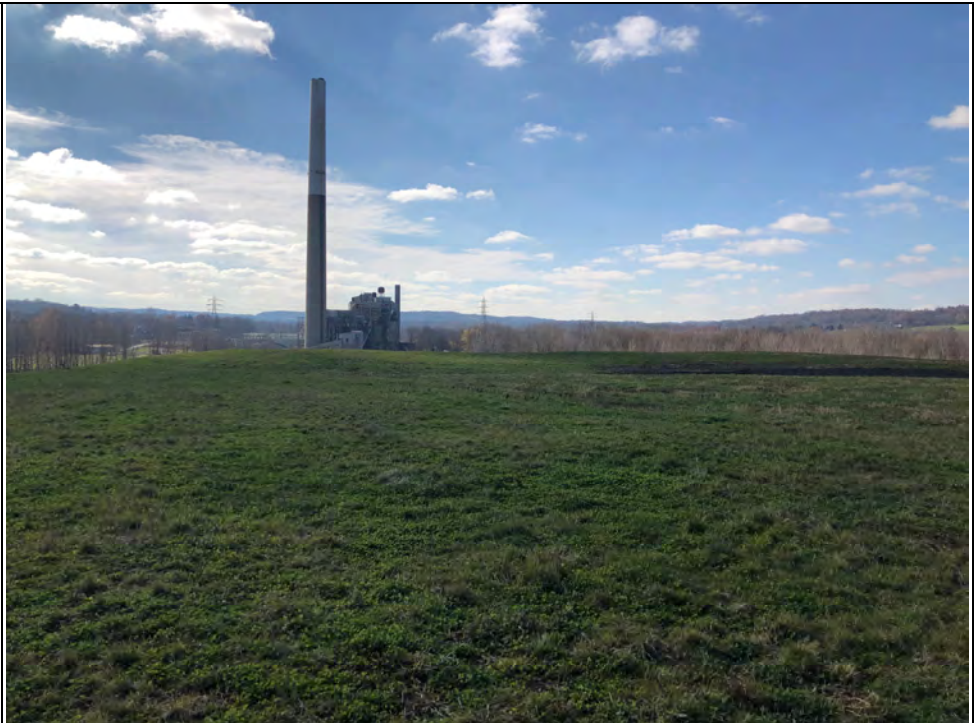
Stage 4 intermediate cover.
Vegetation has become established. No erosion observed.

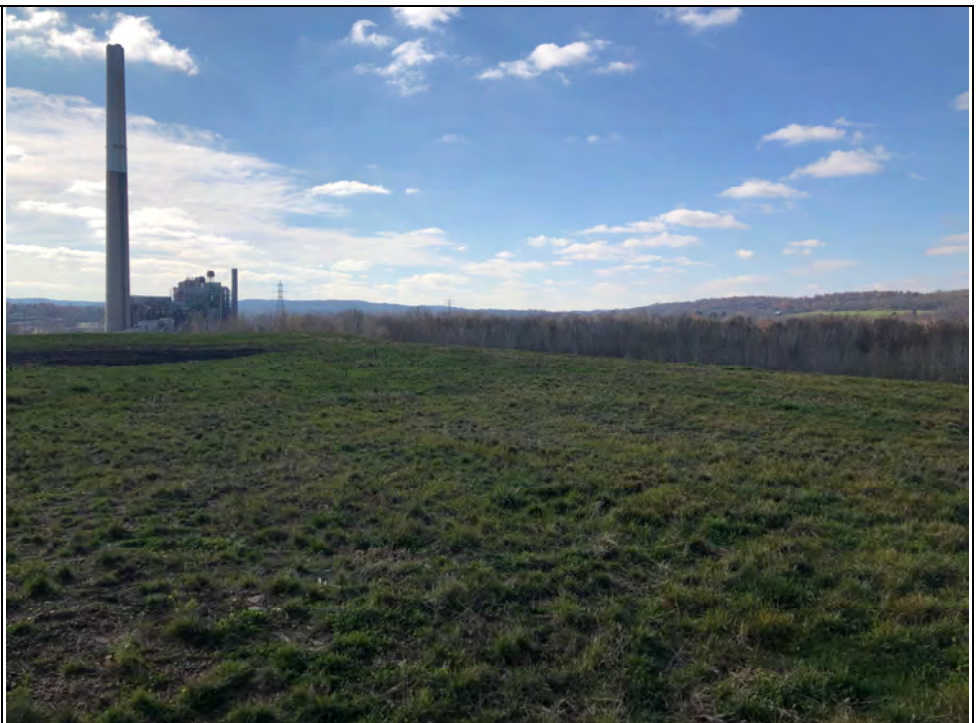
Image: 8126
Date: 11/12/2020
Time: 9:36 AM
Direction: South-Southwest

Stage 4 intermediate cover.
Vegetation has become established. No erosion observed.

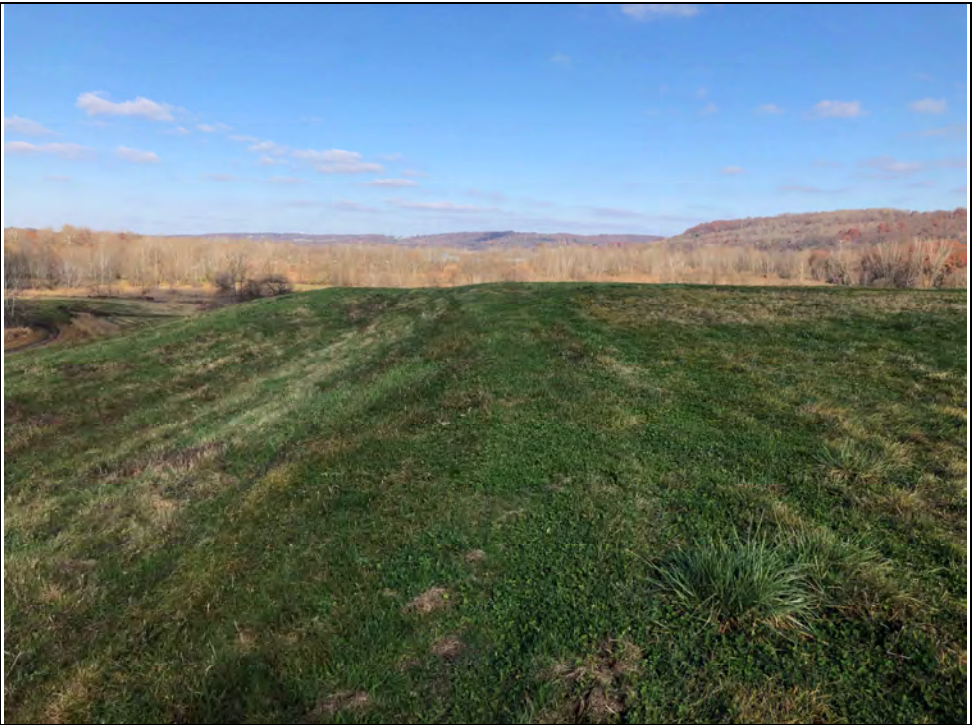
Stage 4 intermediate cover. Vegetation has become established. No erosion observed.

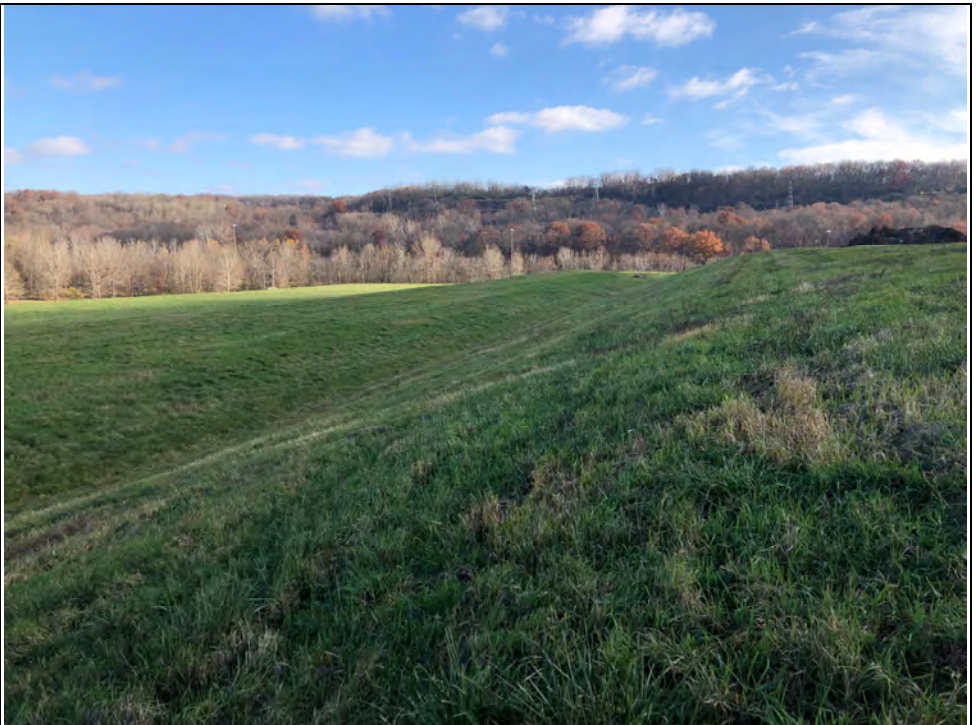
Image: 8130
Date: 11/12/2020
Time: 9:37 AM
Direction: Northeast

Transition slope between Stage 4 and Stage 5. No evidence of slope instability.

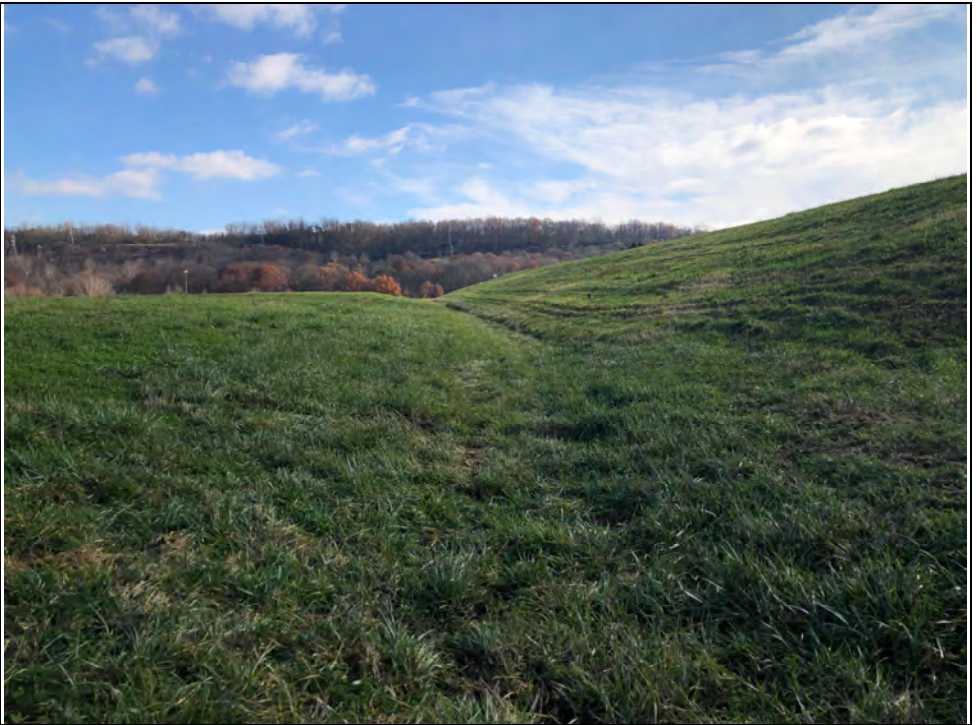
Stage 5 final cover. Final cover is in good condition with no erosion, animal burrows, or evidence of instability observed.

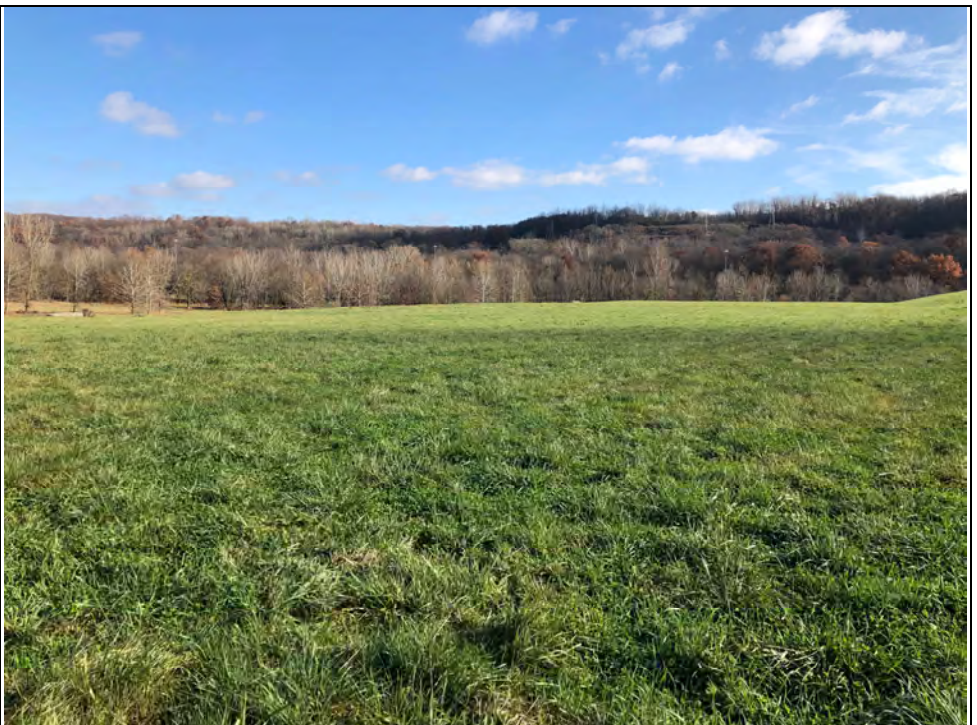
Image: 8134
Date: 11/12/2020
Time: 9:38 AM
Direction: Northeast

Stage 5 final cover. Final cover is in good condition with no erosion, animal burrows, or evidence of instability observed.

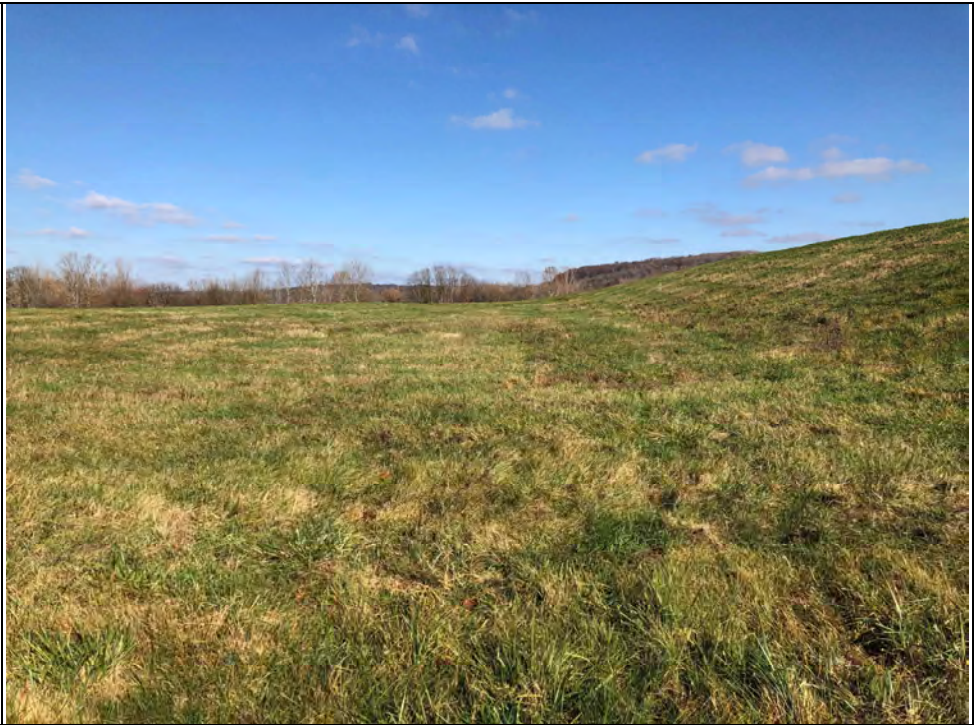
Stage 5 final cover. Final cover is in good condition with no erosion, animal burrows, or evidence of instability observed.

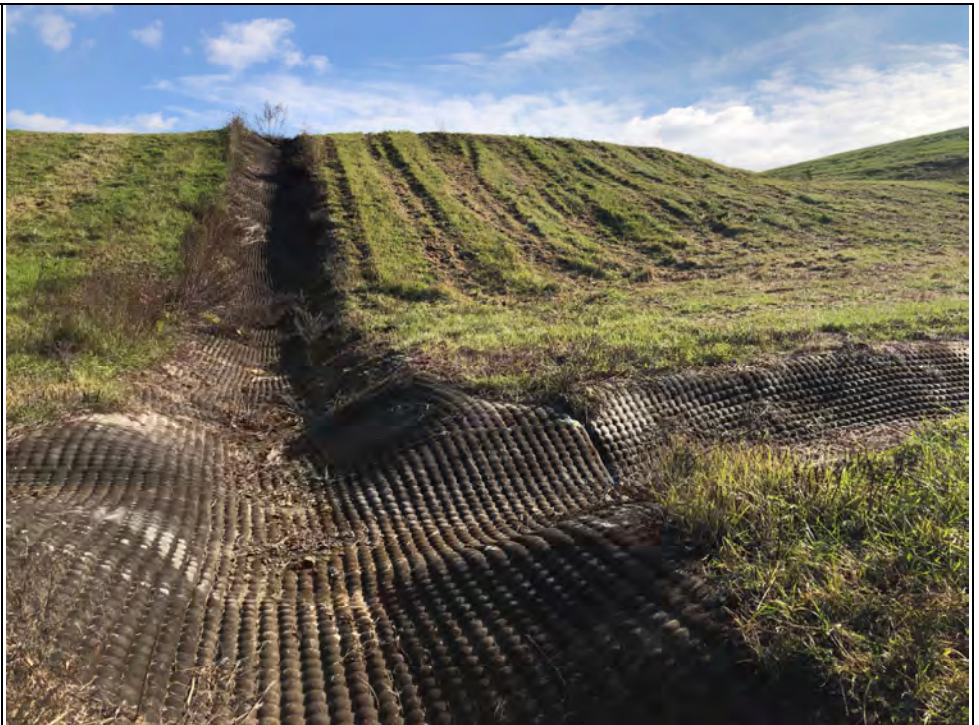
Image: 8138
Date: 11/12/2020
Time: 9:39 AM
Direction: East

Confluence of downchutes (downslope ditches). Free of obstruction, functioning as intended.

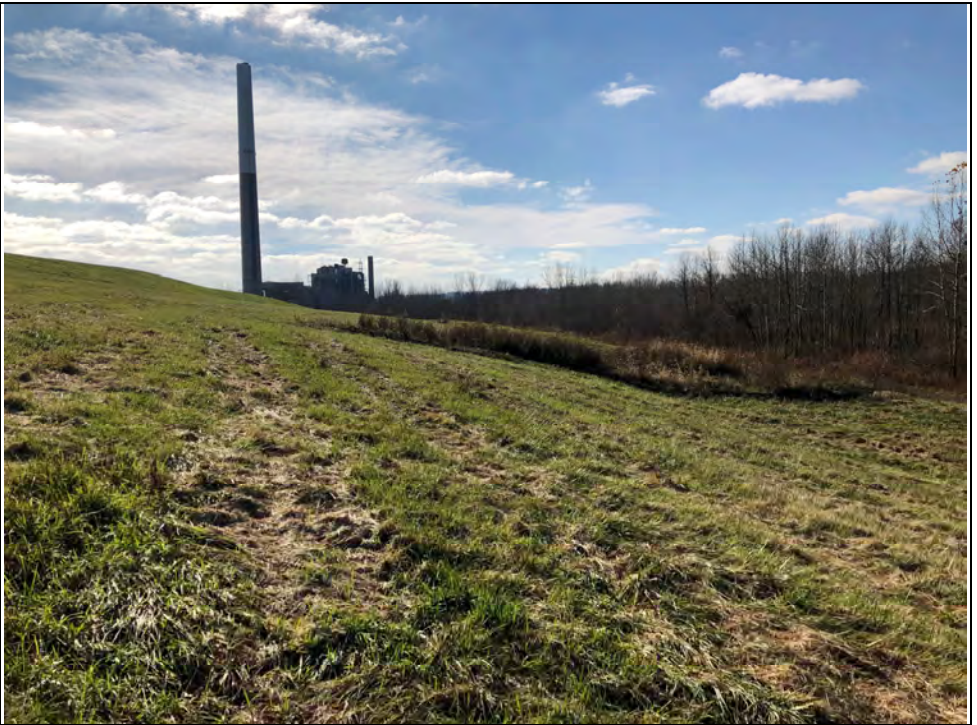
Final cover on the sideslopes of Stage 4. Final cover vegetation is healthy and well established. No stability concerns evident.

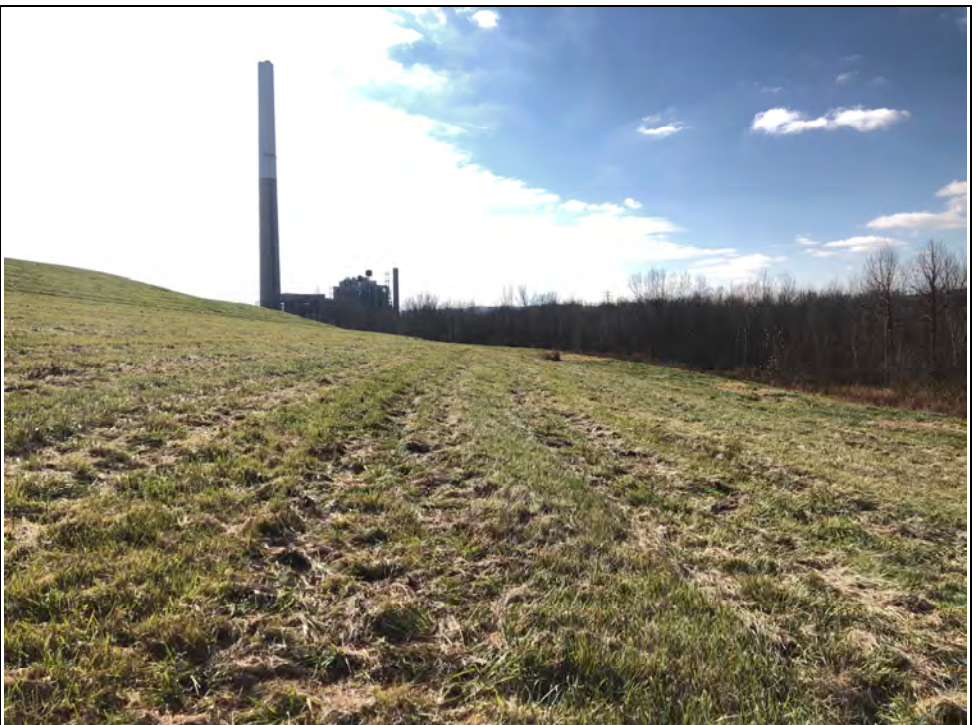
Image: 8142
Date: 11/12/2020
Time: 9:40 AM
Direction: South

Final cover on the sideslopes of Stage 4. Final cover vegetation is healthy and well established. No stability concerns evident.
