Inspection Report

To: Brian Baierl (New Castle Generating Station)
From: Richard Southorn, P.E., P.G.
Re: New Castle Plant Ash Landfill—Annual CCR Unit Inspection Report
Inspection Date: November 12, 2020
Report Date: January 15, 2021

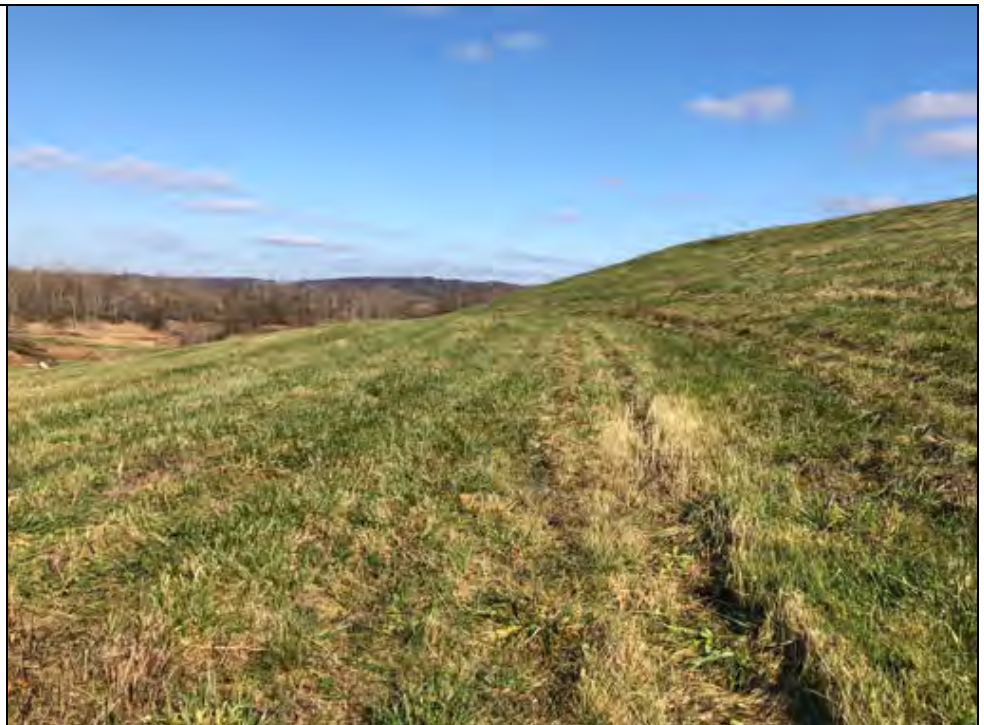
Final cover and terrace on the sideslopes of Stage 4. Final cover vegetation is healthy and well established. No stability concerns evident. Terrace shows no indication of washout or evidence of erosive flow.

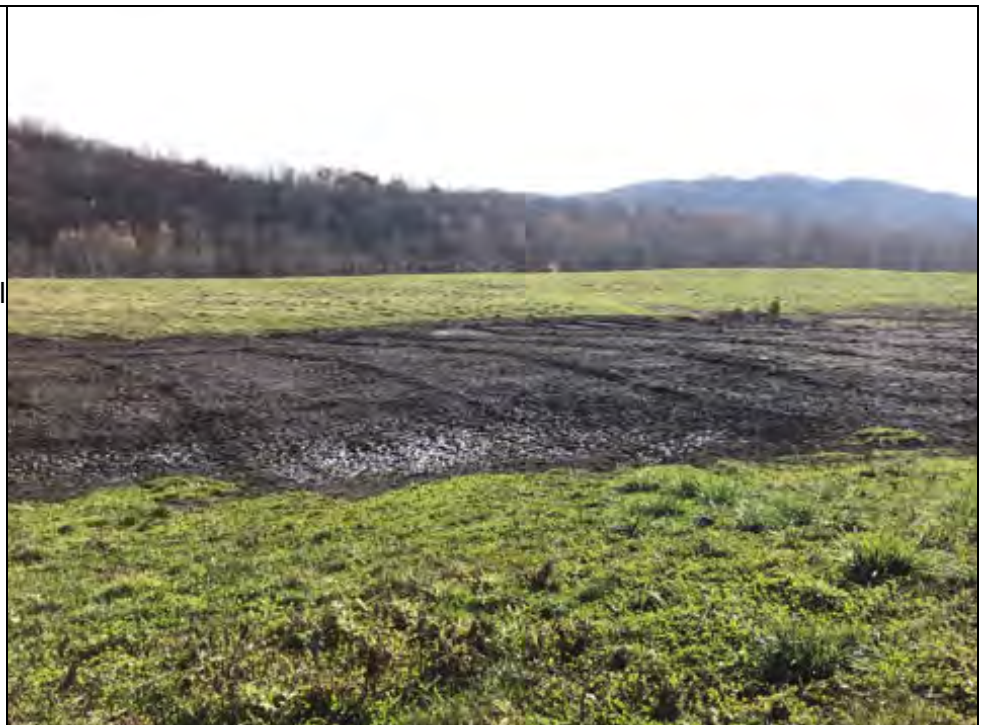
Image: 8147
Date: 11/12/2020
Time: 9:42 AM
Direction: Southeast

Active face of Stage 4. Well graded and maintained.

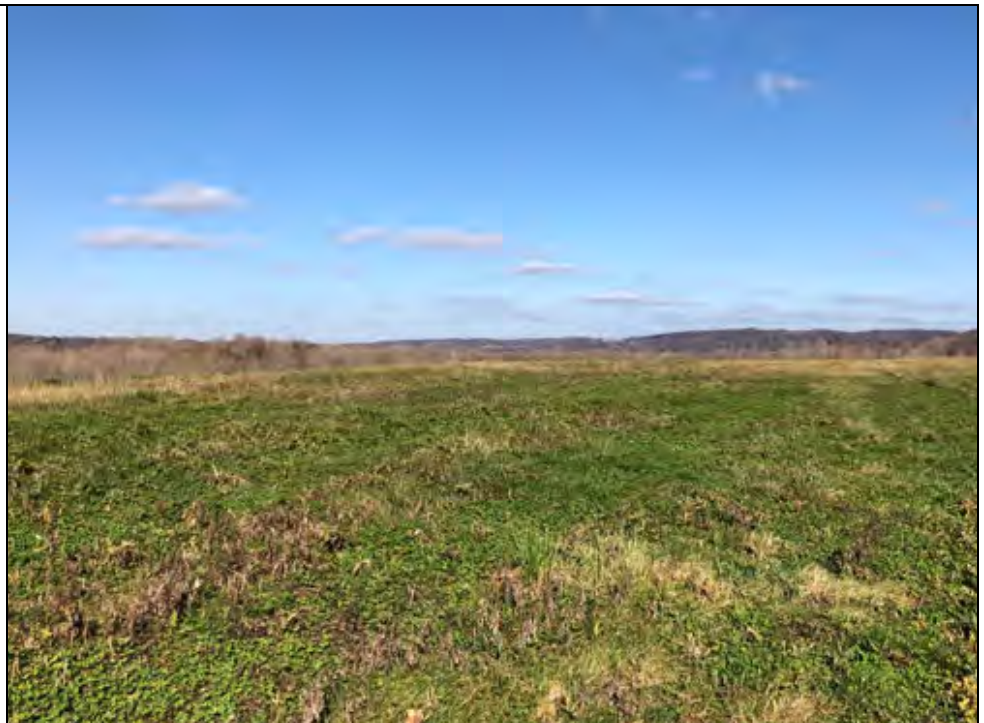
Intermediate cover on Stage 4. Vegetation has become established. No erosion noted.

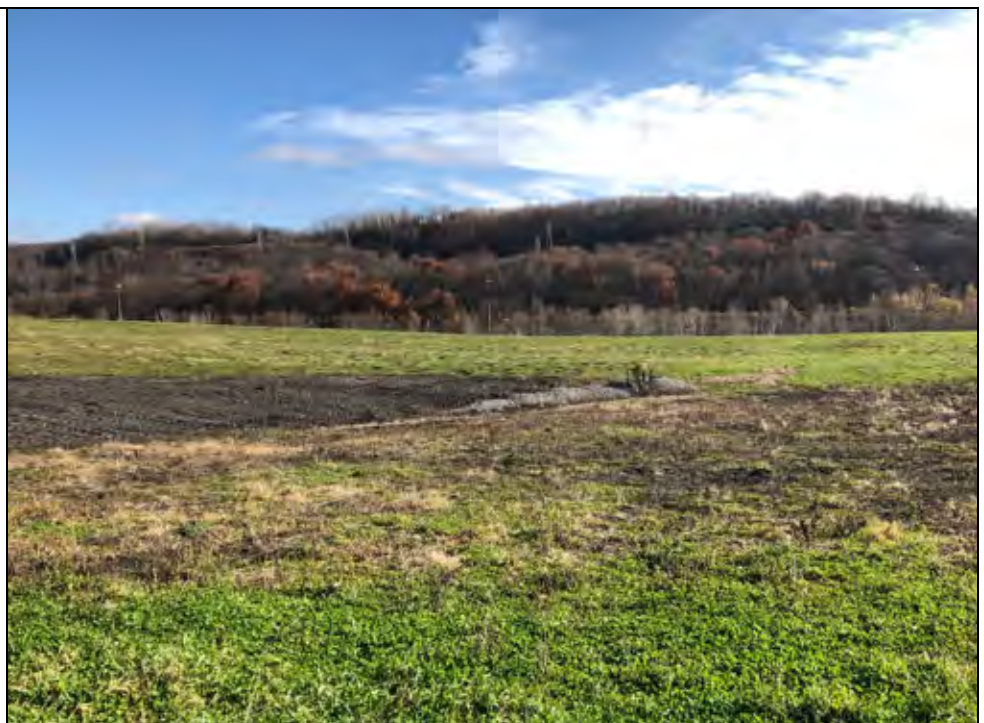
Image: 8149
Date: 11/12/2020
Time: 9:44 AM
Direction: Northeast

Active face of Stage 4. Well graded and maintained.

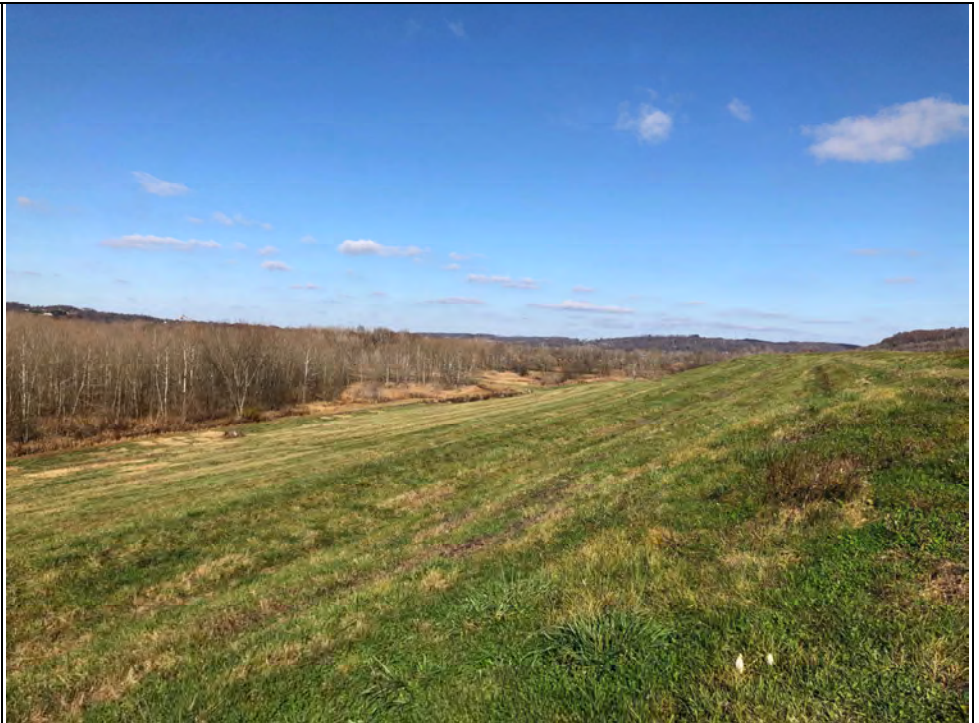
Final cover on the sideslopes of Stage 4. Final cover vegetation is healthy and well established. No stability concerns evident.

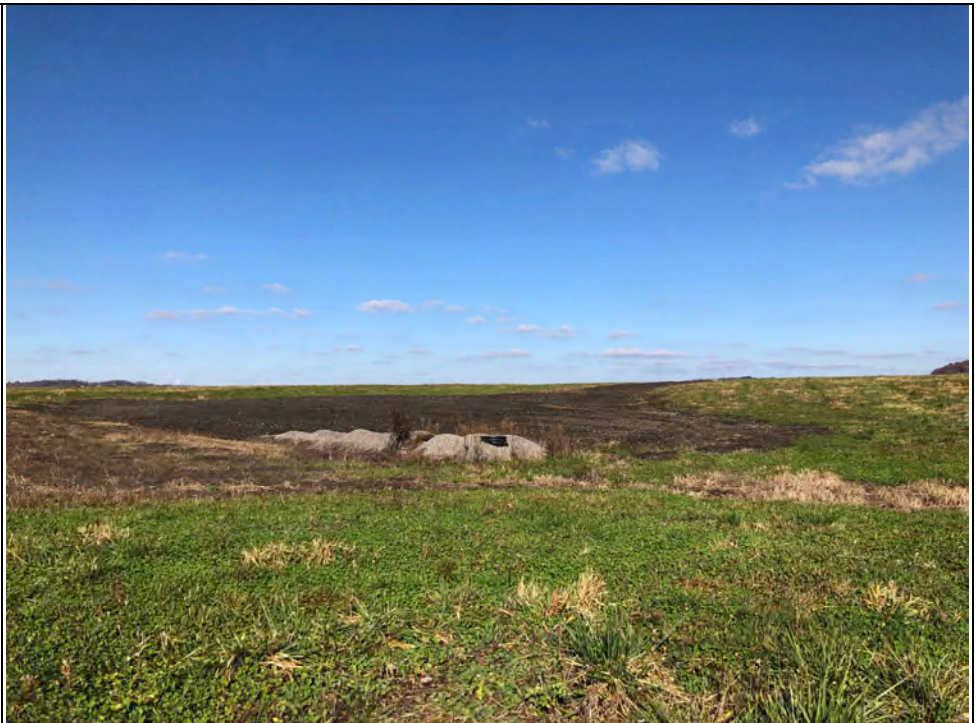
Image: 8152
Date: 11/12/2020
Time: 9:46 AM
Direction: North-Northwest

Vertical leachate riser within active area. The ground is sloped to drain into this riser, with contact stormwater treated as leachate.

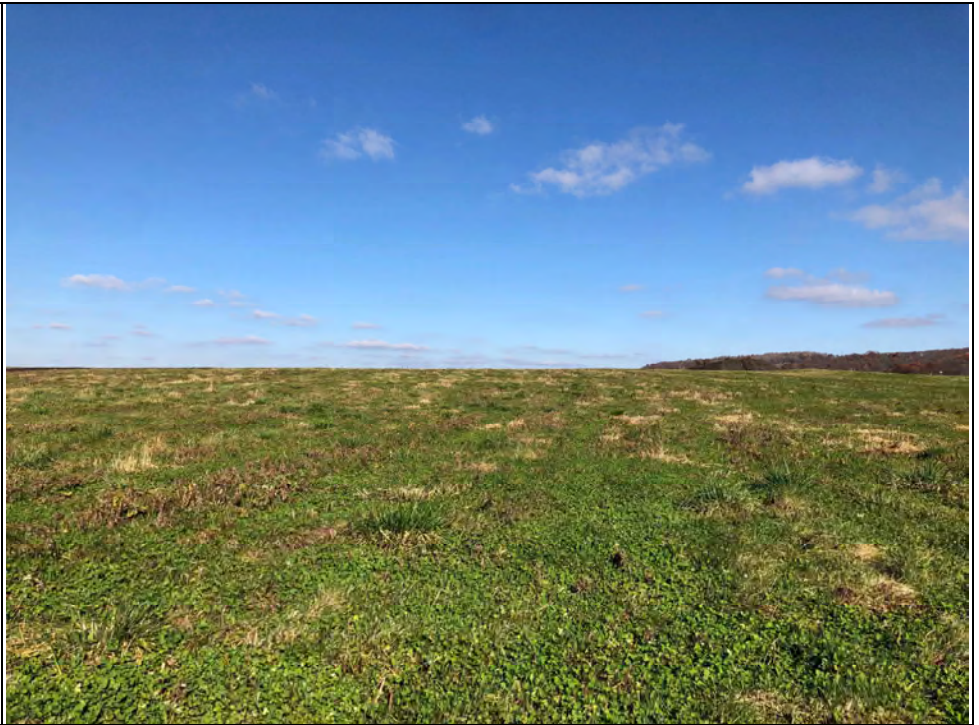
Stage 4 intermediate cover. Vegetation is well established.

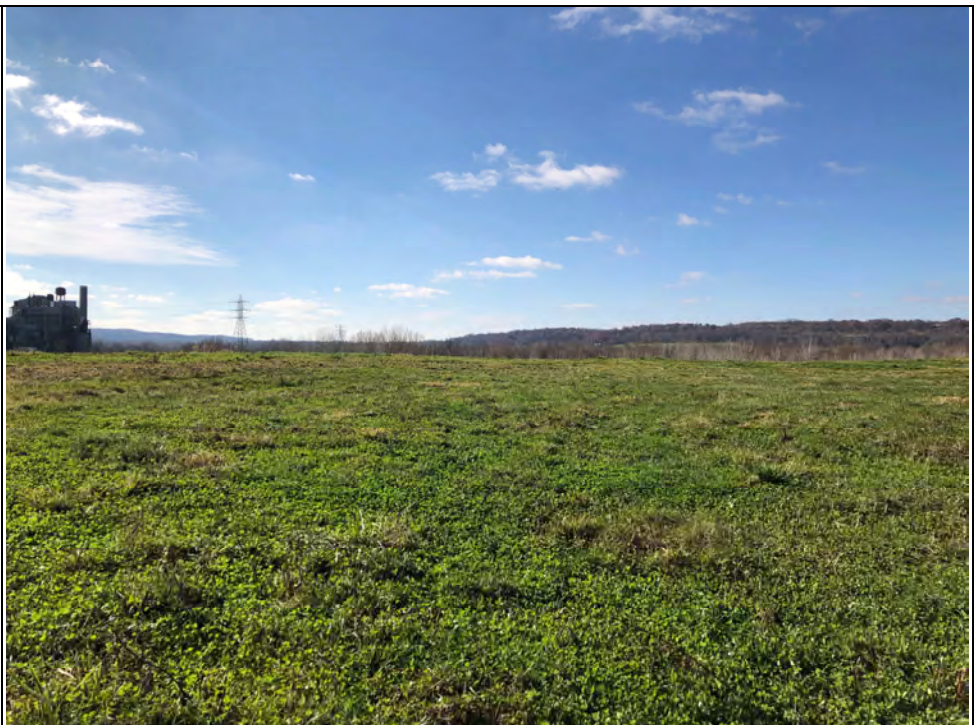
Image: 8156
Date: 11/12/2020
Time: 9:47 AM
Direction: Southwest

Stage 4 intermediate cover. Vegetation is well established.

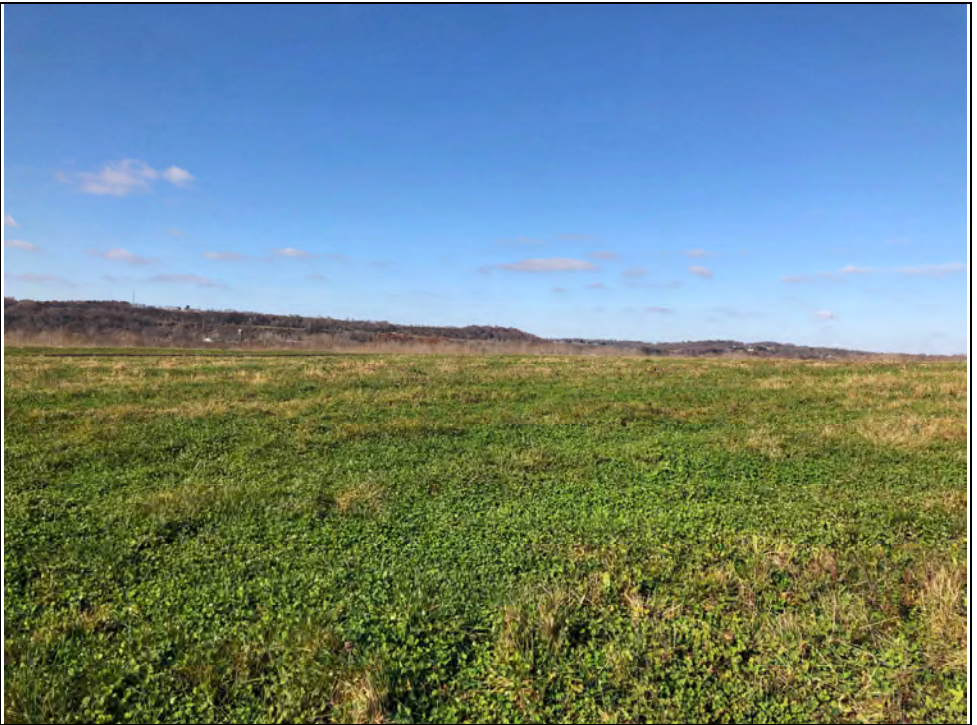
Stage 4 intermediate cover. Vegetation is well established.

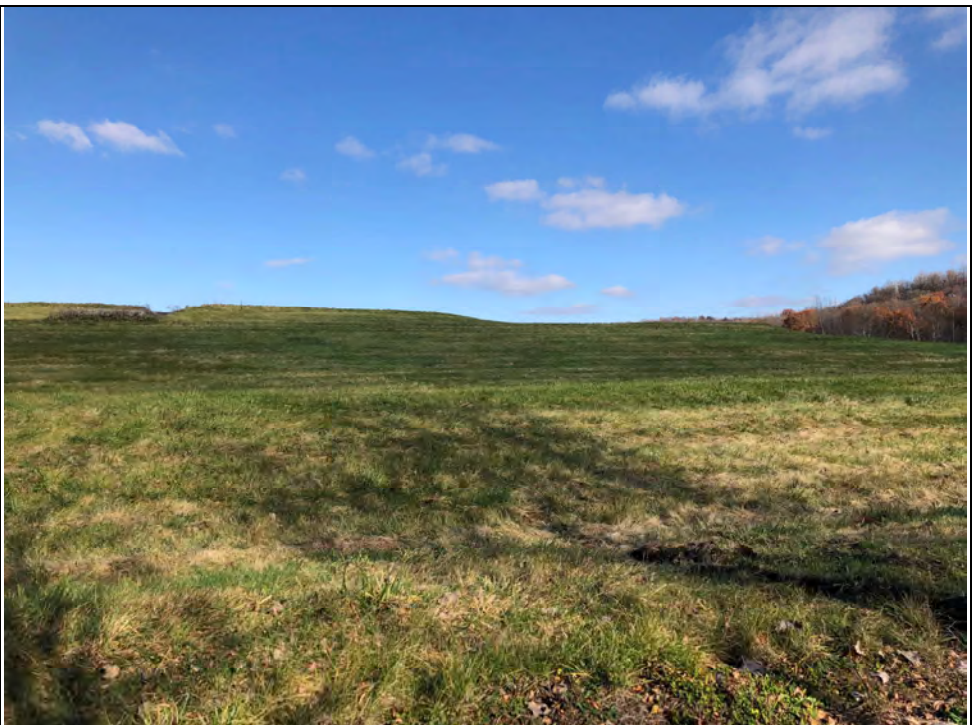
Image: 8160
Date: 11/12/2020
Time: 9:48 AM
Direction: North

Final Cover on Stage 6 sideslopes is in good condition with no evidence of damage from erosion, animals, or sloughing or stability issues.

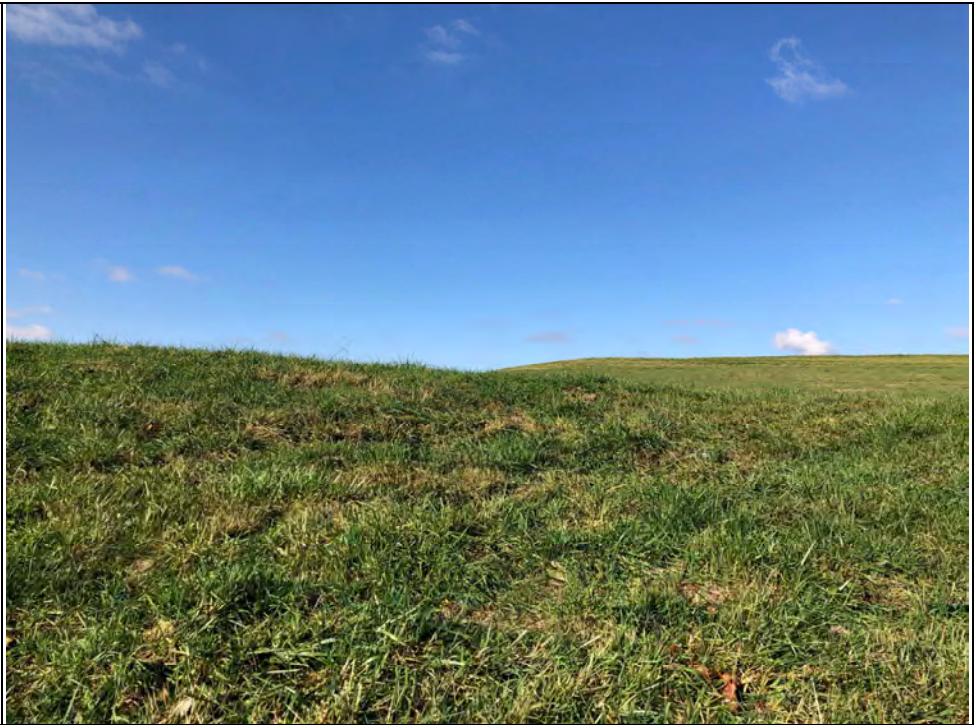
Final Cover on Stage 6 sideslopes is in good condition with no evidence of damage from erosion, animals, or sloughing or stability issues.

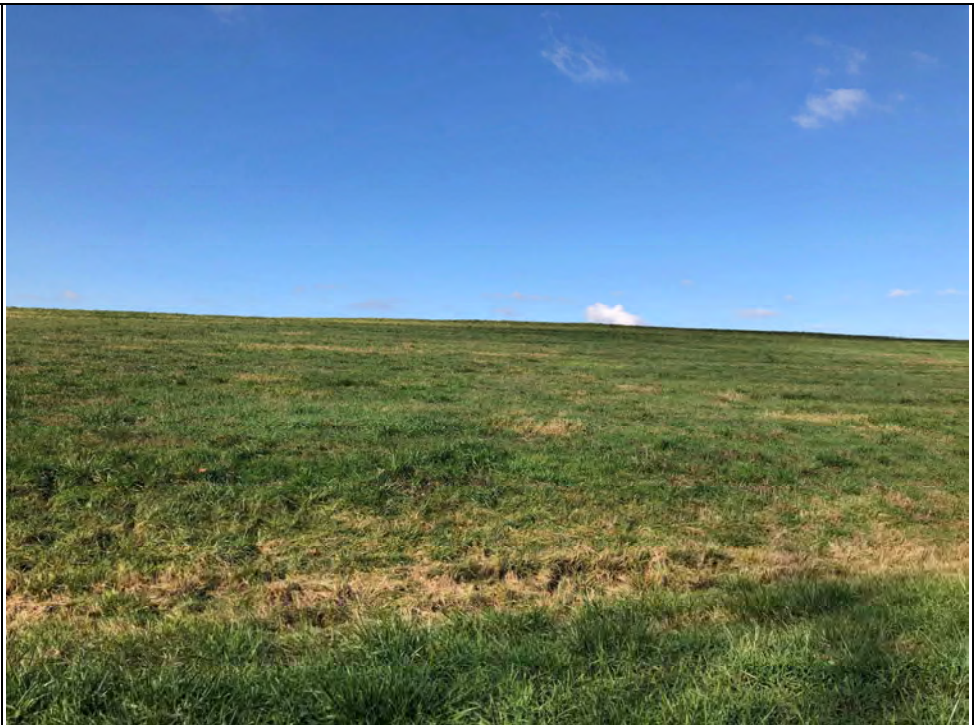
Image: 8164
Date: 11/12/2020
Time: 9:50 AM
Direction: Northwest

Final Cover on Stage 6 sideslopes is in good condition with no evidence of damage from erosion, animals, or sloughing or stability issues.

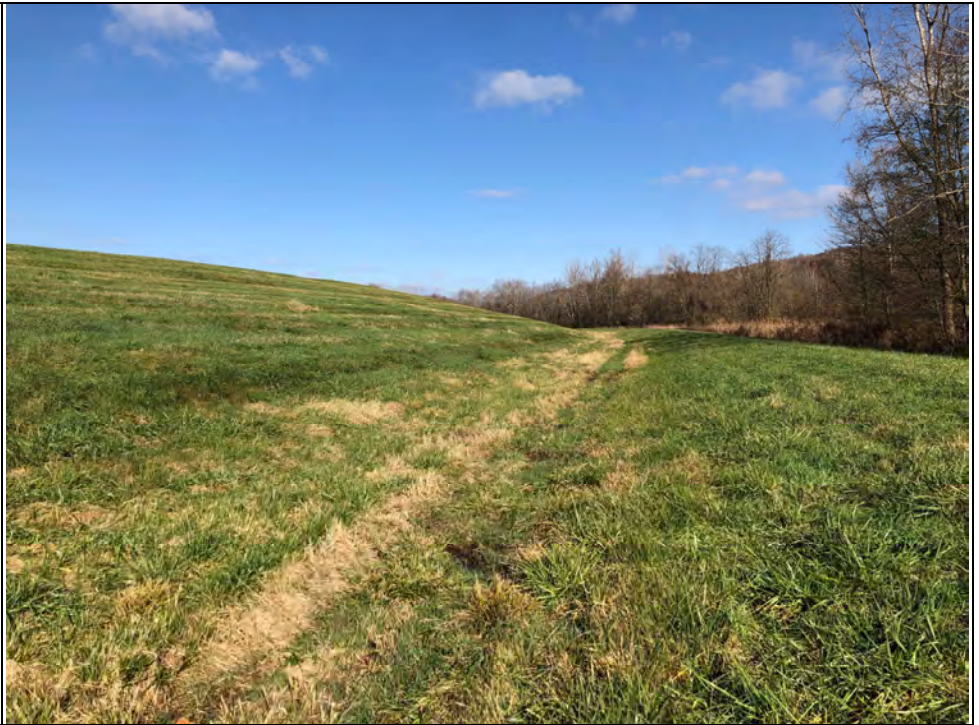
Non-contact stormwater ditch along Stage 6 is free of obstructions and does not exhibit scour or erosion issues.

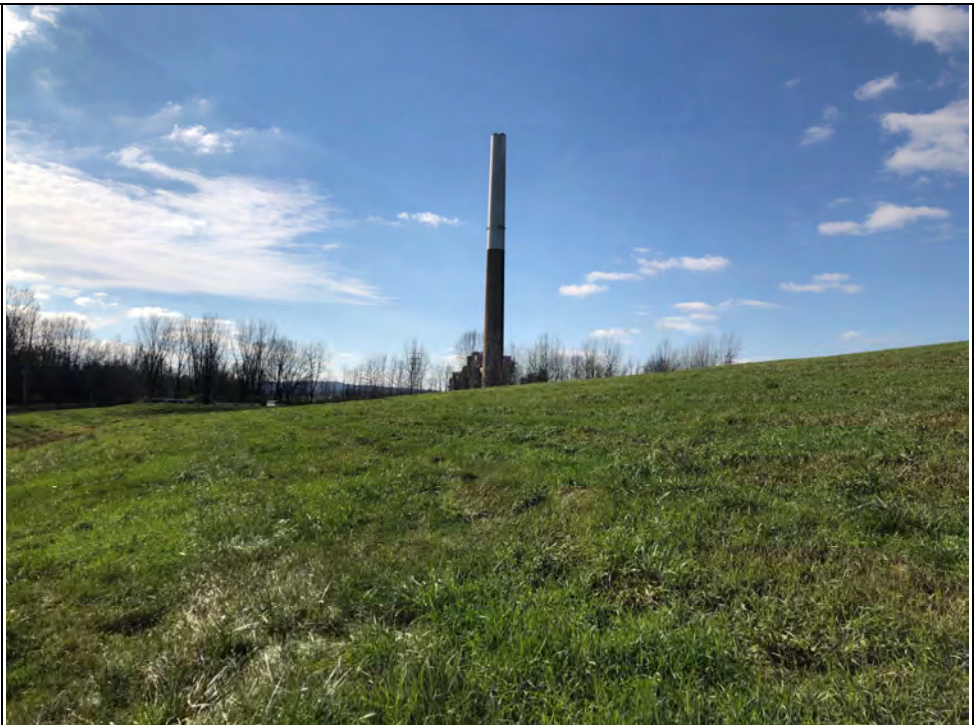
Image: 8168
Date: 11/12/2020
Time: 9:51 AM
Direction: Southwest

Final Cover on Stage 6 sideslopes is in good condition with no evidence of damage from erosion, animals, or sloughing or stability issues.

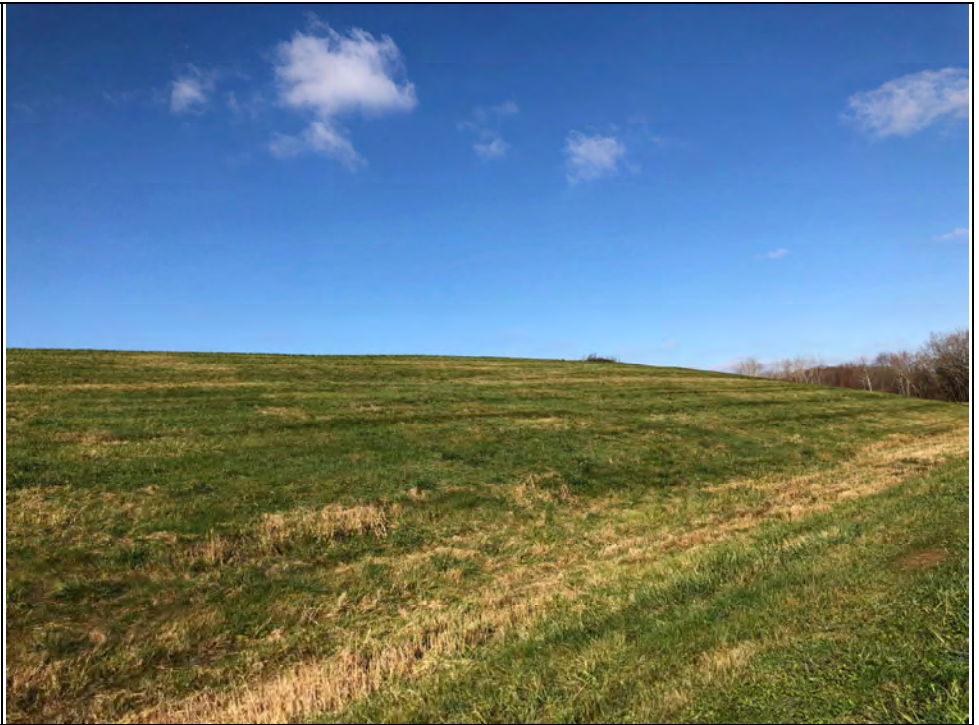
Non-contact stormwater ditch along Stage 6 is free of obstructions and does not exhibit scour or erosion issues.

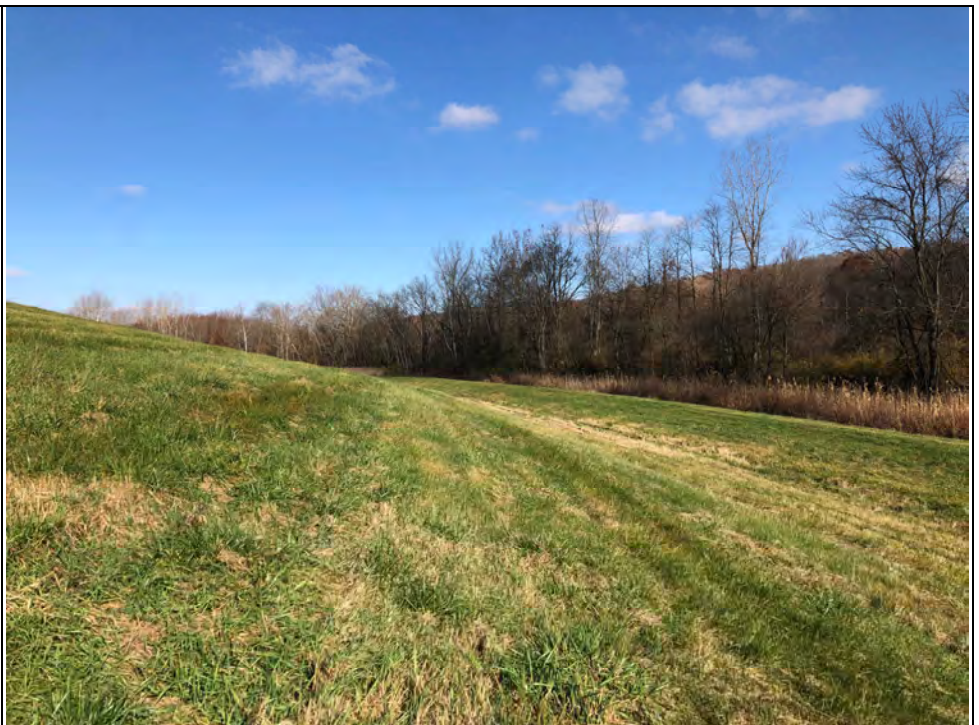
Image: 8172
Date: 11/12/2020
Time: 9:52 AM
Direction: North

Final Cover on Stage 6 sideslopes is in good condition with no evidence of damage from erosion, animals, or sloughing or stability issues.

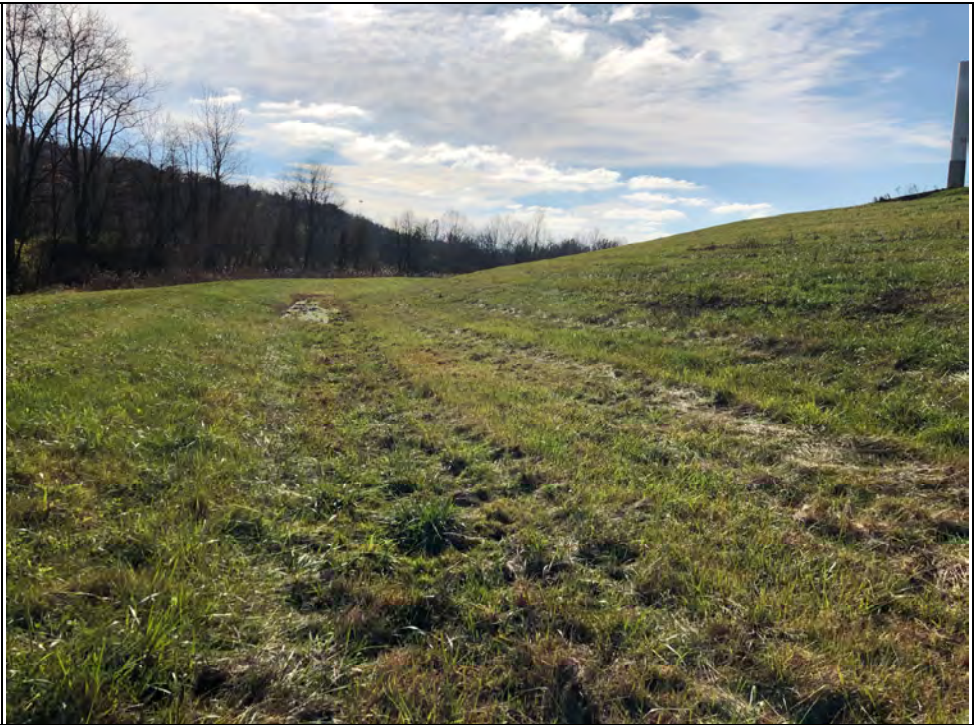
Non-contact stormwater ditch along Stage 5 is free of obstructions and does not exhibit scour or erosion issues.

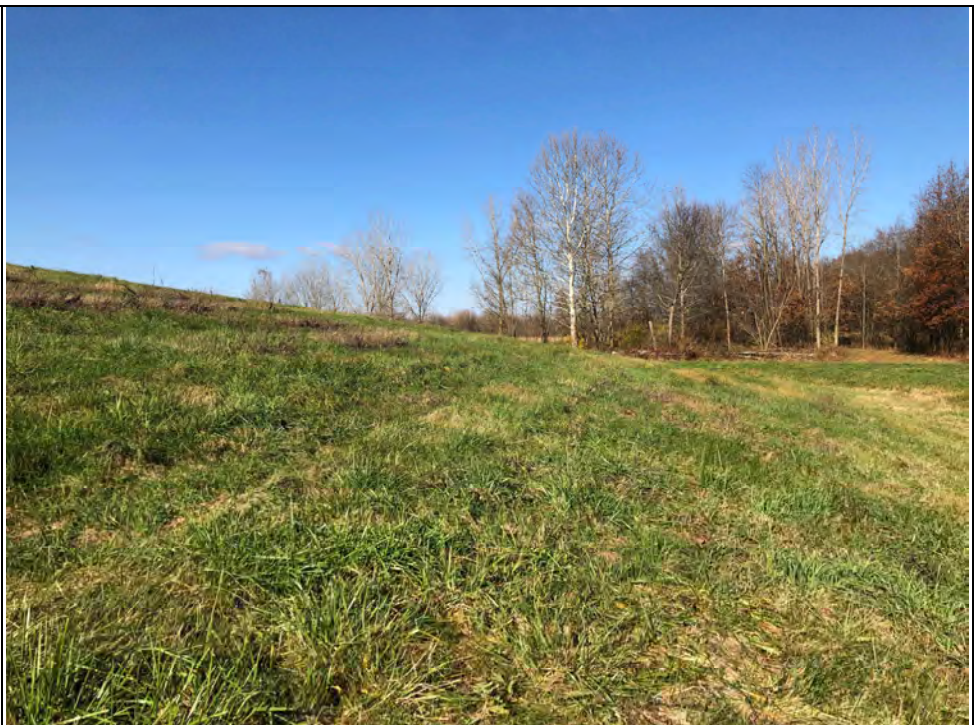
Image: 8176
Date: 11/12/2020
Time: 9:53 AM
Direction: Northwest

Non-contact stormwater ditch along Stage 5 is free of obstructions and does not exhibit scour or erosion issues.

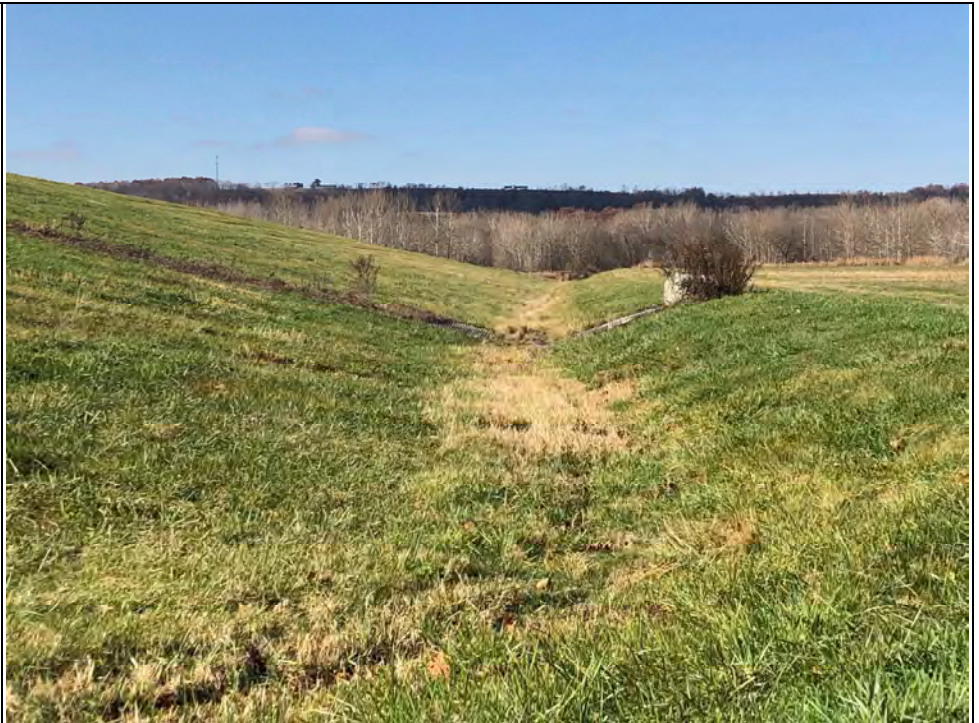
Non-contact stormwater ditch along Stage 5 is free of obstructions and does not exhibit scour or erosion issues.

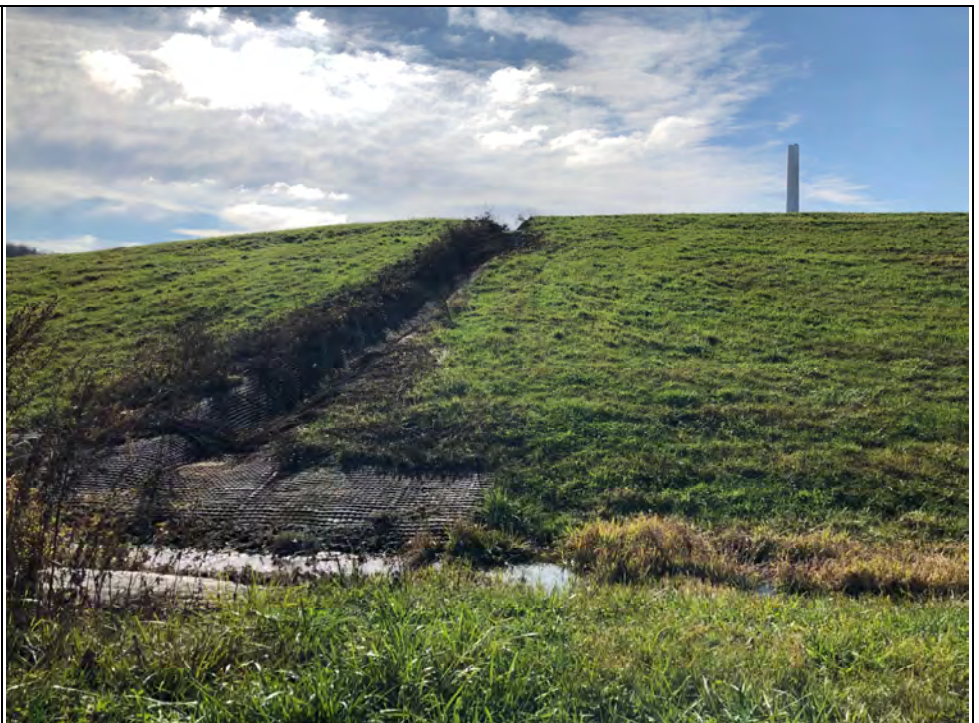
Image: 8180
Date: 11/12/2020
Time: 9:54 AM
Direction: Southeast

Non-contact stormwater downchute. Clear of obstructions. Revetment is in good condition. Functioning as intended.

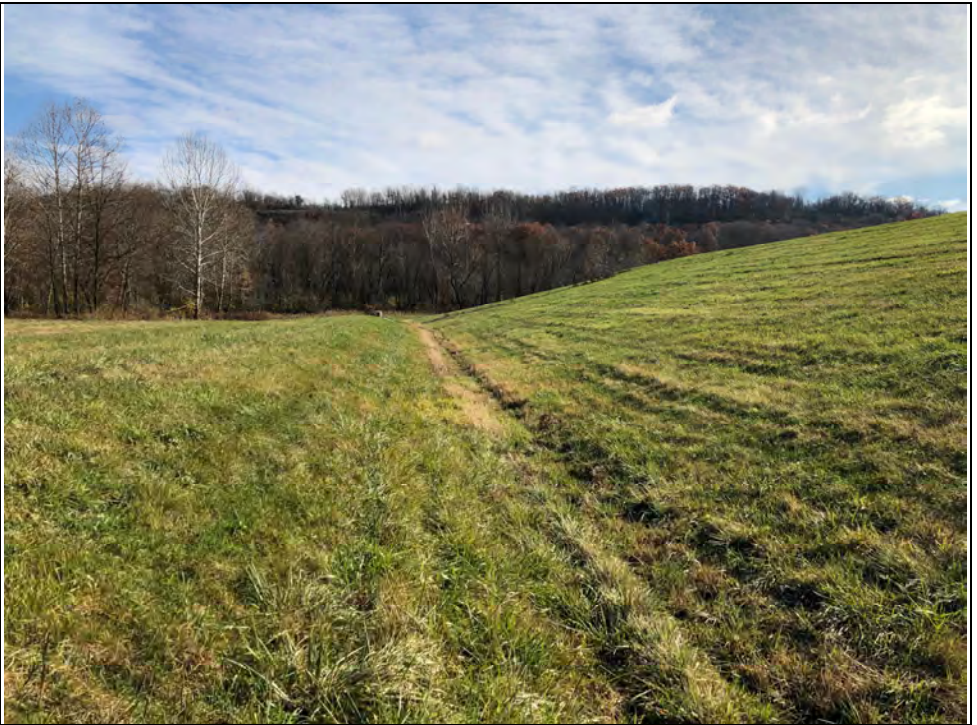
Non-contact stormwater ditch along Stage 5 is free of obstructions and does not exhibit scour or erosion issues.

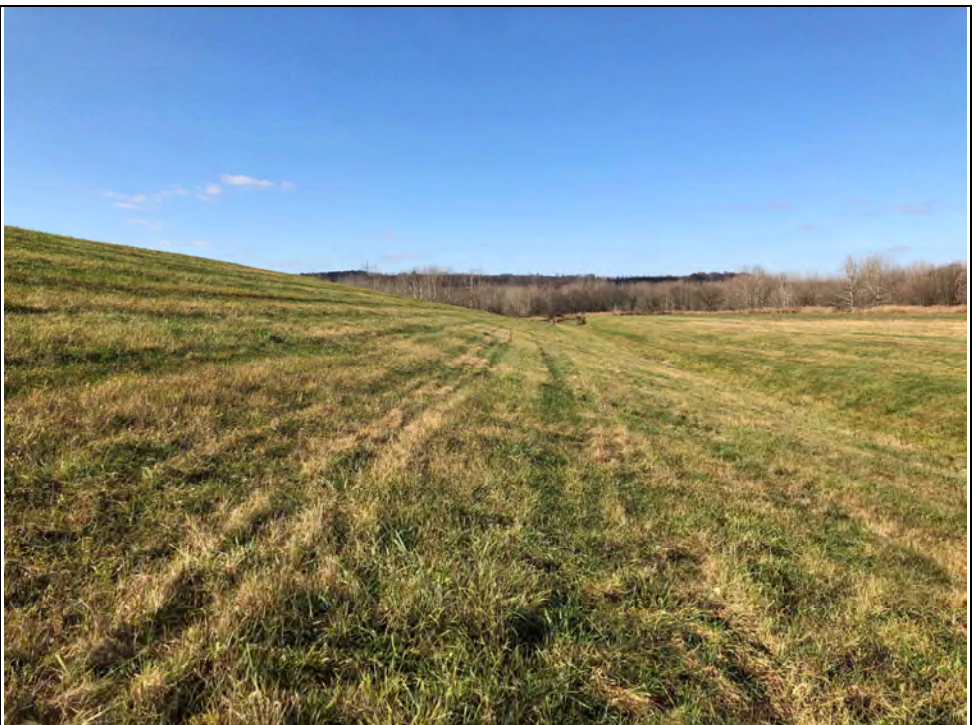
Image: 8184
Date: 11/12/2020
Time: 9:55 AM
Direction: West

Final Cover on Stage 5 sideslopes is in good condition with no evidence of damage from erosion, animals, or sloughing or stability issues.

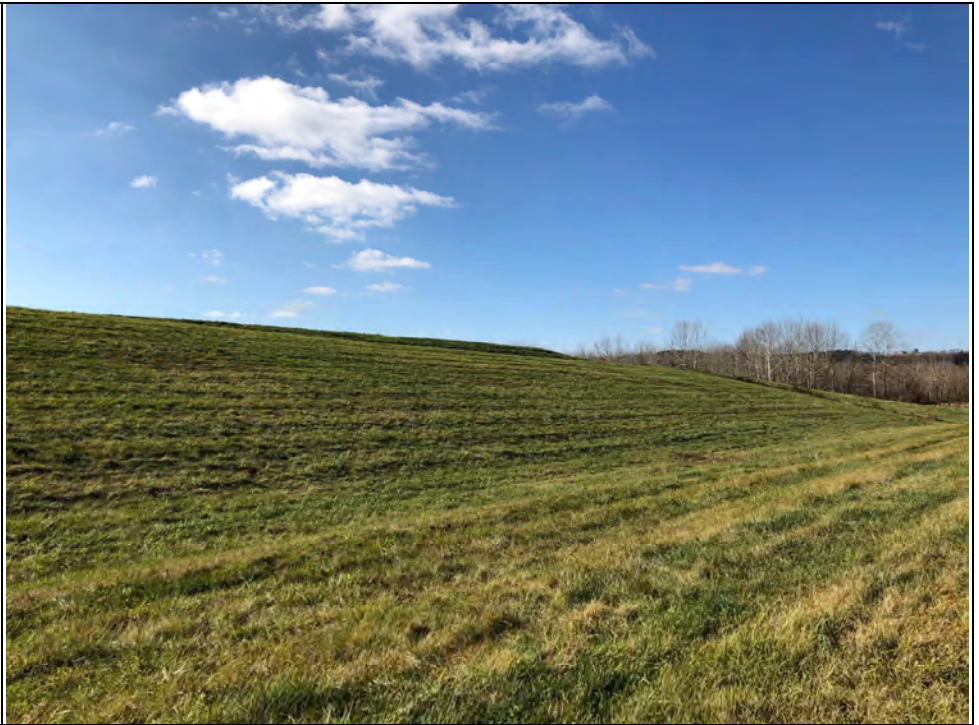
Final Cover on Stage 5 sideslopes is in good condition with no evidence of damage from erosion, animals, or sloughing or stability issues.

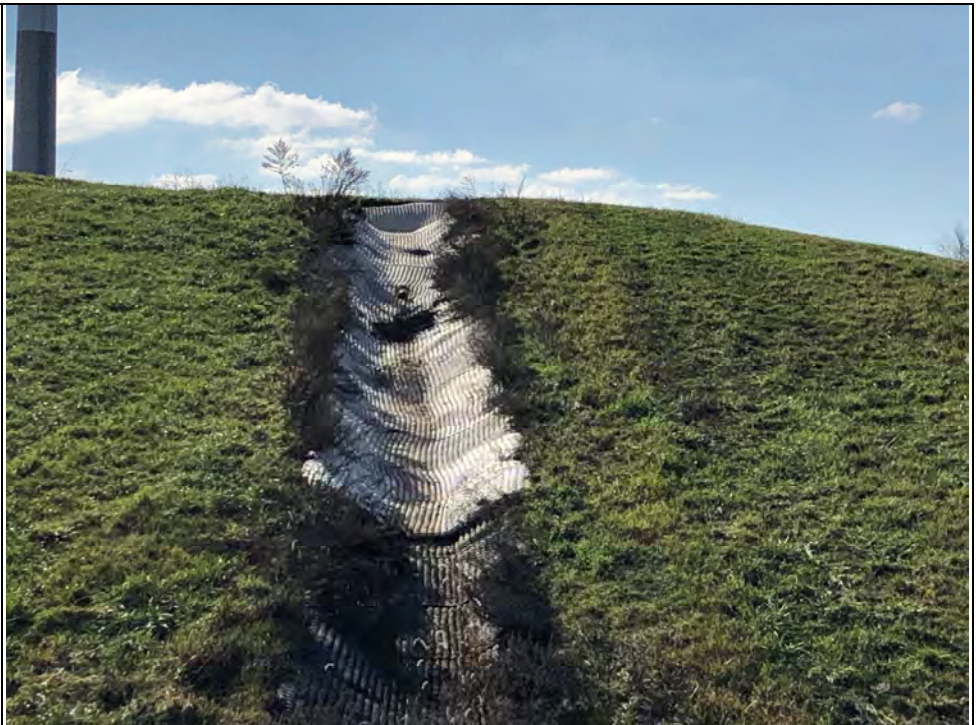
Image: 8188
Date: 11/12/2020
Time: 9:56 AM
Direction: South-Southeast

Non-contact stormwater downchute. The upper segment was replaced in 2020 because the 4-inch non-contact stormwater drain (shown in photo) became detached. This issue was identified during routine inspections and corrected. Downchute is functioning as intended after this repair.

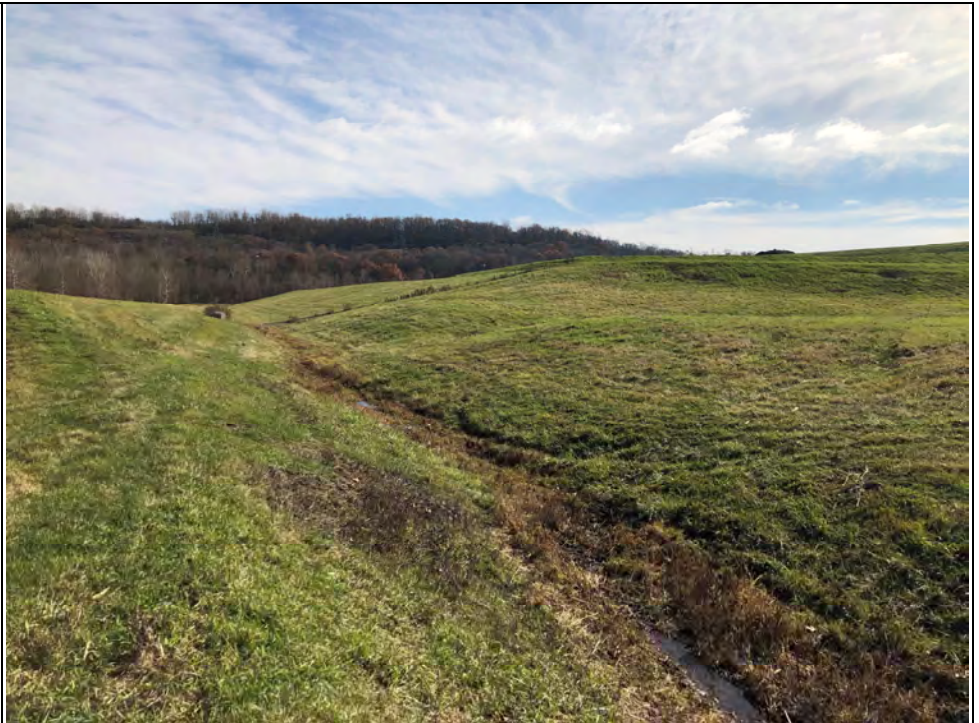
Non-contact stormwater ditch along Stage 5 is free of obstructions and does not exhibit scour or erosion issues.

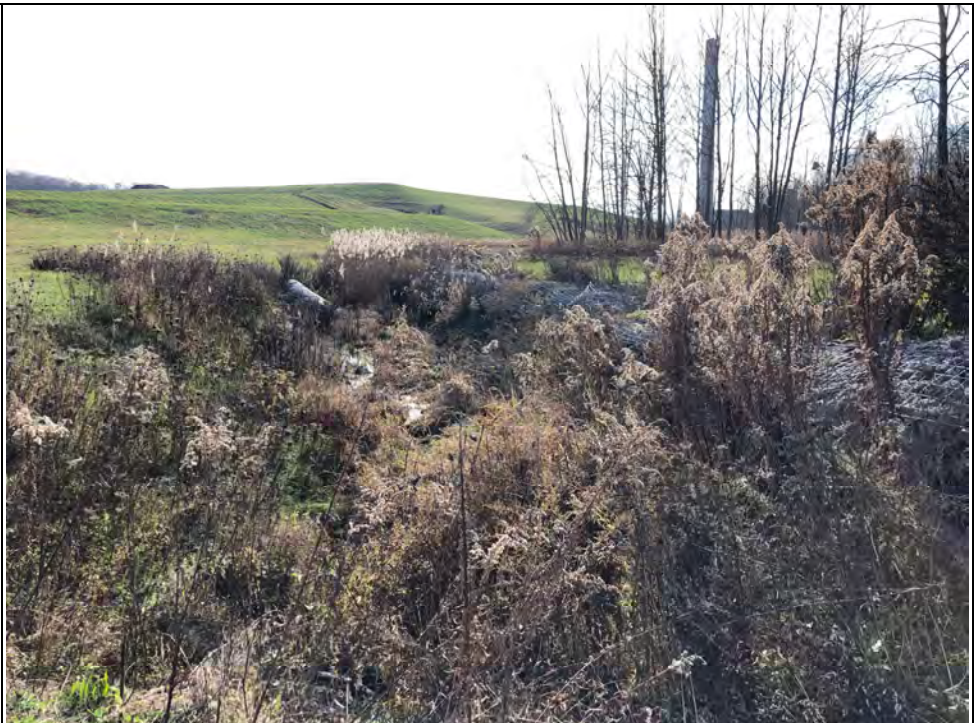
Image: 8192
Date: 11/12/2020
Time: 9:58 AM
Direction: Southeast

Stormwater ditch is in good working order.

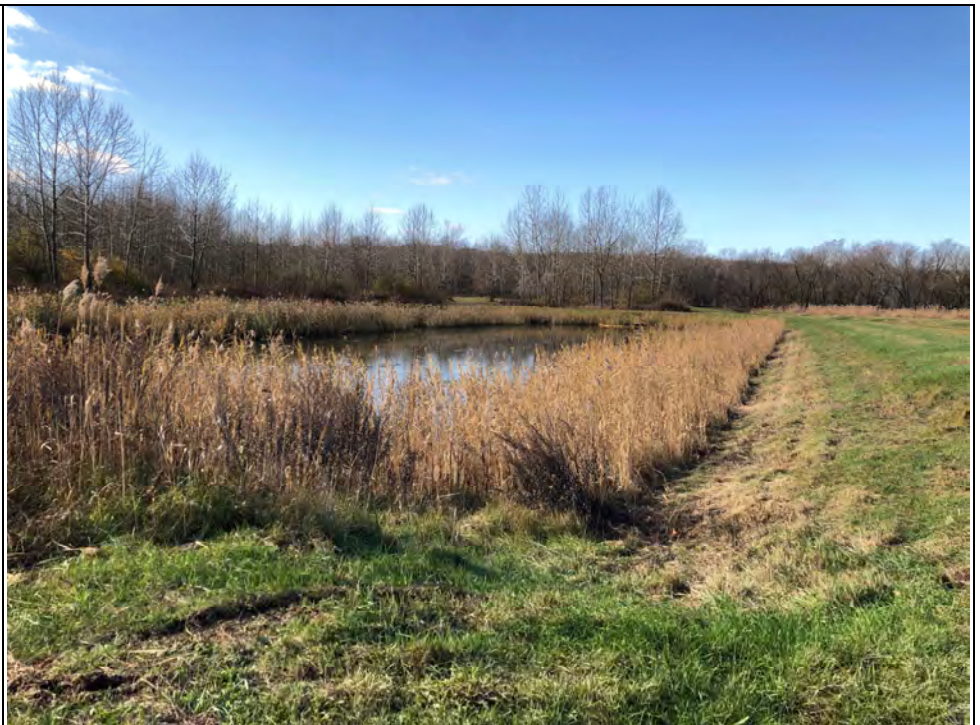
Leachate pond. No deficiencies observed.

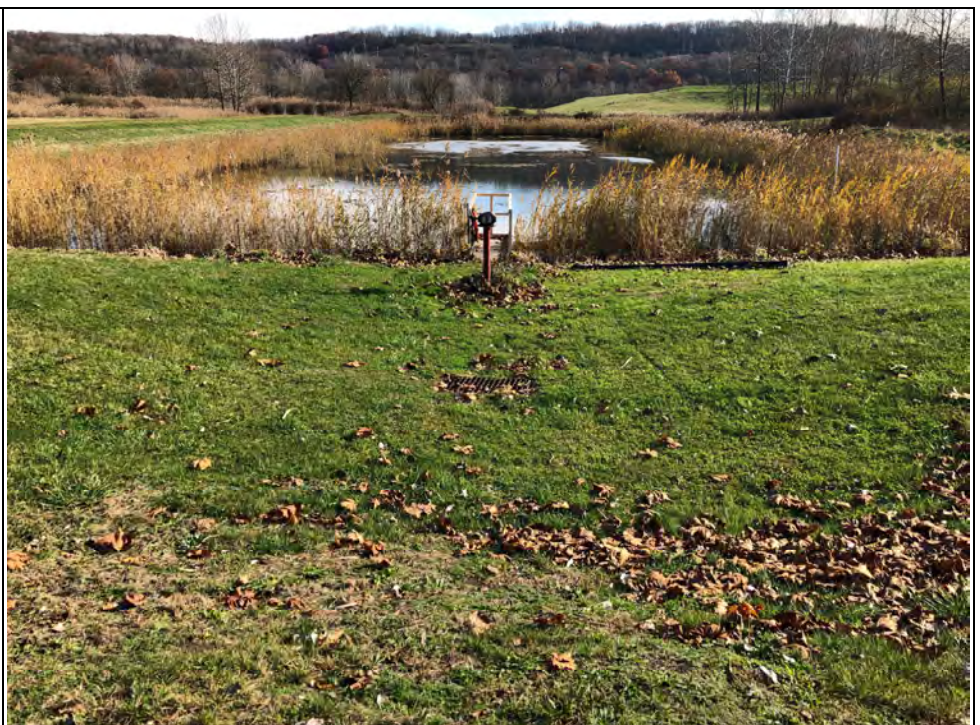
Image: 8200
Date: 11/12/2020
Time: 10:01 AM
Direction: East

Overview of leachate pond and gate valve at outlet. Leachate pond is in good working order.

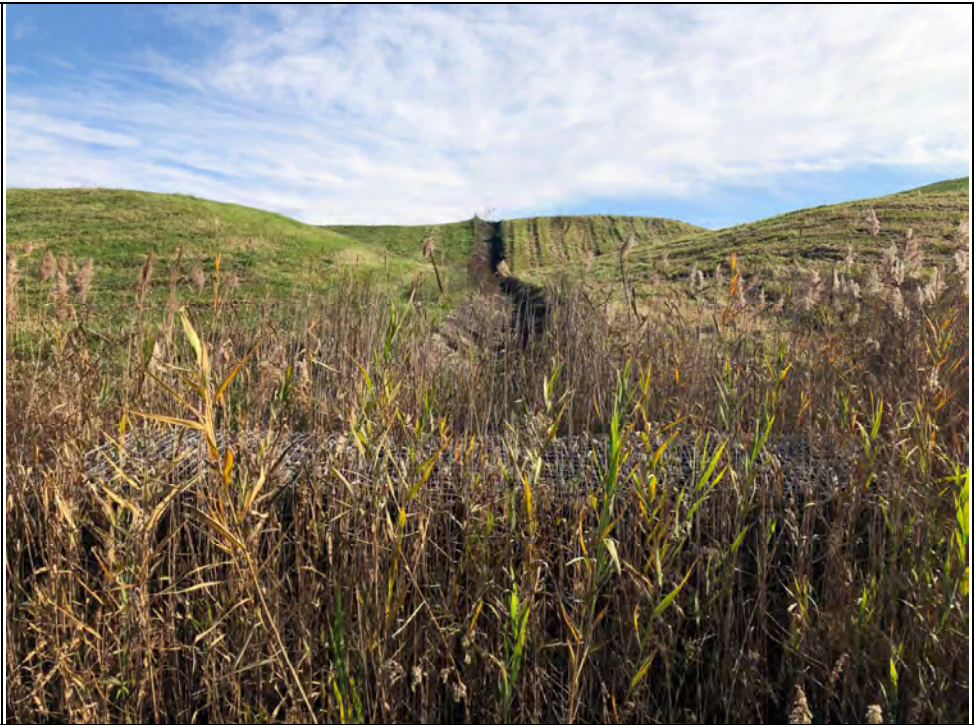
Non-contact stormwater downchute (background) and energy dissipation gabion basket. Clear of obstructions. Revetment is in good condition. Functioning as intended.

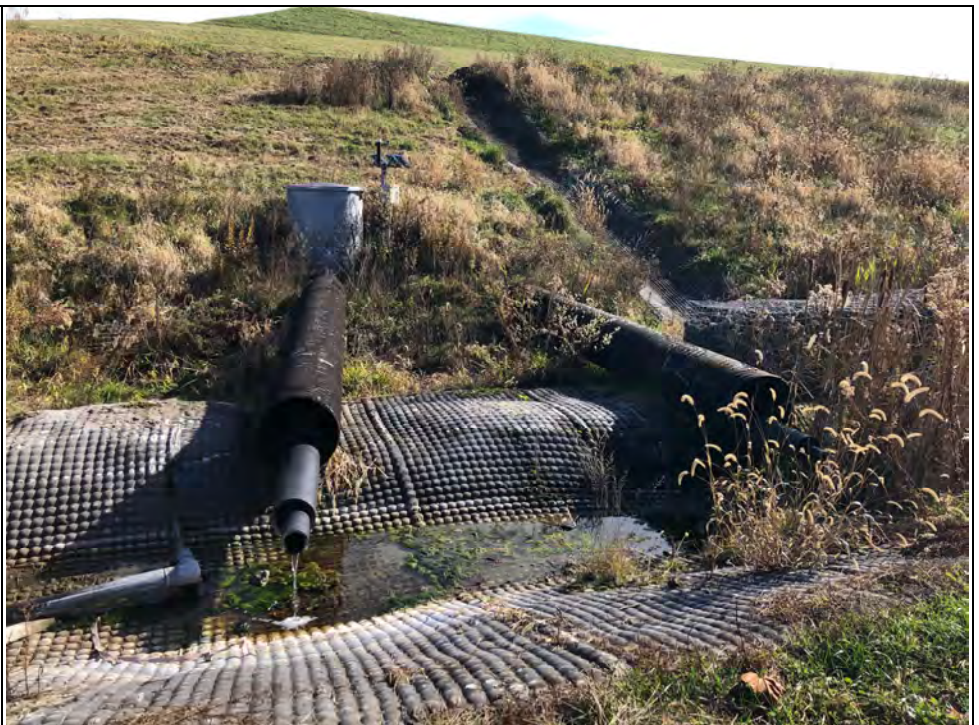
Image: 8204
 Date: 11/12/2020
 Time: 10:04 AM
 Direction: Southeast

Leachate pipe (on left) discharging into contact stormwater ditch, which ultimately flows to Leachate Pond. Leak detection pipe (on right) which was not flowing, demonstrating that the liner is not leaking. Ditch is clear of obstructions.

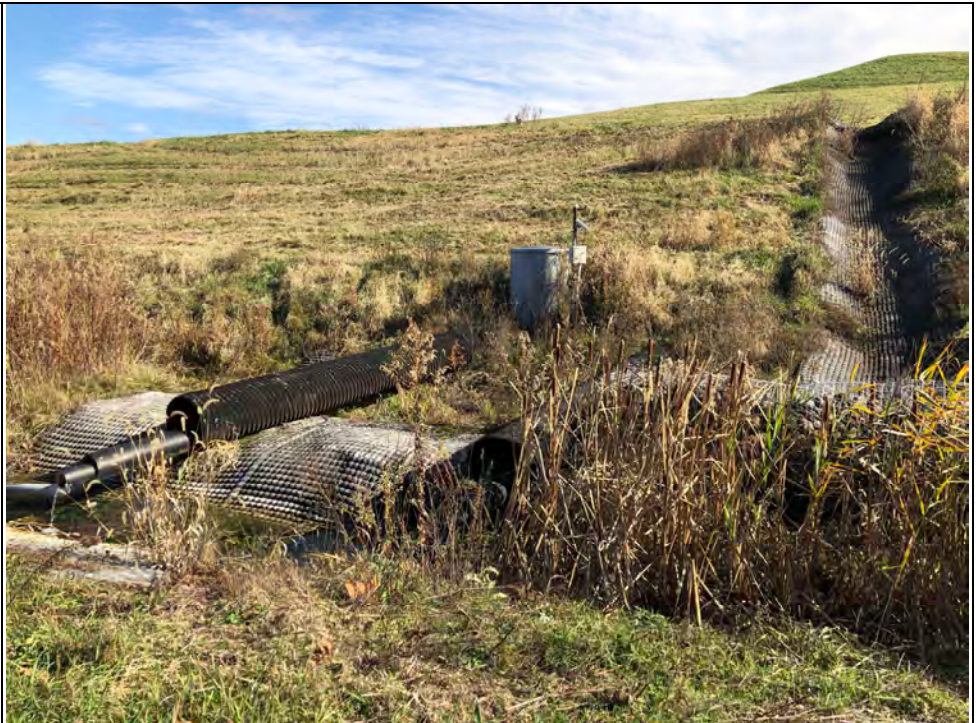
Leachate pipe and associated ditch is shown on left.
