Inspection Report

To: Brian Baierl (New Castle Generating Station)
From: Richard Southorn, P.E., P.G.
Re: New Castle Plant Ash Landfill—Annual CCR Unit Inspection Report
Inspection Date: November 12, 2020
Report Date: January 15, 2021

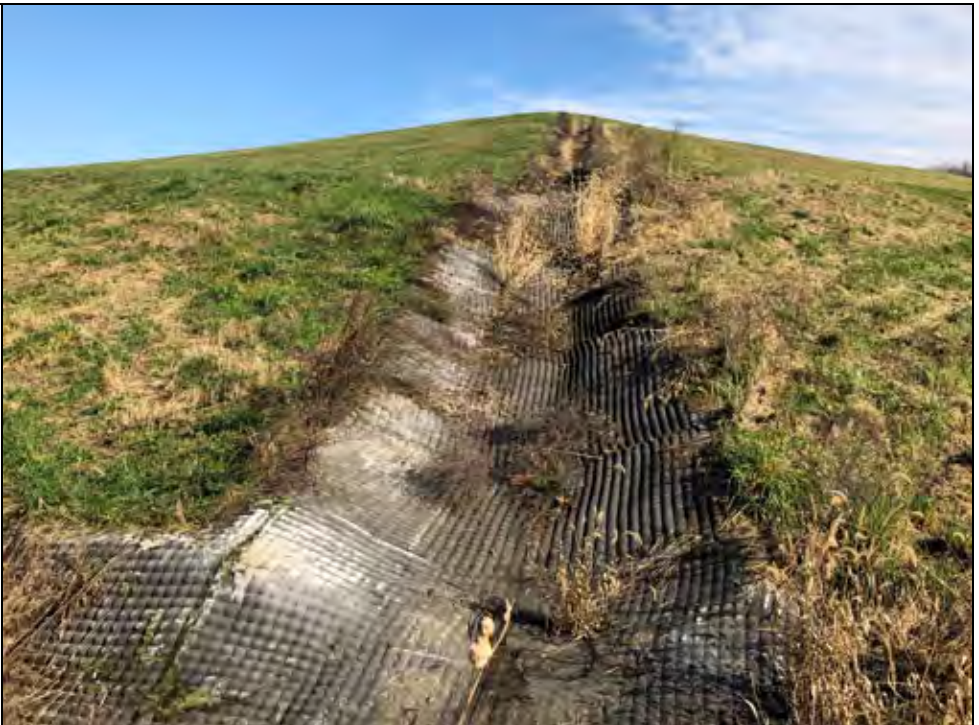
Image: 8216
Date: 11/12/2020
Time: 10:08 AM
Direction: Northeast

Non-contact stormwater downchute. Clear of obstructions. Revetment is in good condition. Functioning as intended.
