Inspection Report

To: Brian Baierl (New Castle Generating Station)
From: Richard Southorn, P.E., P.G.
Re: New Castle Plant Ash Landfill–Annual CCR Unit Inspection Report
Inspection Date: October 22, 2019
Report Date: January 16, 2020

**NEW CASTLE GENERATING STATION
WEST PITTSBURG, PENNSYLVANIA**

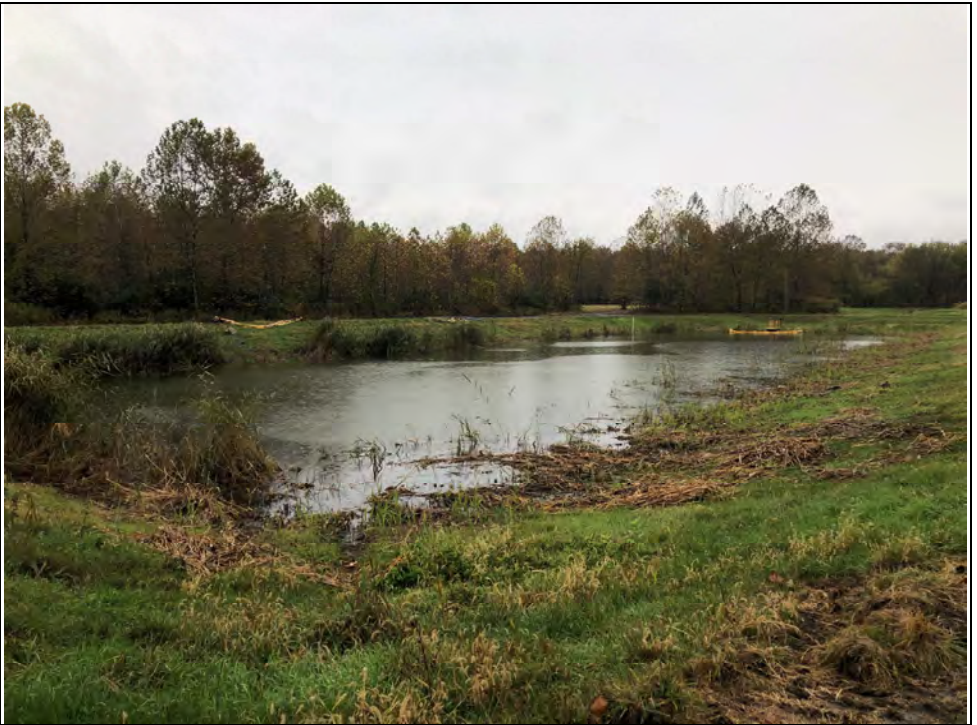
Image: 3815
Date: 10/22/2019
Time: 9:18 AM
Direction: East

Non-contact stormwater downchute. Clear of obstructions. Revetment is in good condition. Functioning as intended
