Inspection Report

To: Brian Baierl (New Castle Generating Station)
From: Richard Southorn, P.E., P.G.
Re: New Castle Plant Ash Landfill—Annual CCR Unit Inspection Report
Inspection Date: November 12, 2020
Report Date: January 15, 2021

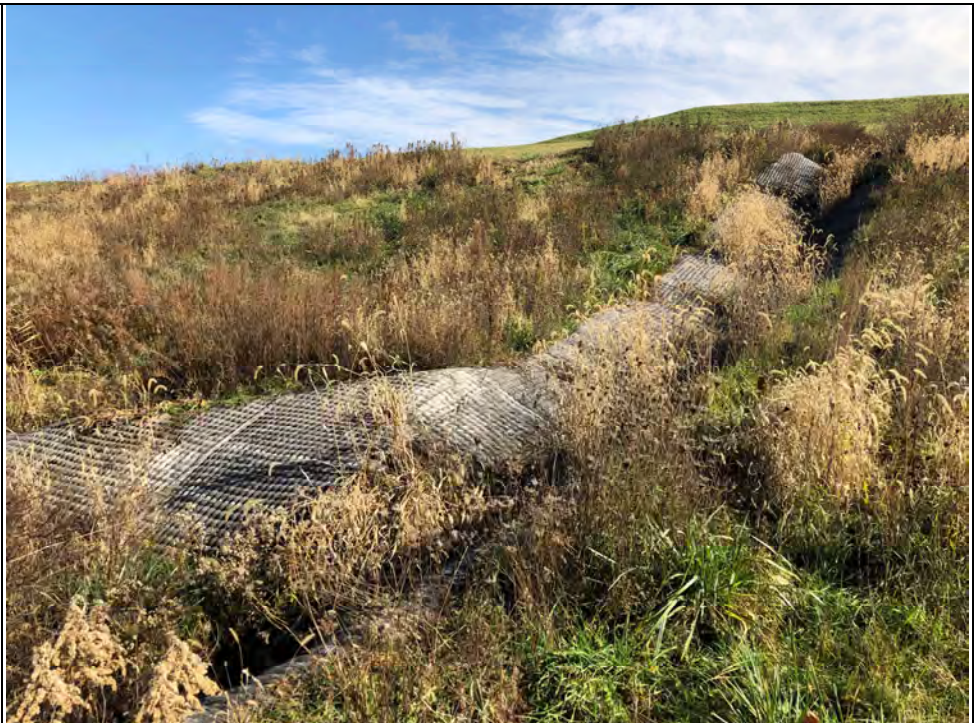
Non-contact stormwater downchute into non-contact stormwater ditch (right). A gabion basket energy dissipator reduces energy from stormwater as it enters the ditch (shown in foreground).

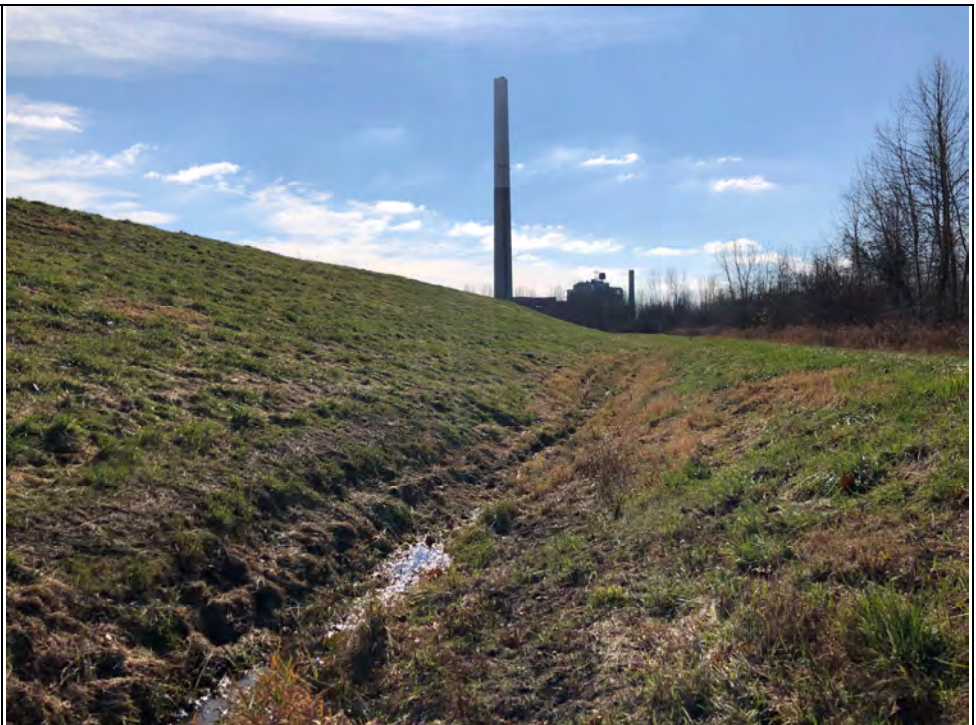
Image: 8210
Date: 11/12/2020
Time: 10:05 AM
Direction: South

Non-contact stormwater ditch along Stage 4 is free of obstructions and does not exhibit scour or erosion issues.

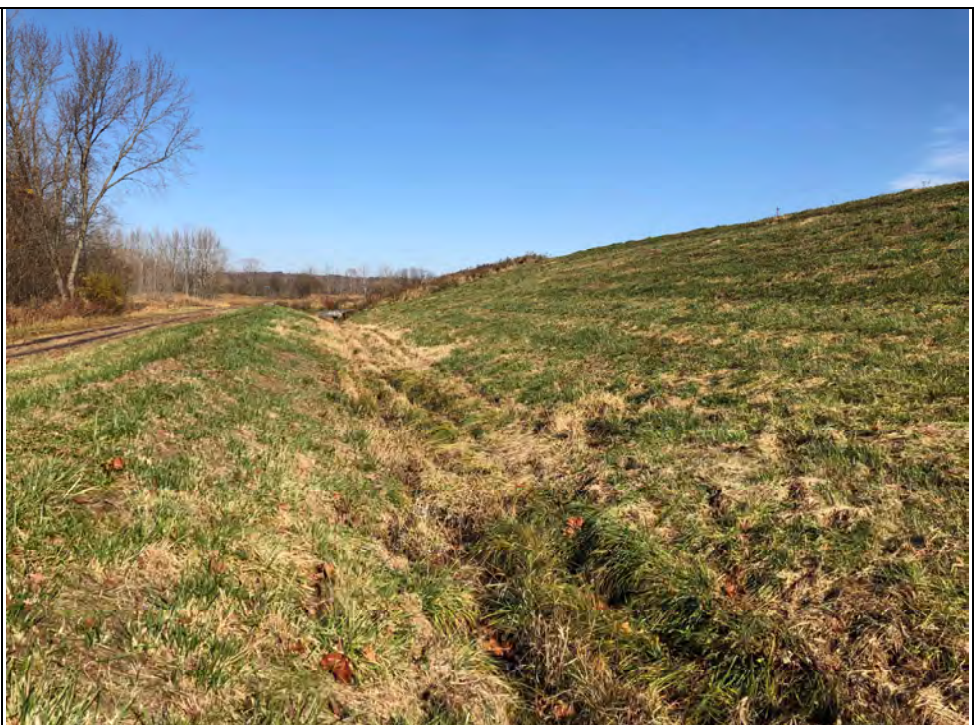
Image: 8212
Date: 11/12/2020
Time: 10:07 AM
Direction: North

Non-contact stormwater ditch along Stage 4 is free of obstructions and does not exhibit scour or erosion issues.

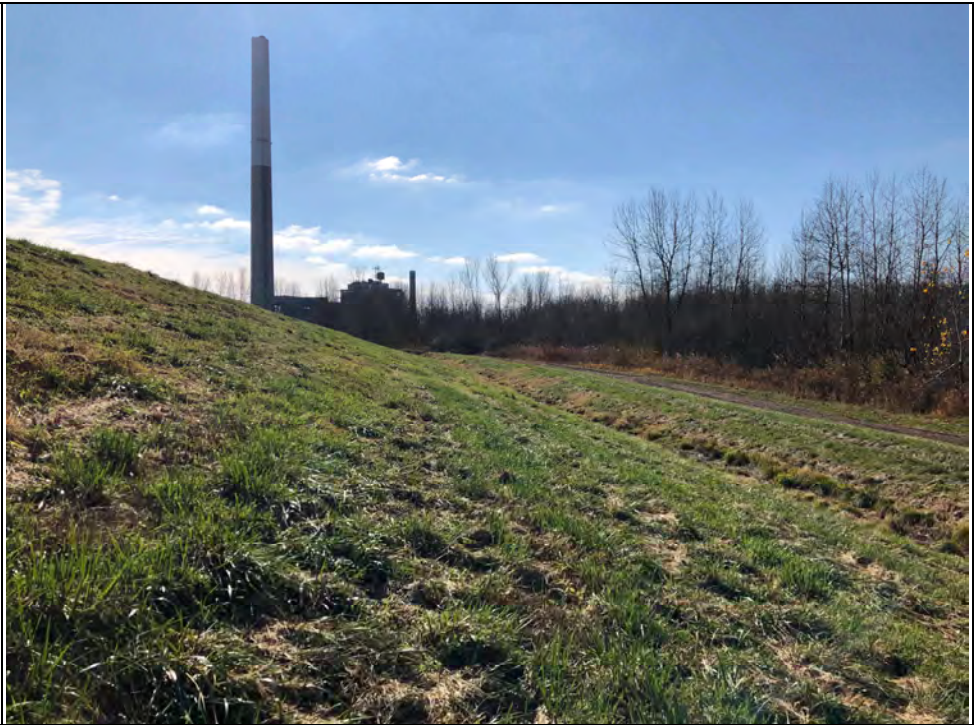
Image: 8214
Date: 11/12/2020
Time: 10:07 AM
Direction: South

Final cover on the sideslopes of Stage 4. Final cover vegetation is healthy and well established. No stability concerns evident.

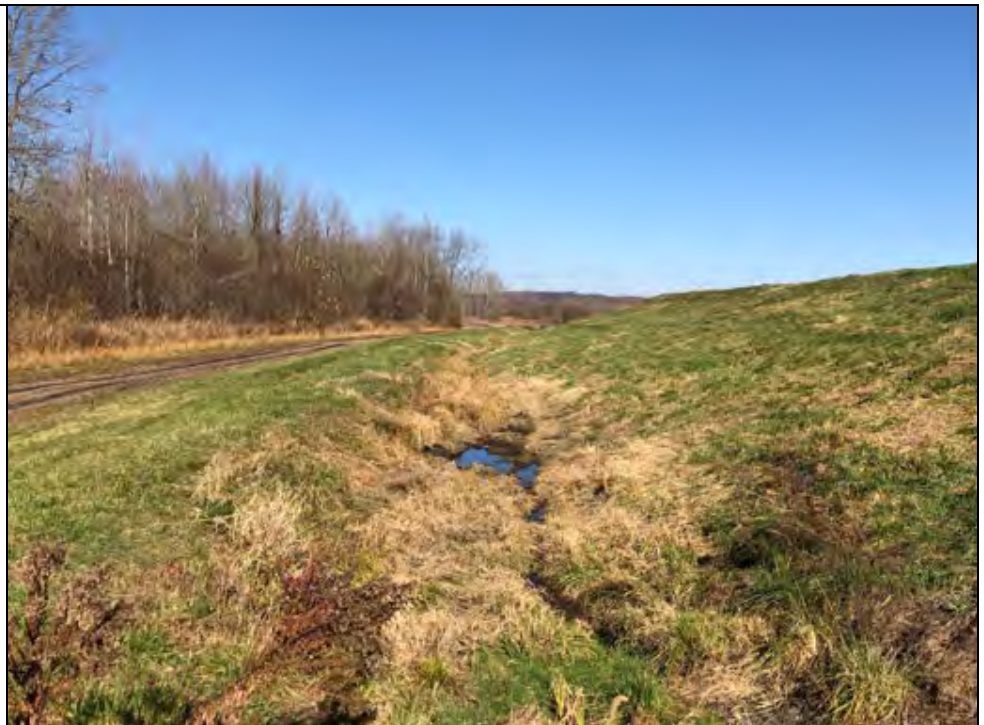
Image: 8217
Date: 11/12/2020
Time: 10:08 AM
Direction: North

Non-contact stormwater ditch along Stage 4 is free of obstructions and does not exhibit scour or erosion issues.

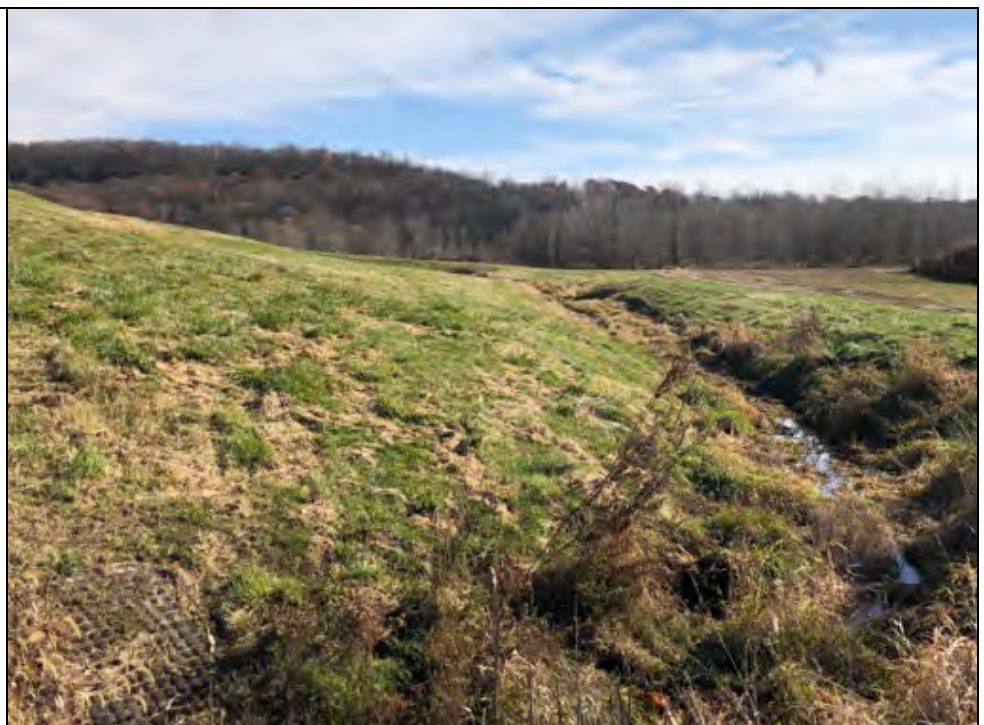
Image: 8218
Date: 11/12/2020
Time: 10:08 AM
Direction: Southeast

Non-contact stormwater ditch along Stage 4 is free of obstructions and does not exhibit scour or erosion issues.

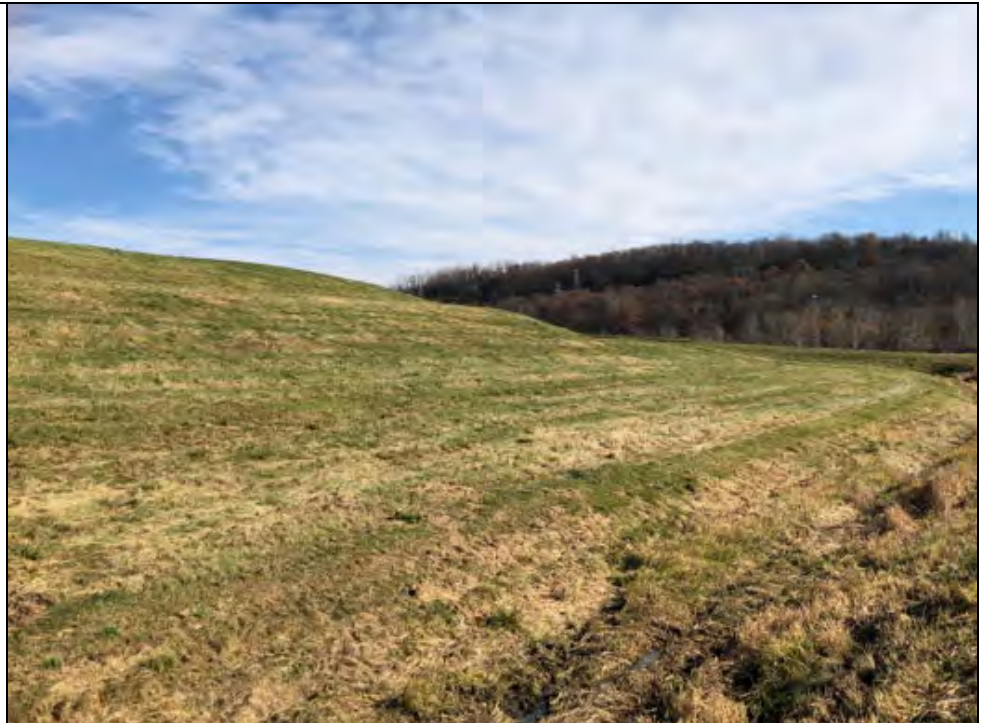
Image: 8219
Date: 11/12/2020
Time: 10:09 AM
Direction: Northeast

Final cover on the sideslopes of Stage 4. Final cover vegetation is healthy and well established. No stability concerns evident.
